AIR RESCUE REPORT

International Commission for Alpine Rescue

October 9 - 12, 2008 - Chamonix - France

ACCIDENTS & INCIDENT REVIEWS FROM MEMBER COUNTRIES:

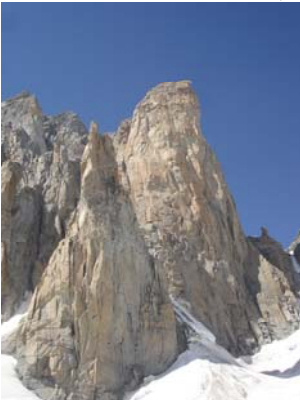
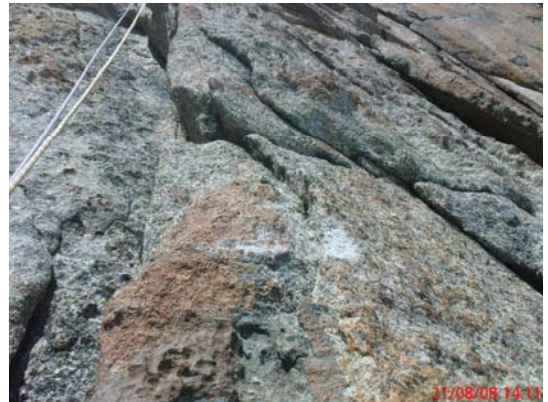
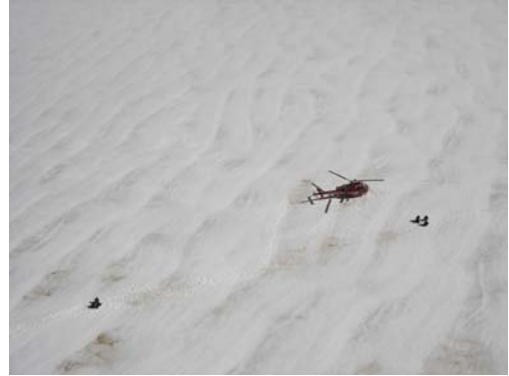
France – Accident, Rotor Strike. While on a high angle rescue on the Swiss Route of the Grand Capucin in the Mont Blanc Massif, an Alouette III of the Securite Civile experienced a main rotor strike. A climber had experienced a 40 metre leader fall and sustained serious injuries. Two

rescuers were hoisted onto the accident site separately.

Given the steepness of the terrain, all available 40 metres of hoist cable were used. Given the severity of the injuries, the rescuers requested that the doctor attend the scene. While the crew was hoisting the doctor towards the ledge, the main blades of the helicopter struck the granite wall. The doctor was down 30

metres. The pilot struggled to maintain control of the aircraft and pulled away from the wall. The hoist operator told the pilot he would take care of getting the doctor back on board while the pilot performed an emergency landing. The pilot headed immediately for the glacier below and was able to land the aircraft safely after running it on over 50 metres horizontally. The hoist operator was able to get the doctor back inside before the helicopter hit the ground. During the debrief, the crews commented that with additional cable length, they would have had a larger margin of safety. The victim was a trained mountain guide rescuer known to the rescue crew. To complicate the operation, there were other climbers above the helicopter during the hoisting operation.

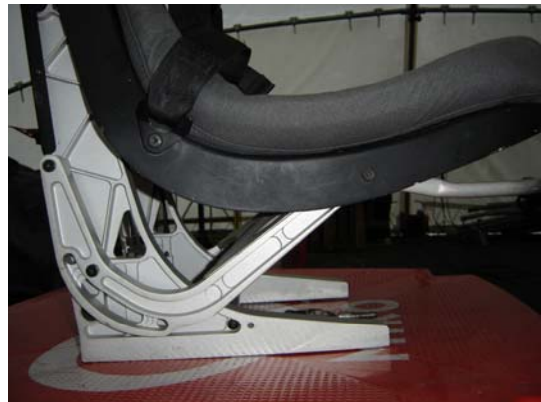
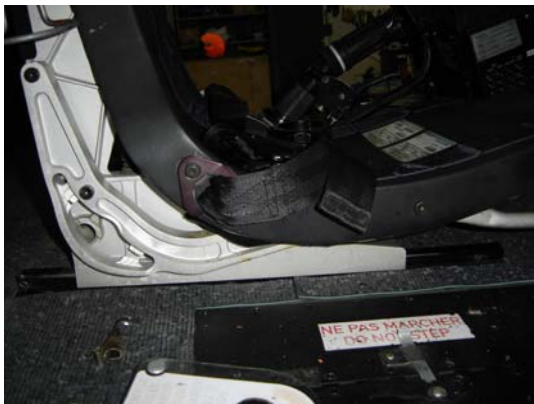
France, accident, crash

An AS350B3 crashed on take-off in the Chamonix area. The helicopter lost power while it was climbing and crashed on a glacier. There were two important factors that allowed the pilot to escape with minor injuries. His helmet prevented him from sustaining head injuries and the crash absorbing seats minimized back injuries.

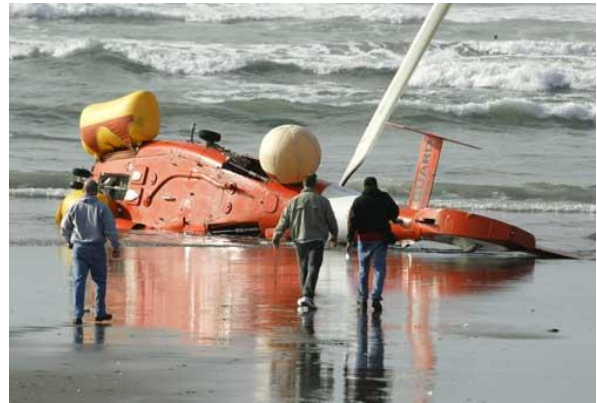
The U.S. Coast Guard released their “final report” on the February 11, 2006 helicopter rescue accident, which took place along the Humboldt Coast of California. The accident involved a USCG HH-65 Dauphin, which responded from Air Station Humboldt Bay with crew of four to an 18-foot boat capsized in the surf with four persons in water. Finding an 82 year-old female in cardiac arrest, the rescue swimmer was deployed from the helicopter. The rescue swimmer moved the victim to the beach and conducted CPR. As the helicopter re-positioned over the remaining victims, the number one engine suddenly shut

down resulting in a “rapid power loss”. The helicopter crashed from a 25 foot hover into shallow water 40 yards from shore, where all three crew members exited uninjured and reached the beach. Two of the four original rescue victims died.

The USCG Report has identified that the co-pilot was in the process of moving from the cockpit to the aft cabin, in order to be hoisted into the surf. During this movement, his flight helmet accidentally snagged the engine fuel flow control lever overhead. *“The copilot was focused on not making contact with the primary flight controls and failed to adequately judge clearance to the overhead console.”* A lack of policy was in place for this acknowledged procedure. For years the in-flight movement from the cockpit to the cabin was an “unofficial practice” used to carry out missions. The USCG has now validated the need for this procedure and will develop a formal policy with associated training.

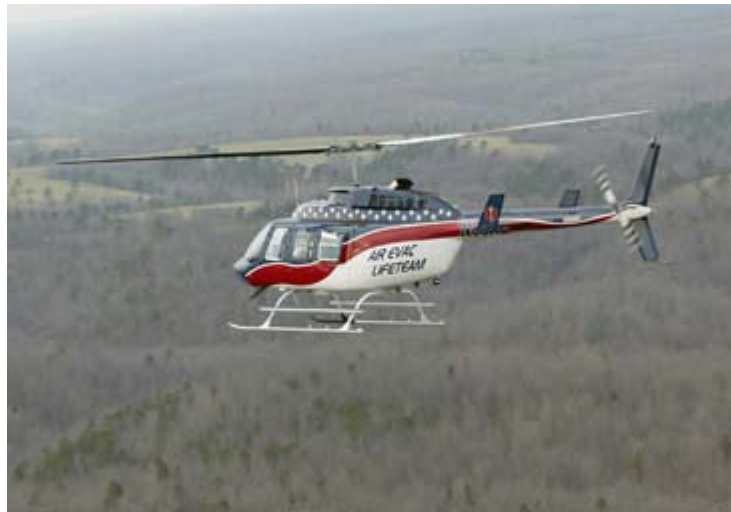
On December 30, 2007 AIR EVAC LIFETEAM Bell 206 L3 crashed near Cherokee, AL, in the Freedom Hills Wildlife Management Area, while assisting in the search for a missing hunter. According to the NTSB, *“the flight was a voluntary mission, as the operator would not receive payment for the flight unless the hunter required air transport to a hospital.”* The helicopter crewmembers had

located the missing hunter with a spotlight and intended to illuminate him till ground rescuers reached him. The helicopter was about 100-150 feet above the trees, and in a hover or very slow flight, when the witnesses heard a decrease in engine noise, followed by an increase in engine noise. They then observed the helicopter spinning right, with a "fireball" near the engine exhaust, as it descended vertically into wooded terrain. The pilot, paramedic and nurse were all killed in the crash at 0306 hours.

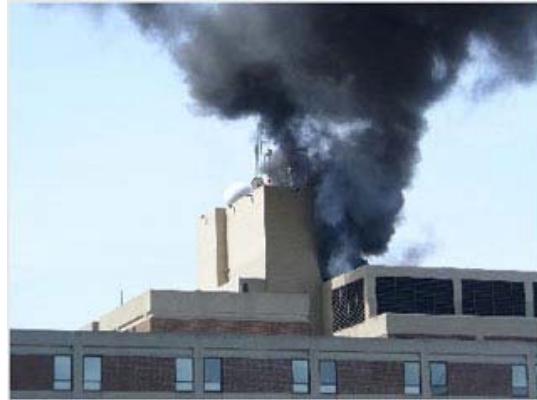
Aero Med Accident in Grand Rapids. MI

May 29- Aero Med S-76A crashed at 1101 hours on Spectrum Hospital roof in Grand Rapids, MI. FAA observer and pilot aboard sustained injuries, but exited aircraft before it was consumed by fire.

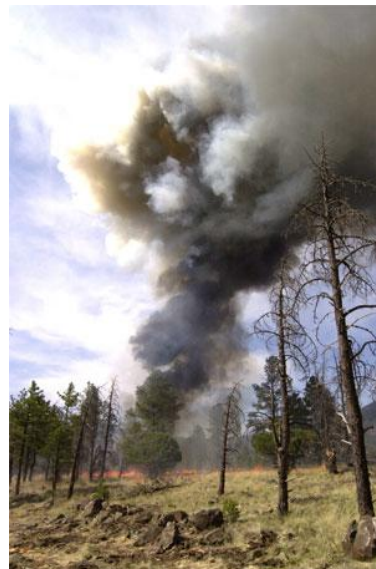
HEMS Mid-Air Collision, Flagstaff, AZ

June 29: Classic Lifeguard and Guardian Air Bell 407 helicopters collide in mid-air at 1547 hours near Flagstaff Medical Center in Arizona, killing seven people in clear weather. Both aircraft were in-bound to the hospital with patients aboard.

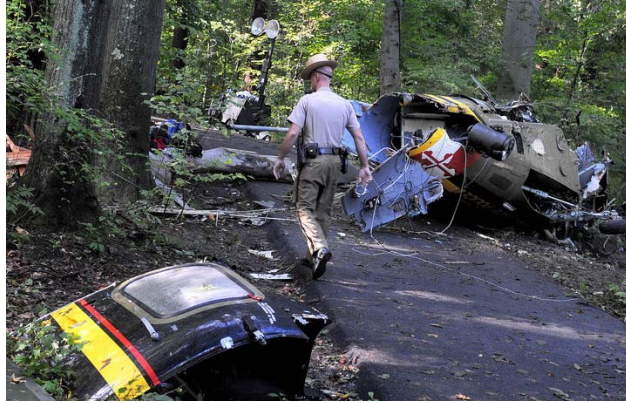
Wreckage of Maryland State Police AS365 Dauphin

Sept. 27- Maryland State Police AS365N1 Dauphin crashed at 2358 hours near Forestville, MD in IFR conditions, while transporting two patients. Four of the five persons on board were killed.

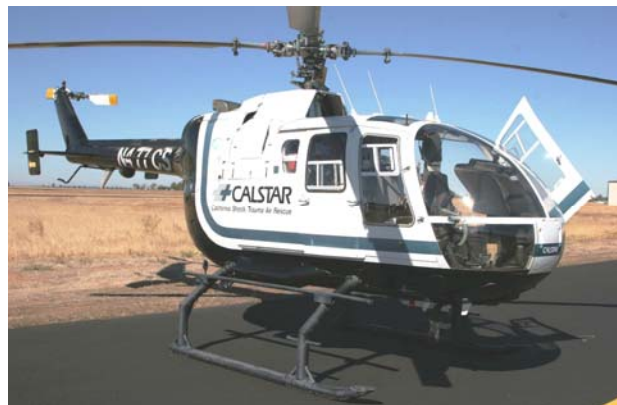
One month prior to the Flagstaff, AZ mid-air collision, a hauntingly similar accident nearly occurred in Sacramento, CA. On May 27, 2008 a HEMS CALSTAR BO105T was on approach to Sutter Roseville Medical Center landing pad with patient aboard in clear weather. The aircraft had to take evasive action to avoid a public agency Bell 205 on collision course. The Sacramento Metro Fire Department Bell 205 helicopter never changed course. It was assumed the CALSTAR aircraft was never seen by them. As a result of this incident, CALSTAR officials are working to develop an assigned statewide HEMS radio frequency.

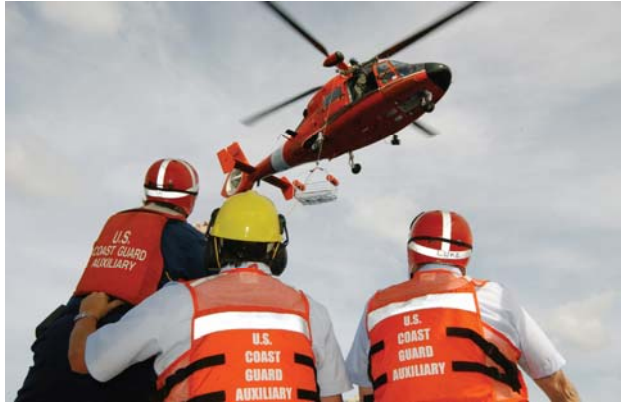
On September 4, 2008 a U.S. Coast Guard HH-65 Dauphin crashed at about 8:15 pm near Honolulu, Hawaii, off the coast of Oahu, killing the four crew members on board. The aircraft was conducting night-time small boat hoisting drills with a 47-foot motor lifeboat at the time of the accident.

According to media reports, “a distress signal was received from the Coast Guard vessel participating in training two minutes before the accident.” Rear Adm. Manson Brown, Coast Guard Sector Honolulu Commander, has stated, *“the line used to lower a rescue basket to the sea apparently malfunctioned.”* A USCG official confirmed *“Snagging of the hoist cable was involved. Don’t know at this time if it was a factor.”* The chopper's fuselage and data and voice recorder were later recovered and are being examined.

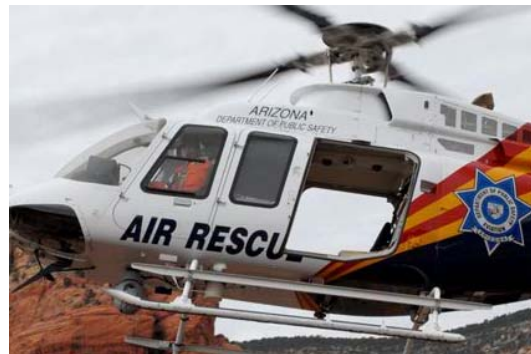
On October 13, 2008 a 36 year-old Arizona Department of Public Safety (DPS) Air Rescue paramedic was killed during a helicopter rescue near Sedona, AZ.

Bruce Harrolle, a 9-year veteran of the rescue unit, was fatally struck by the main rotor blades of the Bell 407 helicopter. The rescue helicopter with pilot and paramedic had responded from their Flagstaff base, at the request of the Sedona Fire Department, to provide assistance in locating two uninjured “stranded hikers” in the Bear Mountain area. While the helicopter responded, Sedona FD personnel visually spotted a male and female couple matching the description and DPS was asked to verify location and identity of the hikers. The DPS crew landed near the hikers on Bear Mountain in a rugged drainage. The helicopter, which is equipped with high skids, landed with both skids on the ground, however the uneven terrain forced the pilot to maintain a “power-on landing” for stability of the aircraft. Bruce escorted the male subject to the aircraft and was in the process of the loading the female hiker, when the accident occurred. As he escorted her to the helicopter, they momentarily became physically separated on either side of a cactus. When they reconnected Bruce stood upright facing the helicopter from the twelve o’clock position and he was struck by the rotor blades.

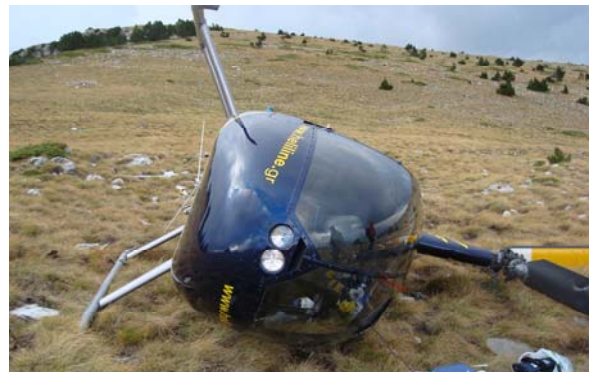
A Robinson Helicopter crashed during an October 5th rescue attempt on Mount Olympus. This non-fatal crash occurred in windy conditions as the aircraft attempted to evacuate a casualty from the 2,200 meter elevation on the mountain. The light helicopter had lifted off with a limited fuel load on board to increase the allowable weight and the flight crew weight was 140 kg. The aircraft experienced a “downwash” over a ridgeline” and suffered a sudden five meter drop to the ground. The aircraft impacted and rolled on its side. The only injury was sustained during breaking the Plexiglas to exit the aircraft.

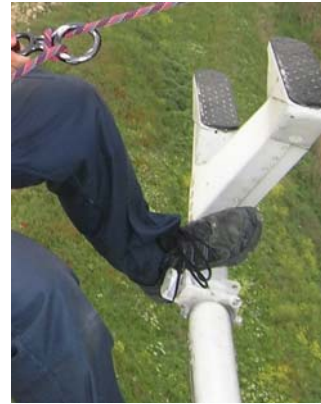
On April 12th an entanglement incident occurred during a heli-rappel training session. As a trainee rappelled from a rented Eurocopter AS 350 helicopter, his shoelace became entangled in an exposed mounting bracket on the aircraft skid. The entanglement was brief as the rappeller was able to free himself and reach the ground. The actual incident was captured on film. The involved rescuer was new and performing their initial helicopter rappel, although they had previous rappelling experience. Following the incident, a rappeller safety check is now conducted by an instructor and prior to rappelling from a helicopter training rappels are conducted from a bridge. It is worth noting that entanglement has been pointed out as a recurring problem in previous IKAR/CISA reports.

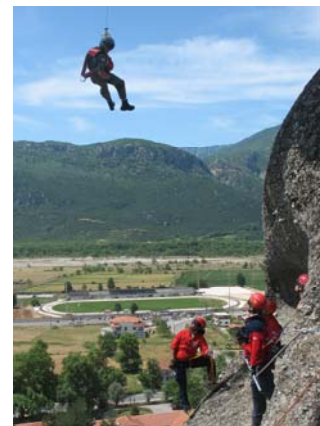
Extreme communication difficulties hampered a hoist training exercise in the Greek Meteora Region. During the training, the pilot of a Greek Military Super Puma had extreme difficulty with inserting rescuer on to the shoulder of a large boulder. In spite of a human relay, ground rescuers were unable to provide adequate radio communications as the helicopter approached the scene due to their radio transmissions being blocked by the terrain. Once over the scene, the pilot worked laboriously for a long time trying to place the rescuer on target. Finally, the rescuer was placed down slope and climbed up the targeted site. Reviewing the incident, it was recognized that during every exercise with the Greek military there is a different aircrew involved. This situation makes it very difficult for rescue personnel to develop solid working relationships. The ground-to-air communications have been improved with the use of three human relays on subsequent training missions at this site. There has been an IKAR/CISA recommendation since 2003 stating "Every HEC operation should be conducted with a proper two-way radio communication system".

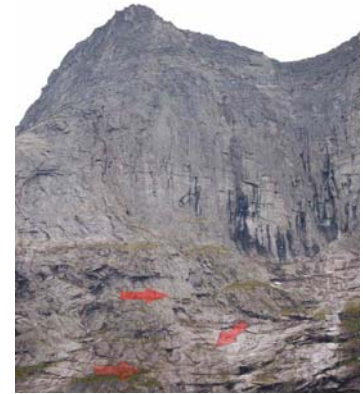
A fatal BASE accident in the Trollveggen (aka Trollwall) became complicated during the helicopter recovery effort. Rescuers located fatality by helicopter and then used captured video images to confirm what appeared to be an obvious fatality. A Sea King was then brought in to the scene and was in the process of lowering a rescuer via hoist, when rotor wash filled the BASE jumper's chute causing the victim to be dragged over a cliff edge and sustain an additional 150 meter drop. The post-incident review pointed out the consideration for conducting the rescuer insertion away from the accident scene to eliminate associated rotor wash hazard, during a mission where there is an associated parachute at the accident scene.

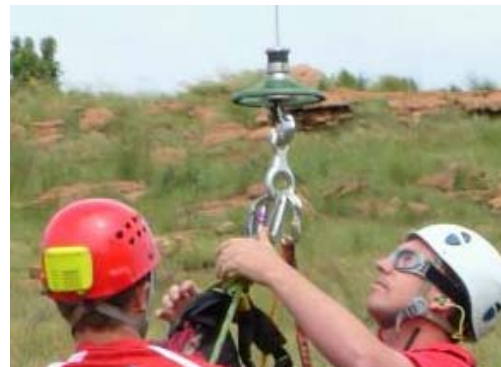
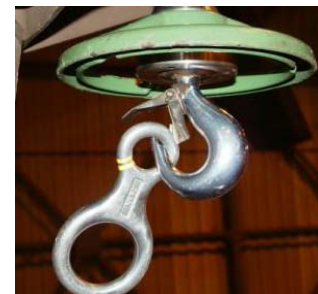
A dynamic rollout from a hoist hook nearly occurred during helicopter hoist rescue refresher training session on March 2, 2006. Although the incident occurred two years ago, it is being reviewed here following release of an official investigative report.

This training was being conducted by the Mountain Club of South Africa's Mountain Rescue Team (Gauteng) in conjunction with 17 Squadron, South Africa Air Force at Dome Kloof in the Magaliesberg. Two members were being hoisted into an SA330 Oryx Helicopter, which was hovering at a height of approximately 16m (50') AGL. As the two members neared the aircraft (2-3m below the aircraft, 13-14m off the ground) one of them noticed

that the figure eight device, to which they were both connected, had undergone a partial dynamic rollout from the hoist hook and was suspended on the lip of the hook. The rescuers decided to complete the hoist rather than try to signal the flight engineer to lower them back to the ground. The hoist was completed and no one was injured. The training session had 11 MCSA SAR members involved, which included two new trainees paired with other team members. Neither of these two "novice" team members was involved in the incident.

The rescuers each had attachment extensions from their harnesses which were connected by carabiners to the large ring of a single common (shared) figure eight abseil device. The small ring of the figure eight was then clipped into the hoist hook, giving one single point of attachment onto the hoist hook. The investigation determined that one of two scenarios occurred. The two rescuers allowed slack to

develop in the system just before they were lifted off the ground, or they were lifted off and then momentarily put back down again, resulting in slack in the system. Once this occurred it is believed that the figure eight became loaded upon the hoist hook latch (keeper). The hoist hook latch was constructed of rolled metal in contrast to the cast cargo hook. The deformed hook latch partially released the figure eight, which instead of falling free from the hoist hook, came to rest on the lip of the hook. The aluminum figure eight, which is a soft metal in comparison, permitted the hoist-hook to gouge a groove in it and ultimately come to rest in that gouged groove.

- Figure eight is being discarded as a helicopter hoisting connector.
- Adjustment of rescuer sling to no longer than harness-to-shoulder length.
- Rescuers are advised to support the hoist hook assembly under tension till they lifted.

- A standardized set of hand signals for use by rescuers and air-crews during hoist operations will be adopted.
- The MCSA SAR procedure recommends the use of steel twist-lock carabiners for helicopter work. Steel-on-steel components will slip instead of gouging into one another.

- Air-crews should be reminded that the procedure for hoisting is to lift the rescuer using the aircraft collective. Once the rescuer is off the ground they should inspect their connection to the hoist hook, and only when signaled to proceed, raise the rescuer up to the aircraft. If the hoist is used to lift the rescuer from the ground, it is possible that a small but sharp descent by the aircraft could result in a rescuer being put back on the ground. This in turn could result in the entire hoist hook connection to capsize into a hazardous configuration for lifting.

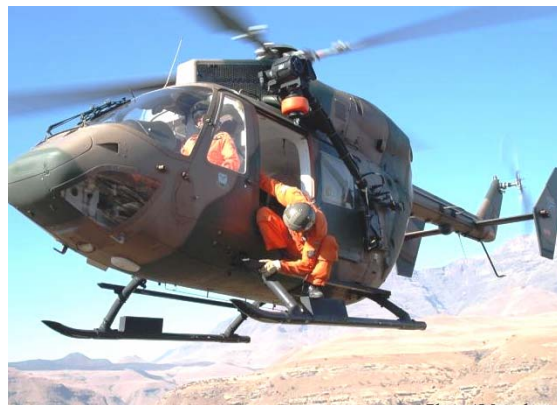
During a Mountain Club of South Africa's Mountain Rescue Team helicopter hoist training exercise with a South African Air Force BK- 117 an entanglement was encountered. The BK-117 is equipped with a "Mandela Step" to assist the 90 year-old former President with getting on board the helicopter. During a hoisting evolution the lip of the step snagged the leg loop strap of a rescuer's harness, causing the rescuer to be entangled with sudden and severe compression to the affected leg.

The location of the incident turned out to be fortunate as the rescuer was able to reach up and grab the hoist operator's leg in order to get their attention for immediate assistance. The potential for this step to be an entanglement hazard had been previously considered.

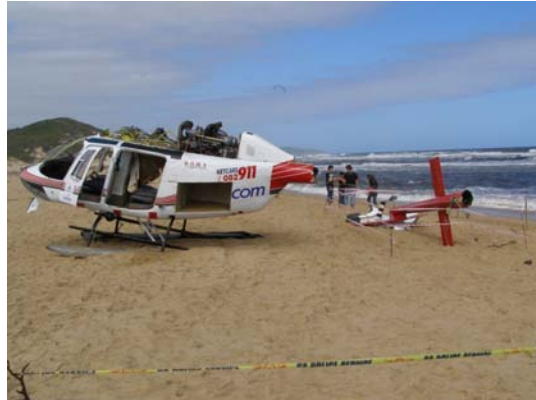
A Bell 206 Jet Ranger crashed during a joint-agency surf rescue short-haul training exercise at 1300 hours on December 18, 2007. The training was being conducted by National Sea Rescue Institute (NSRI) along with a Vodacom Netcare 911 Surf Rescue helicopter. The Jet Ranger ditched in the surf, approximately 50 meters off-shore, near Groot Brak River, between Mossel Bay and George. The pilot, Paul Davidson and the duty NSRI helicopter crewman, Jaco de Jong, safely exited the aircraft and received assistance by the two Vodacom Netcare 911 Surf Rescue swimmers who had been in the surf preparing to be static line hoisted. The two rescue swimmers were not injured in the crash. Preliminary reports indicate that the accident might have been caused by “dynamic rollover.” The accident report is pending from the South African Civil Aviation Authority (CAA). Vodacom Netcare 911 Surf Rescue helicopters are based in Durban, Margate, Port Elizabeth, George and Cape Town. Each is crewed by a pilot, a Netcare 911 medic, an SA Lifesaving rescue swimmer and an NSRI rescue swimmer.

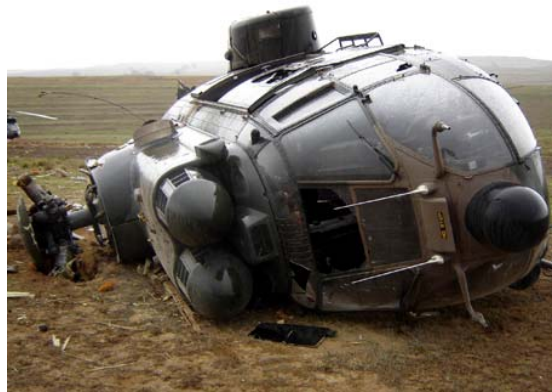
On November 21, 2007 a South African made Oryx, which is equivalent to the Eurocopter Super Puma, crashed in the mountains near the town of Wepener. The accident occurred in South Eastern Free State inside the Lesotho border. The aircraft was on a law enforcement pursuit mission when it went down during a high speed tight turn. The helicopter was carrying a total of 19 personnel on board, including the crew, at the time. One police officer died in the crash.

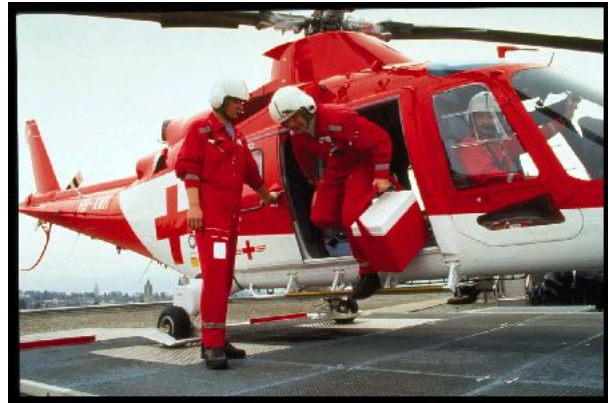
The second incident with an Augusta 109 Power involved ground resonance. The helicopter landed on a heliport and started to experience vibrations so high that the pilot was not able to maintain control. The vibration was so bad that the main rotor damper separated and flew 200 metres away. Collapse of the main landing gear followed. There were no injuries.
