AIR RESCUE REPORT

International Commission for Alpine Rescue

IKAR-CISA

September 23 - 26, 2009 - Zermatt – Switzerland

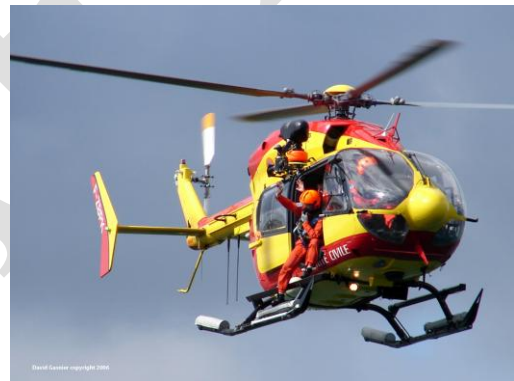
France-Engine failure. An EC145 of the Sécurité Civile was on final approach when one of the two engines failed. The pilot aborted the landing and returned to base where he landed uneventfully. Initial speculations were that the five mobile phones on board may have interfered with the overspeed box but this was later dismissed. The incident is still under investigation.

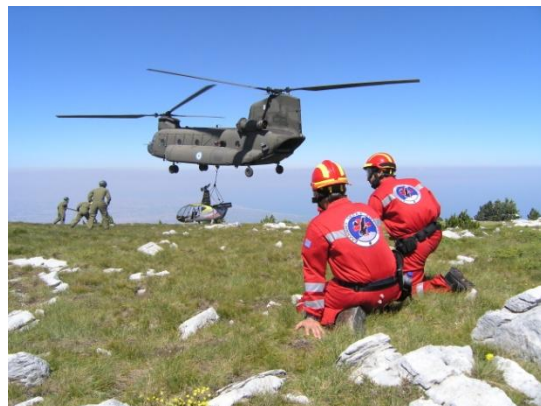
Greece-Crash. A Robinson R44 crashed while accessing a rescue site. None of the crew were severely injured in the crash. The wreckage was removed with a military Chinook.

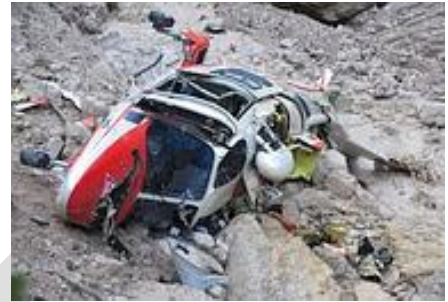
Italy-Cable strike A109

While investigating a landslide for victims near Belluno, an A109 struck cables spanning the valley. The aircraft crashed and all four occupants on board died.

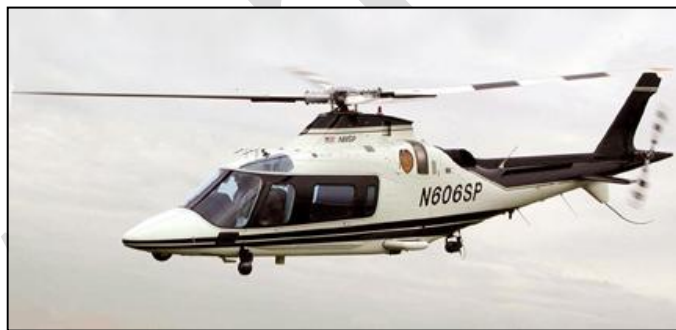
United States (New Mexico) - Accident

On June 9, 2009 a New Mexico State Police Agusta A109E crashed during the attempted rescue of an uninjured hiker near Santa Fe Baldy Peak 12,632 feet (3,850 m) near Santa Fe, New Mexico.

Instrument meteorological conditions prevailed when the helicopter impacted terrain, killing the 46 year-old pilot and female subject. The pilot and police spotter had landed after locating the search subject just before dark. Dispatchers had directed the helicopter crew to the missing hiker, as they spoke with her by cell phone. While the pilot hiked off from the landing zone to reach the subject, the weather deteriorated and began sleeting. The pilot returned carrying the hiker on his back. After becoming airborne, storm clouds closed in around the helicopter. Based on radio transmissions, the pilot reported "we hit a mountain," and continued to fly for at least one minute. The helicopter impacted terrain and rolled 800 feet down a steep talus slope. The deteriorating weather conditions were known in advance and the helicopter response lacked a formal mission briefing between all personnel involved. The incident commander had not dispatched and was not in operational control of the helicopter during the mission. The flight crew was not prepared with adequate survival equipment to remain at the landing zone overnight. A late season snowstorm hampered rescue efforts and the spotter, who was the sole survivor, was not located until the following day.

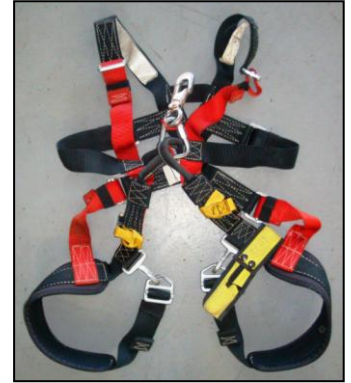
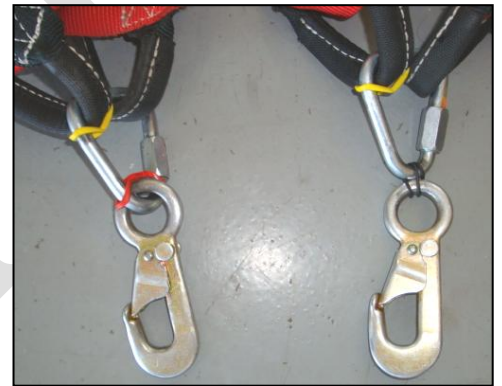
United States (California) – Heli-Rappel Accident

A 20 year-old US Forest Service Firefighter died on July 21, 2009, when he fell 200 feet during a proficiency heli-rappel training session. The incident occurred during the 6,000 plus acre (2428 hectare) Backbone Fire on the Shasta-Trinity National Forest (CA). The accident occurred during the initial load of rappellers for the training exercise. Personnel were on board the Bell 212 helicopter on the ground, with the engine running, while safety checks were completed. During the safety check, it was observed that the involved firefighter was missing an elastic O-ring keeper within the triangular screw link on his harness. The screw link is the connection point on the rappeller's WBBH-HR-2 Harness to a spring-loaded locking "J-hook", which is ultimately connected to the Sky Genie descender on the rappel line. The firefighter left the aircraft and got his harness reconfigured with the missing O-ring. The O-ring was tragically configured in such a manner that it created the sole connection between the triangular screw link and the "J-hook". The training exercise proceeded without the improper rigging being detected. The aircraft was stabilized in a 200 foot hover, away from other aircraft at the helibase. As the involved firefighter leaned back and loaded his harness, the connection created by the lightweight O-ring failed, causing him to fall un-arrested to the ground below. The aircraft landed immediately, and following resuscitation attempts, the firefighter was pronounced dead at the scene.

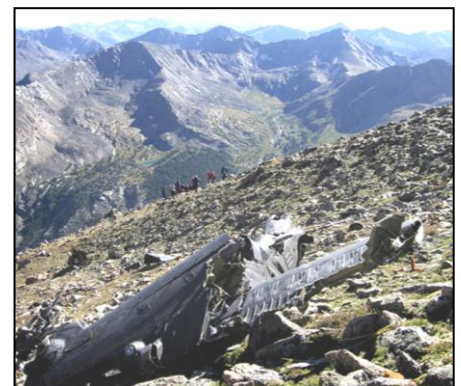
United States (Colorado) – Accident

Four soldiers died on August 19, 2009 after a Black Hawk helicopter crashed 400 feet (122 m) below the summit of Colorado's 14,421-foot (4,396 m) Mount Massive, during a training mission. The high-altitude training began from Peterson Air Force Base in Colorado Springs, which is 90 miles (145 km) east of Mount Massive. The helicopter was assigned to the 160th Special Operations Aviation Regiment (Airborne) at Fort Campbell, KY. Soldiers in the 160th are known as "Night Stalkers" because they specialize in nighttime operations. A trail crew working nearby witnessed the aircraft descend and impact a ridgeline. Two crew members were ejected from the wreckage as it rolled down the mountain. Prevailing weather conditions reported 4,000 feet lower than the crash weren't unusual for the mountains with temperatures in the 60s and winds gusting up to 26 mph. The entire inter-agency response, recovery, investigation and salvage at the high altitude site took a total of eight days. The Black Hawk's flight recorder was recovered and military investigators from Fort Rucker, AL are examining the accident.

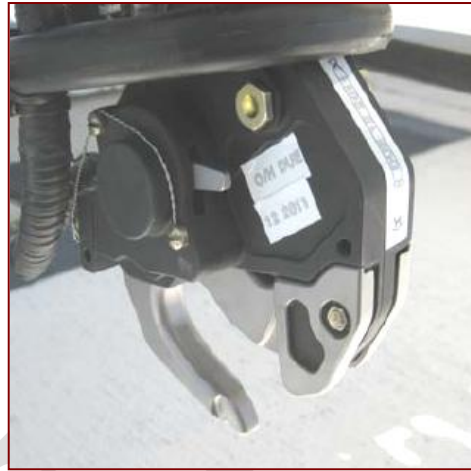
United States (Wyoming) - Inadvertent Short-Haul Hook Release

During a helicopter short-haul training session on July 9, 2009 at Grand Teton National Park an inadvertent release occurred of the primary anchor point, which is a Talon Keeperless Cargo Hook (manufactured by Onboard Systems). During this release, with a suspended human load, the backup anchor point, a three-ring release system, caught load as designed. Prior to the mishap, the involved Eurocopter AS 350 helicopter was returning from refueling and the spotter observed the short-haul rope had released from the cargo hook and was held by the backup “three-ring”

system. Subsequently the equipment was inspected and tested with training resumed. During the training exercise, with a human load suspended 10 feet AGL, the primary anchor (cargo hook) experienced an inadvertent release. The release shifted the load to the secondary anchor (three ring release). Following the release from the primary hook, the litter and attendant began to spin. Several attempts were made by the attendant to slow the rate of spin, but with only limited success. The litter and attendant were immediately returned to staging site. Subsequent investigation noted damage on the outer sheath of the manual release cable. With the manual release mechanism cover removed, the rigging of the fore and aft cables could be measured. The manual release cable to the cargo hook had approximately ¼ inch (0.6 cm) of the movement necessary to effect a mechanical release when connected. Any bending of forward cable, such as when the collective is raised, causes an effective “shortening” of the inner cable. Unlike conventional hooks which reset themselves, Talon Keeperless Hook must be manually re-cocked. Rigging of the release cables should be done with hook open and minimum clearance in system. Closing and latching hook eliminates clearance and pre-loads release trigger.

Post-Incident recommendations included:

1. Check clearance between end of the inner cable and end of the outer sheath.
2. Check clearance between the guide on forward cable and end of the aft cable.
3. Check general cleanliness and condition of the release cable.

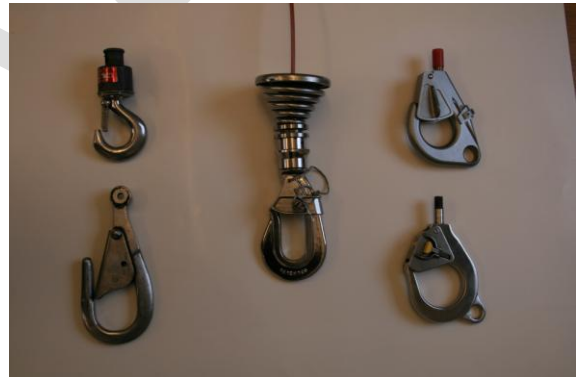
A number of near miss incidents were described involving cable strikes against aircraft fuselage. It was reiterated that abseiling from the hoist hook is a dangerous practice not supported by the manufacturer. A number of different hooks were shown and the manufacturer is trying to come up with hook designs that will preclude the possibility of rollout.
