**IKAR/CISA 2003**  
**Coylumbridge - Scotland**  
**Kommission für Luftrettung**  
**Commission pour le Sauvetage Aérien**  
**Commission for Air Rescue**

**ACCIDENTS/INCIDENTS FROM MEMBER COUNTRIES:**

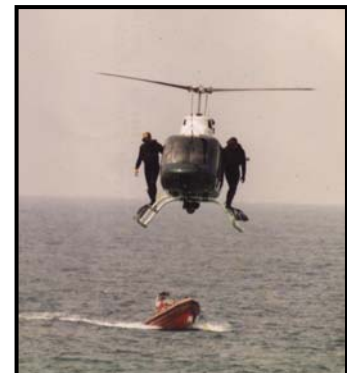
Helocasting Training,  
Bay County Sheriff's Dept.

This water deployment technique has its origin with the military for tactical insertions. At the time of the accident two new jumpers were seated in the aft cabin along with a pilot and observer up front. When the aircraft was at the proper altitude, the pilot turned

backwards to signal a “thumbs up” to the jumpers. In doing so, the pilot inadvertently pulled back on the flight controls and the helicopter climbed to an altitude of 35 feet, at which point the jumpers exited the aircraft. The injured jumper rotated sideways and on to his back, fracturing vertebrae and three ribs.

- No new jumpers are to be paired together during future training jumps.
- Static jumps are to first be accomplished on a swimming pool high board.
- Instructors must be comfortable with individual rescuer proficiency prior to approving them for advancement to helicopter jumps.
- Complacency during training was cited as an additional human factor.

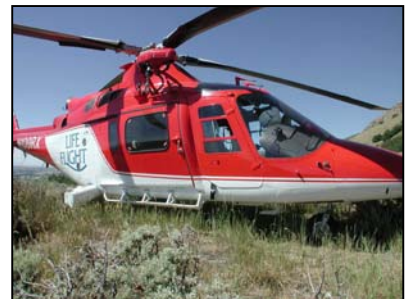
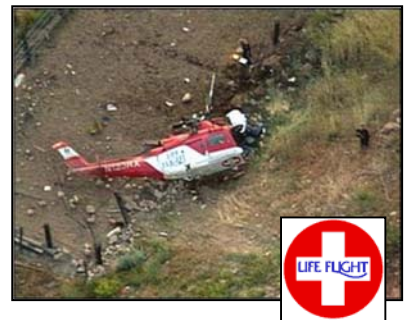
IHC Lifeflight based in Salt Lake City, UT suffered two very tragic fatal crashes during the past year. The first accident occurred on January 10, 2003, when an Augusta 109 K2 (N601RX) crashed in foggy conditions near the Salt Lake City Airport. The crew was responding to an accident near the Utah-Nevada border, when they encountered IMC (Inadvertent Meteorological Conditions). They aborted the mission and attempted to return to their hospital base, when the aircraft crashed in thick fog near the Salt Lake City Airport.

On June 7, 2003 a second crash occurred following a rescue on Mount Olympus near Ogden, UT. The aircrew had just completed the hoist rescue of a dehydrated female hiker, who had become “ledged out”. The patient was then dropped off at the incident command post and the crew was returning to their home base. Shortly after lifting off at 8:15 p.m. the aircraft (Augusta A109 K2, N123RX) dropped from 600 ft AGL and crashed. The pilot was fatally injured and a flight paramedic on board sustained minor injuries. Investigation found the accident related to a material failure of the tail rotor trunion.

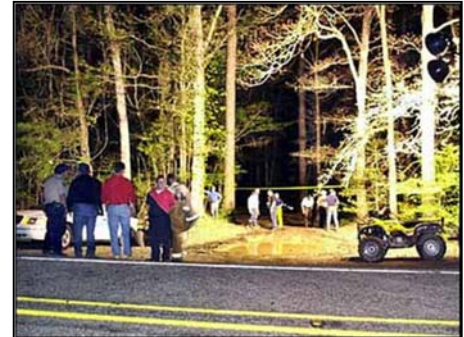
During the aerial search operations to locate Columbia Space Shuttle debris, a Bell 407 helicopter crashed in wooded terrain near Broadus, Texas on March 27, 2003. Five personnel were on board at the time of the accident, which resulted in fatal injuries to the pilot and helicopter manager. The helicopter was completing its second search mission of the day, while hovering about 125 feet above the ground. The aircraft lost power and descended rapidly into the 80-foot tall trees with no warning. The interagency effort to locate Columbia Space Shuttle debris, which involved a search area that stretched for 380 miles, was being managed by FEMA. The investigation determined the accident cause was related to an inherent flaw in the fuel Potentiometer, which leads to a sudden failure in fuel control.

Broadus, Texas Crash Site  
Recovery Operations

According to the NTSB; “During the test cell run, it was discovered that the power lever angle (PLA) indicator on the Hydro Mechanical Unit (HMU) responded erratically to normal throttle input when the engine was operated in the electromechanical mode. The engine operated normally in the manual mode. Further testing and evaluation of the HMU revealed anomalies with the potentiometer component of the system.”

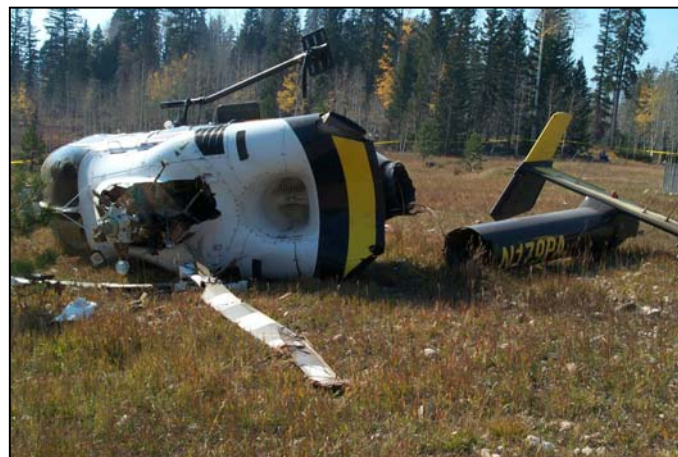
During a fire reconnaissance flight on October 16, 2003, the National Park Service contract MD 900 Explorer (N179PA) experienced a loss of control while landing at a remote helispot. The aircraft impacted the ground and rolled over. In spite of substantial damage to the aircraft, none of the five personnel on board received any injuries. The accident occurred just north of the park boundary on the Kaibab National Forest.

NPS Helicopter Wreckage

According to the NTSB; “Thirty feet above ground level (agl), fifty feet away from the

*landing zone (LZ), the helicopter began an uncommanded right yaw. The pilot applied full left pedal; however, there was no response. He stated that it felt as if the flight controls were disconnected. He lowered the collective, with the helicopter still turning, and landed hard. Post accident examination of the helicopter control systems revealed that a failed force limiting control rod assembly had broken internally in the spring capsule assembly. This control rod assembly controls the pitch of the NOTAR fan blades through pedal inputs.”*

- This accident is the first operational crash of any MD 900 Explorer.
- A satellite phone kept on board the helicopter was invaluable for post crash communication.
- Four-point restraints on every seat as well as flight helmets were effective in preventing any occupant injuries.
- The integrity of the composite fuselage prevented intrusion into the passenger cabin and increased survivability.

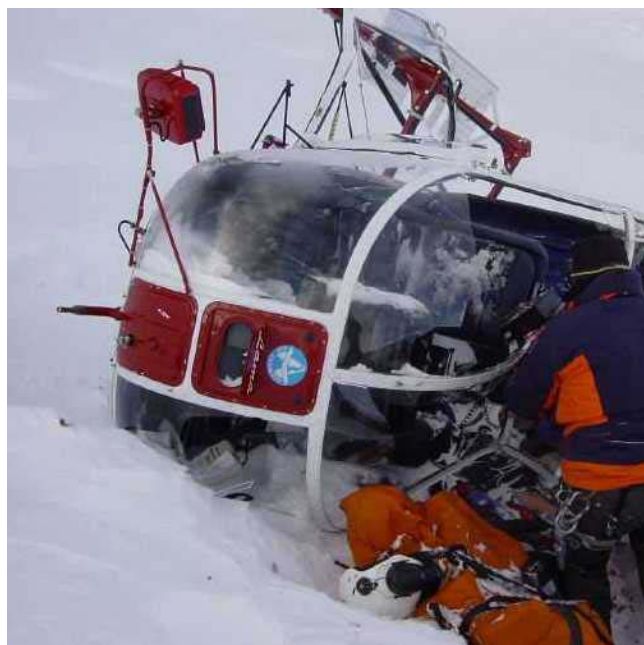
Although, this was not an incident involving rescue, it was mentioned because of the involvement of a longline. While flying a cargo load on a 20-meter longline with a Lama, a pilot tried to land beside the load without releasing the longline. The line snagged and a dynamic rollover ensued damaging the helicopter. There were no injuries.

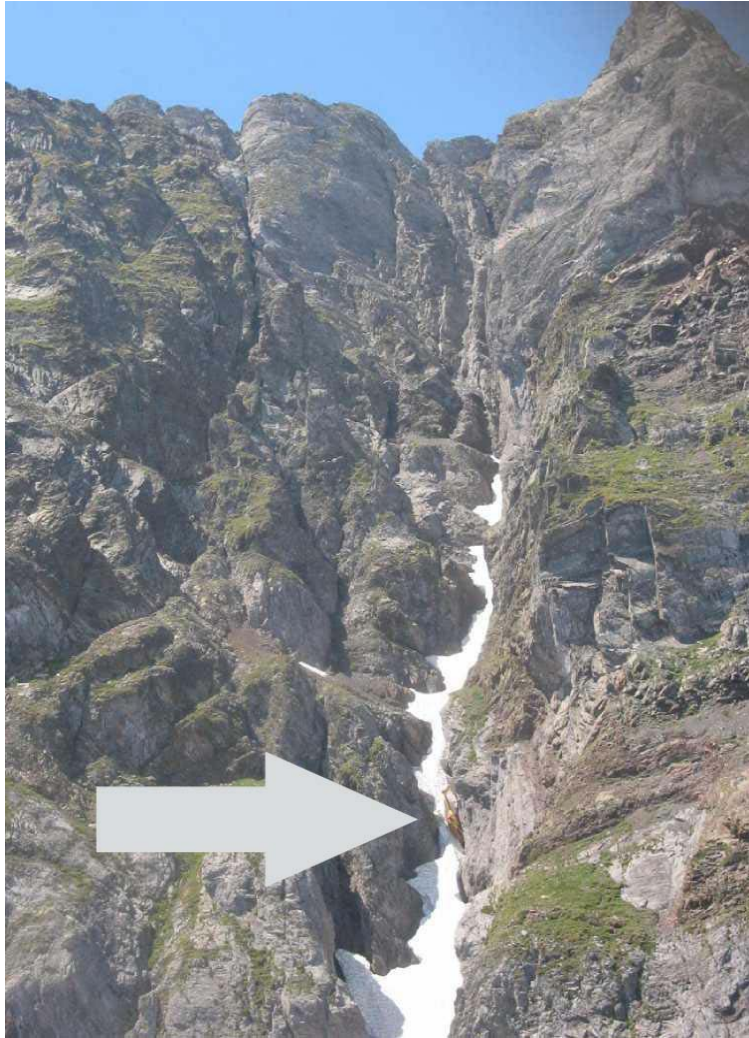
Although, this was not an incident involving rescue, it was mentioned as the incident happened immediately following a hoist rescue with that aircraft. A Lama with five people on board was on a sightseeing flight. The weather was overcast. During the flight, the pilot heard a bang and immediately noticed an increase in rotor RPM. The pilot pulled on the collective but found no response whatsoever. He immediately began an autorotation down to the glacier below. The helicopter rolled once it landed and sustained severe damage. A number of the occupants were injured during the

crash. The subsequent investigation revealed a failure in the collective linkage (the “combinator” became unthreaded). It appears that the collective was not functioning when the pilot performed his emergency landing.

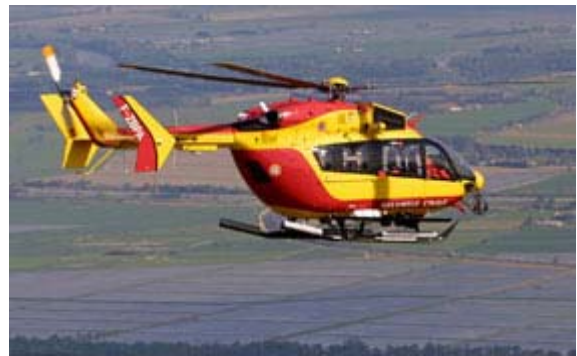
**EC145**

A Eurocopter EC145 crashed during July, while on a rescue mission in the Pyrenees. The aircraft belonged to the Sécurité Civile, which is a civil defence organisation, involved in coast guard, SAR, ambulance and fire-fighting duties. There were five people on board at the time of the crash. One rescuer died and the pilot and hoist operator were seriously injured. The doctor and patient were not injured. The accident occurred at 2400 meters elevation (7,874 feet). The crew remembers a bang and some vibrations followed by an apparent loss of control of the aircraft. One of the engines was still running when a rescue team arrived. The first rescuer at the crash site had to shut the engine down. The wreckage could not be recovered until later in the summer once enough snowmelt had occurred. The accident is still under investigation and the cause has not been determined.

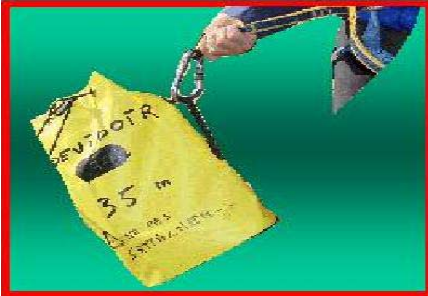
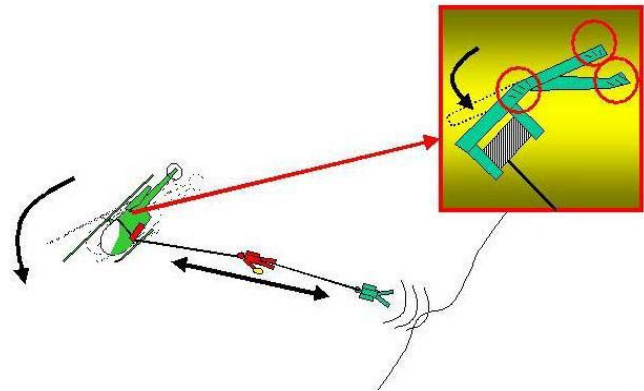
While performing a body recovery on the North Face of the Grandes Jorasses, the rescue crew experienced a close call. Due to very hazardous conditions at the site where the body was located it was decided, that the rescuer would not get off the hook to minimize his exposure. The helicopter was a hoist equipped Allouette 3. The hoist is only rated for

one person and consequently, the following technique was used. The rescuer was lowered to the site with the hoist cable. He did not detach from the hook and with a rope stored in a rope bag attached one end of it to the victim. The plan was to bring the rescuer back up into the cabin while he fed the rope out of the bag. Once in the cabin, the other end of the rope could be attached to a hard point on the

hoist and the victim could be long-lined to a safe location. In the event of a problem, the rescuer could simply let go of the rope and bag. To facilitate feeding out the rope, the rescuer clipped a carabiner to the rope bag. This carabiner was attached to a lead back to his harness that meant that the tied to him through the intermediary of While he was being hoisted back up, was hit by down flow and the pilot had from the face. Suddenly both rescuer were hanging on the hoist. The cut the rope to the victim and released or its cable did not fail but both substantial damage.

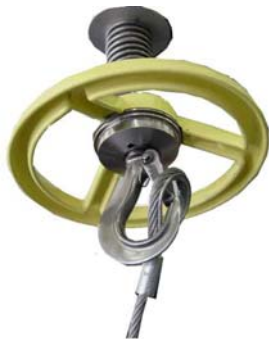
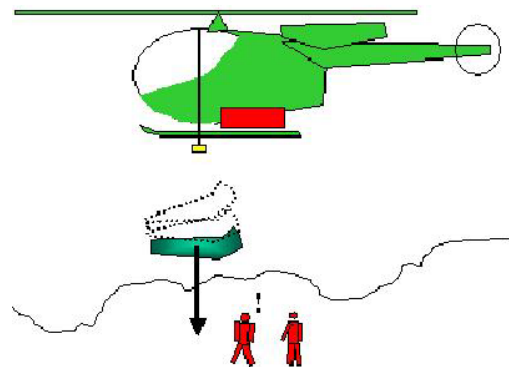
While hoisting a patient in a stretcher with an Allouette 3, the stretcher came unattached to the hook after it was about 10 meters off the ground. The patient sustained further injuries. It is speculated that the swaged eye of the stretcher may have been cross-loaded and

subsequently experienced "rollout" on the hook gate. The solution is to only use rings or eyes of a small enough diameter that preclude rolling out of hoist or cargo hooks.

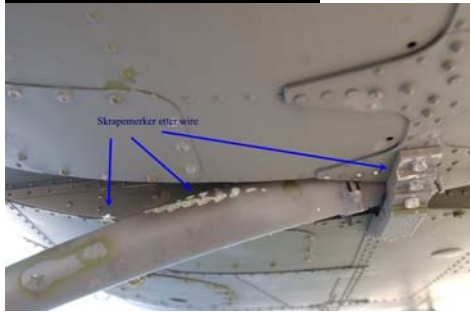
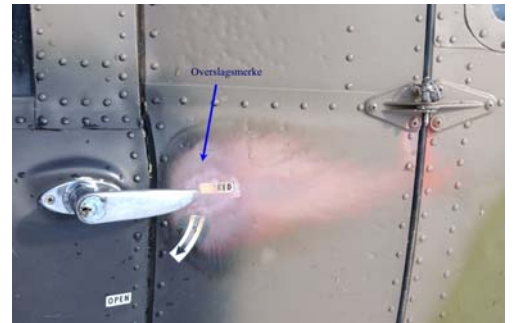
While flying at low level with 11 people on board, a BH412 hit a 24,000 volt high tension line. The helicopter was equipped with wire strike protection. The cables were cut on impact. The helicopter continued to a

safe landing and no one was injured. The helicopter sustained extensive burn damage.

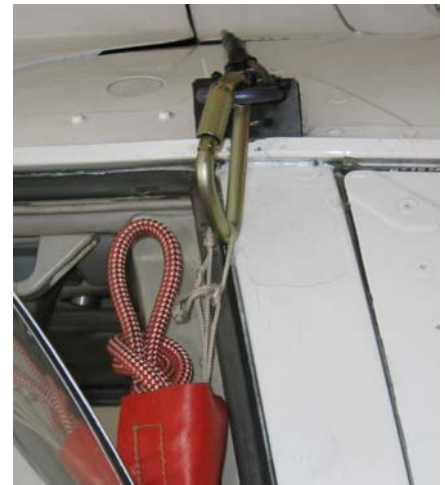
During a training session with an AS365 (Dauphin), the fixed rope on the helicopter came unattached. No one was attached at the time and there were no injuries. In this configuration, the rescue rope is attached to the roof of the helicopter and there is edge protection on the floor to protect the line. After hooking up the line the helicopter started to lift off. Before the line came taught, it came off the attachment point. It is speculated that only the protecting sheaf of the rope was connected and that the eye of the rope itself was not.

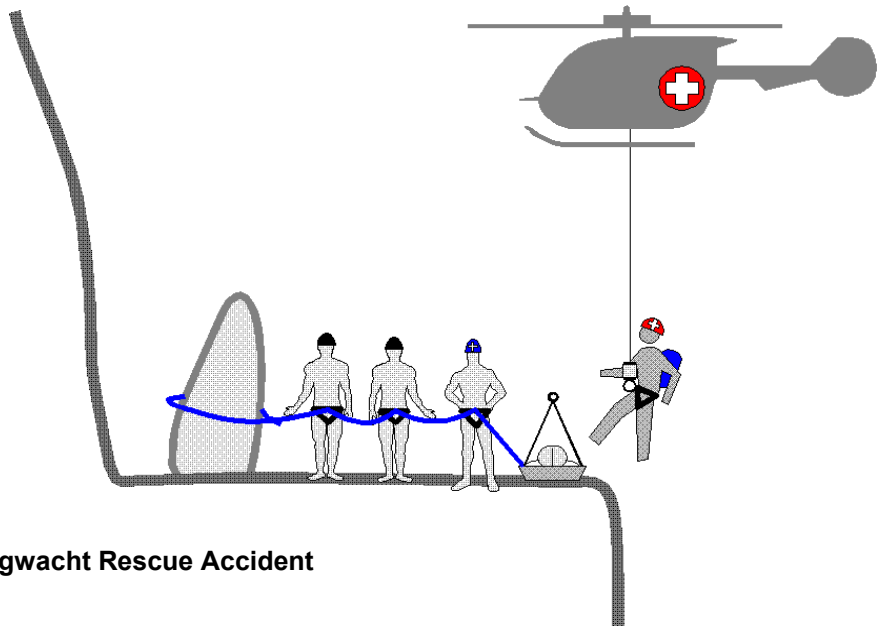
**Bergwacht Rescue Accident**

Working at a cliff edge, during a night rescue, two rescuers and a physician were tethered by a safety line to single large anchor. The physician had tethered the litter with the patient to his harness for security. No radio communications with the aircraft were in place. When the helicopter lowered a rescuer on a hoist and began raising the litter, the safety tether was inadvertently left attached to the litter. The helicopter lifted all the rescuers clear of the cliff and suddenly had the weight of five persons and two rucksacks. However, a crash was averted as the pilot managed to perform a running landing at a nearby German soccer field.

- Preventing line entanglement is paramount.
- Brief in advance on emergency procedures.
- Minimise attachment of the helicopter directly to the ground.
- Keep the rigging at the bottom end of the rescue line/hoist cable simple.
- Always double check attachment points with a safety check.
- Clear radio communication is vital for an effective rescue evolution.
- Recognise that lifting during a rescue extraction is a “critical phase” of flight.
