AIR RESCUE REPORT

International Commission for Alpine Rescue

October 13-15, 2005 - Cortina D'Ampezzo - Italy

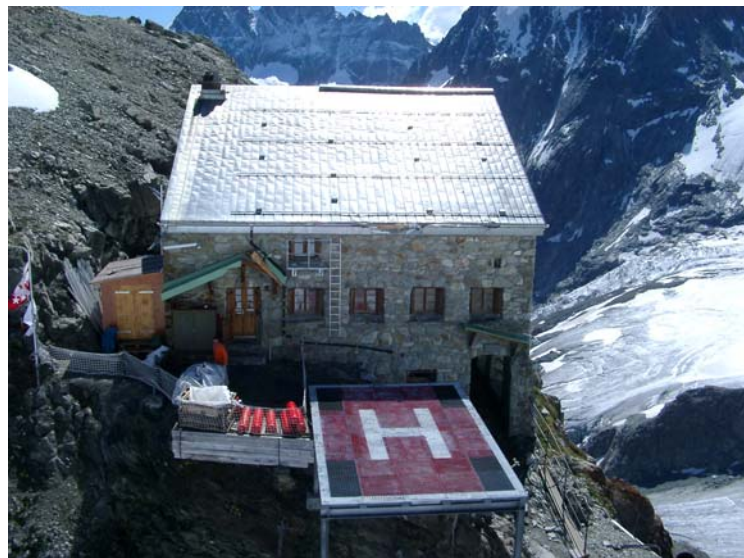
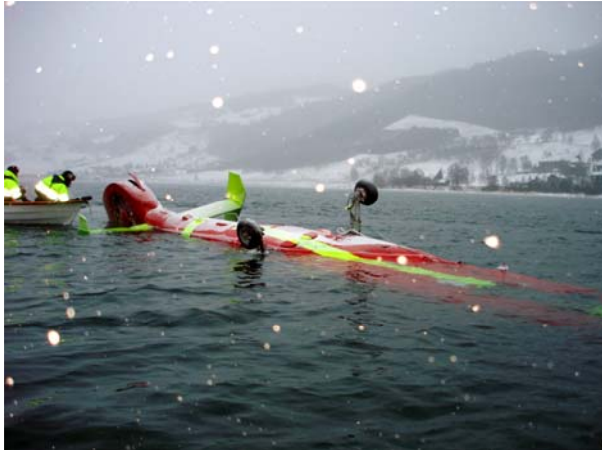
Crash - A Llama crashed when it was conducting external sling work at a high mountain hut well above timberline. The hut had a small confined helipad constructed right against the building with a safety net suspended below due to the steep exposure to the glacier below. The pilot had turned the helicopter 90 degrees to the hut (parallel to the building). The tail rotor and main rotor struck the building during take-off. The helicopter crashed on the glacier below.

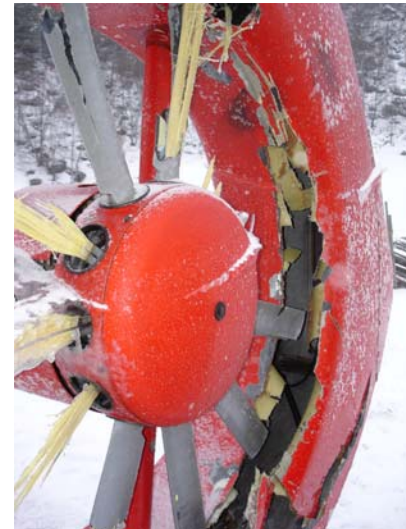
Water Ditching Incident- During a winter water rescue training session on Lake Vågavatnet, a Norwegian Air Ambulance AS 365 Dauphin helicopter crashed into the near-freezing water. The training was being conducted 250 meters (820 feet) from shore of the lake, which has a few houses surrounding it in a very rural area. The training evolution involved a water rescue pick-up of an air rescue crew person via fixed rope. It required that the helicopter first move into a three meter (10 feet) hover, so the rescuer could jump into the icy lake. It was during this low hover that the

aircraft crashed into the lake, without injuring the rescuer already in the water. The pilot and doctor on board the stricken helicopter were only dressed in normal clothing. The doctor became so hypothermic after a few minutes in the water that he could not help himself and was assisted by the rescue crewman, who was wearing a cold-water survival suit. The pilot and doctor had been sitting on same side of the aircraft and were assisted on to the floating fuselage after the accident. A local resident in the area luckily witnessed the accident and contacted additional emergency rescue personnel.

The exact cause of the accident has not been officially released. However there is speculation that ice from the lake surface became airborne during the hover and impacted the Fenstrom tail rotor of the EC135. Additional factors relating to this accident were the fact that dunker training by the crew was indispensable in their personal survival and being dressed in inadequate PPE was a shortcoming. Operating procedures are being changed to eliminate the hover jump and utilize only a water entry via rescue sling on a fixed rope. This will eliminate exposing the aircraft to foreign debris at ground level. In the future, training site selection will not be so isolated or far from a shoreline in the event of rescue. Operating 50 meters (164 feet) from shore instead is recommended. Finally, it was noted that during water rescue operations the rescue crewperson in the water can experience difficulty with visibility from the rotor wash. An immediate mitigation technique for this situation is to move aircraft or change height.

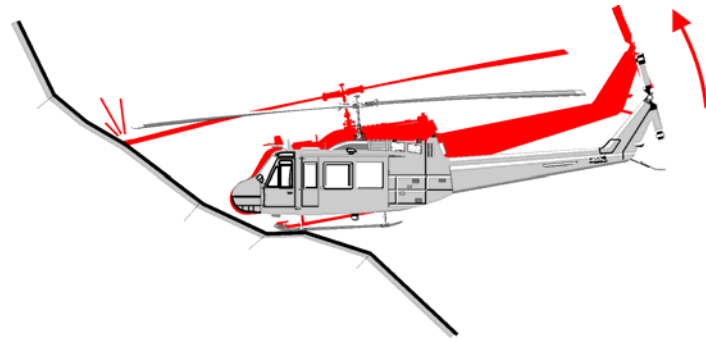
Toe-In Landing Accident- During Spring 2005 the Italian Air Force was conducting toe-in landing training against a mountainous slope. The AB (Augusta-Bell) 212 had the front tips of its skids in contact with the slope during the toe-in procedure. During take-off the aircraft tilted forward on the tips of the skids. The main rotor struck the slope and resulted in a crash, which killed five out of the six personnel on board.

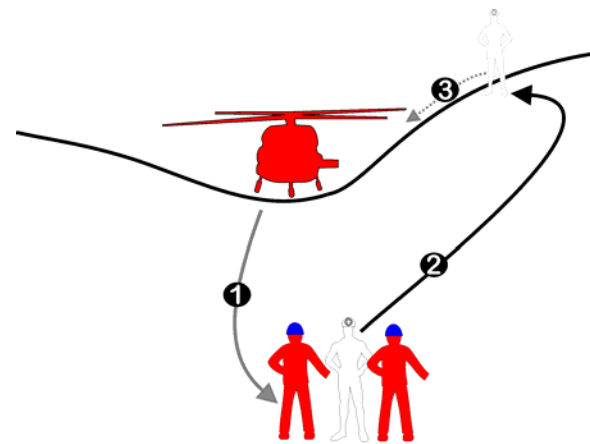
Hoist Operator Struck By Main Rotor- On April 20, 2005 another accident occurred when two police investigators were flown to a mountainous valley, for a follow-up investigation to a previous fatality. The landing zone being employed was in a depression with surrounding sloped terrain. Upon landing the investigators were escorted away from the helicopter by the hoist operator (crew chief), while the helicopter (Augusta- Bell 212) departed the scene. The hoist operator then repositioned himself to a slope above the landing zone, while the helicopter returned. Upon landing the hoist operator walked down slope directly into the main rotor blade and was killed when he was struck in the head.

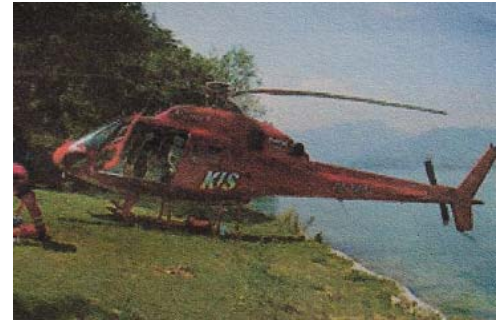
Impaired Visibility- Fixed Rope Rescue- A helicopter rescue was initiated for three climbers who had become stranded on a high cliff face near a lake. The weather conditions included a low cloud layer with rain, which made accessing the accident site difficult from the air. A fixed rope helicopter rescue was commenced with a AS355- Twin Star, and a staging helispot was employed along the shoreline of the lake. During the rigging of the aircraft at the helispot, the pilot became soaked in the rain.

The rescue commenced and during the operation the inside of the helicopter suddenly fogged up with reduced visibility. The aircraft defroster had not been immediately employed. With rescuers suspended below the helicopter it was decided to immediately abort the rescue attempt. The pilot returned to the lake shore to land the rescuers. With reduced visibility and his concentration on instruments, the pilot initially began to set down the rescuers 250 meters (820 feet) from the landing zone. The rescuers radioed “up-up-up” to the pilot. The pilot then landed the rescuers in the shallows of lake up to their waist in the water prior to finally setting them on the established landing zone. Following the near-miss the crew suspended further operations. Two hours later the rescue was finally completed by another aircraft and crew from another operational base.

A mitigation technique for this problem of the aircraft windshield becoming fogged up during rescue missions is to aggressively use the heating/defroster prior to take-off. Remain on the ground until the cockpit is sufficiently warm and in no danger of fogging up.

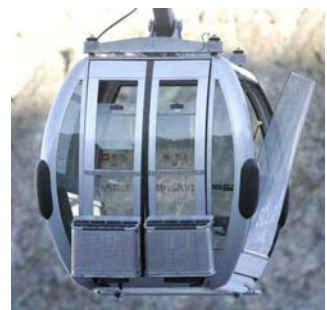
External Load Accident-Multiple Fatalities- On September 5th a helicopter crossing an active gondola cableway dropped the 750 kg (1,654 lbs.) concrete bucket it was carrying beneath it. The bucket struck a cable car, which fell to the ground, while the impact caused the cable to swing violently and six children thrown from a nearby gondola. The accident resulted in nine fatalities, six of them were children. The Heli Alpin Knaus helicopter was transporting concrete for a new mobile phone and radar tower. The helicopter had been climbing to 3,048 meters (10,000 ft) with the concrete bucket and dropped the load from 274 meters (900 ft) above the gondola. The accident occurred in the ski-resort town of Soelden, 40 km (25 miles) southwest of Innsbruck.

The requirement for external sling work in Austria is 800 hours of flight time. The 35-year-old helicopter pilot had only qualified a month prior to conduct external sling missions. The helicopter was not overloaded at the time of the accident, preliminary results showed. The hook was checked post-accident and there was reportedly “evidence of an electrical defect located”. Austrian government regulations prohibit overflying an active cableway at low level.

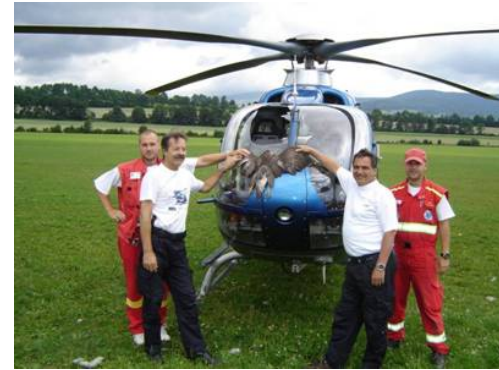
Collision-During a HEMS mission, an EC135 collided with a buzzard at a cruise speed of 120 knots and 500 feet AGL. The bird penetrated the cockpit and struck the pilot in the head. The pilot's headset was pulled off and the NVG lighting switch on the overhead panel was activated, darkening all instrument panel screens. Debris from the windshield became lodged under the collective and this jammed its functionality. The pilot was able to clear the debris, maintain control and safely land the aircraft. Following this incident, Eurocopter is increasing windshield thickness to 5 mm. Discussion followed on the use of helmets and a number of other pilots recounted other incidents with bird strikes.

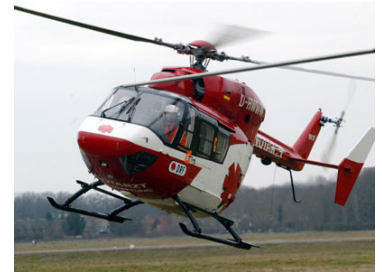
HEMS Accident- On September 28, 2005 a BK117 crashed into a slope at cruise speed in broad daylight (1115 hours) during good weather. The HEMS Christoph 51 helicopter, was operated by DRF Deutsche Rettungsflugwacht and stationed at the Stuttgart Airport. All four occupants of the aircraft, including the female patient, emergency doctor, paramedic and pilot, were killed in the crash. The accident occurred near Weilheim/Teck. Investigators are having a difficult time determining a cause of the accident. One possible cause was that the pilot had become unconscious from a medical problem.

- Eurocopter personnel attending IKAR pointed out how an *in-cockpit monitoring system* would have assisted with this particular investigation. Such a “black-box” system would involve a small video camera mounted directly behind the pilot with full view of the cockpit instrumentation and controls.

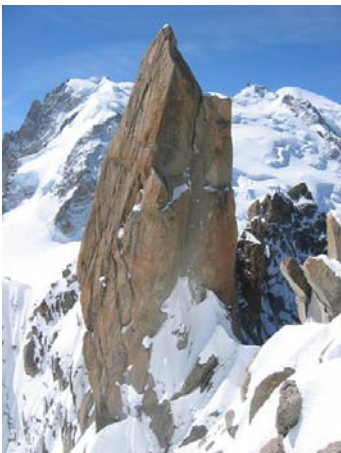
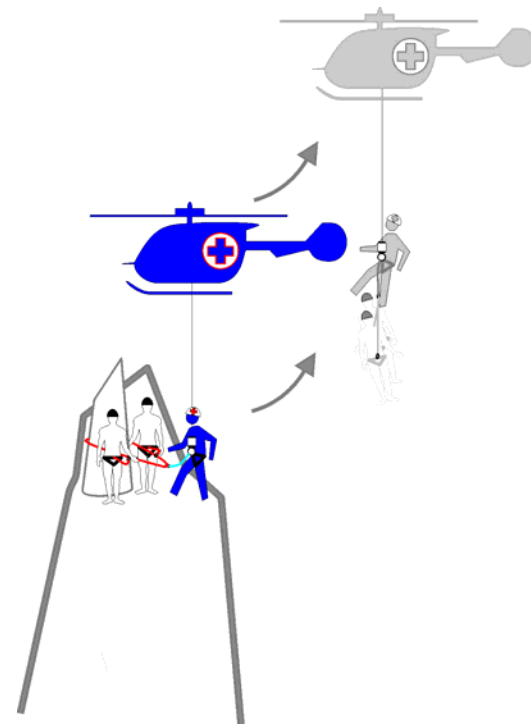
Hoisting incident- An EC145 was performing a hoist rescue on the Arête des Cosmiques of the Aiguille du Midi. With the aircraft well within its limits, a rescuer was hoisted down to two victims one of whom had suffered a minor ankle injury. Both climbers were secured to webbing tied around a rock horn. As the rescuer arrived at the site, he secured himself to the webbing prior to unhooking due to the exposed nature of the site. Before he had a chance to unhook from the hoist cable, the helicopter experienced a sudden updraft and gained altitude. The rescuer, now tied to the webbing, and consequently to the two victims, was lifted up. All three came off the ground when the webbing came off the rock horn. Although there were concerns initially that the people below might collide with the ridge, the pilot was able to fly away uneventfully and land nearby.

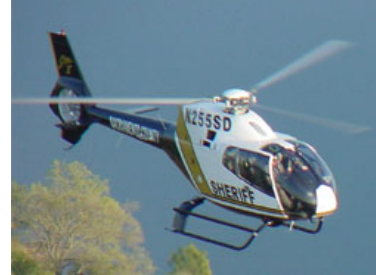
On July 13, 2005 the Sacramento Sheriff's Department EC 120B crashed moments after a "mayday" call from the aircraft was received. The aircraft crashed near Nimbus Dam about 12 miles northeast of Sacramento. Sheriff's Deputy Joseph Kievernagel, 36 and Deputy Kevin Blount, 29 were killed in the crash. Deputy Eric Henrikson, 28 was hospitalized in critical condition.

Investigators discovered a diaphragm in the Turbomeca Arrius 2F's fuel control unit (FCU) was installed upside down at the factory. The diaphragm ruptured allowing maximum fuel to the engine. The only way to control the unit was to shut down the engine. The engine had become so out of control it blew itself apart. Turbomeca issued a mandatory service bulletin on Aug. 3 advising of the problem.

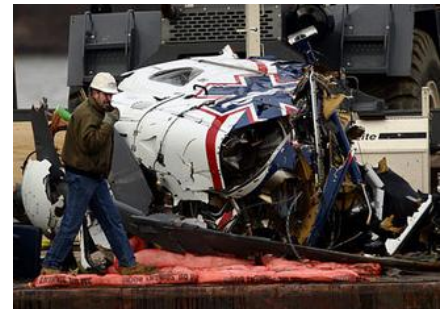
On January 10, 2005 a LifeEvac Air Ambulance (subsidiary of Colorado-based Air Methods Corp). crashed in the Potomac River, near Washington DC, at night near the Woodrow Wilson Bridge. The Eurocopter EC 135 helicopter was returning to its base in Stafford County and no patient was on board at the time. The accident resulted in two fatalities and one significant injury to the crew. ATC radar data revealed a 70-passenger Canadair Regional Jet 700 (CRJ-7), passed over the Woodrow Wilson Bridge a minute and 45 seconds before the accident helicopter passed over the bridge. Radar data showed the helicopter passed 900 feet beneath the flight path of the CRJ-7, in the opposite direction.

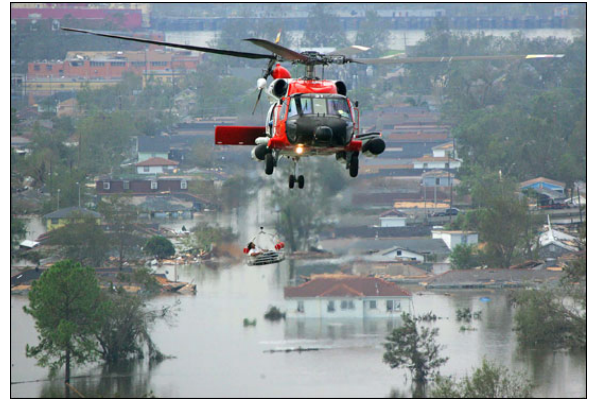
- Sept 4, 2205- AS332 Super Puma (N330CC) suffered damage when it rolled on its side while operating in New Orleans. The aircraft was operated by Sky Cats Super Puma Corp, Lakeview, OR. No reported injuries.
- Sept 7, 2005- Bell 206 (N230CA) owned by GO Interests LLC, Manvel, TX. The pilot reportedly lost control and impacted the roof of a house while in an orbiting turn during a photo flight over New Orleans. The pilot and passengers immediately rescued by a military Black Hawk helicopter which was overhead.
