AIR RESCUE REPORT

International Commission for Alpine Rescue

IKAR-CISA

October 11-15, 2006 - Kranjska Gora, Slovenia

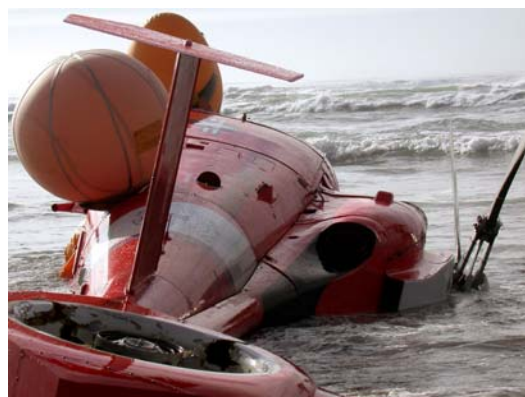
Crash -U.S. Coast – Humboldt Coast, California

On February 11, 2006 U.S. Coast Guard personnel from Air Station Humboldt Bay responded a HH-65A Dauphin with crew of four to a report of an 18-foot boat with an outboard motor capsized in the surf with four PIW (*Persons In Water*). The rescue swimmer deployed from the helicopter to an 82 year-old female who was in cardiac arrest. The swimmer attempted CPR on the

beach shore without successful resuscitation. Subsequently, according to the official Coast Guard synopsis, “the *number one engine shut down resulting in a rapid power loss.*” The aircraft crashed in shallow water 40 yards off shore. All three remaining Coast Guard crew members aboard were uninjured and reached the beach safely. Two of the original rescue victims made it to shore safely. The other victim, the 59 year-old son of the elderly female, was hoisted from the surf by another Coast Guard helicopter, which responded to the scene following the accident. He was later pronounced dead in the hospital. The USCG investigative report is “pending”

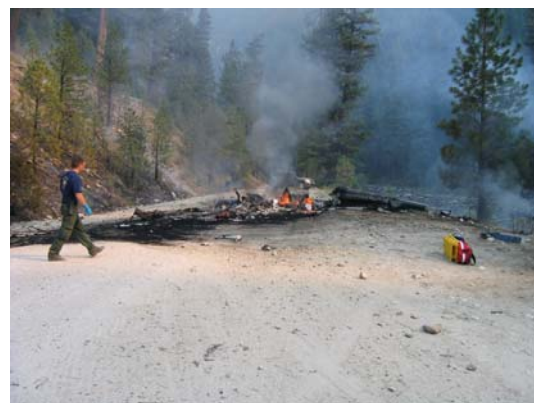
Crash - U.S. Forest Service – Payette National Forest, Idaho

A Eurocopter AS-350-B3, on contract to the Payette National Forest (USFS) crashed on August 13, 2006 tragically killing all four personnel. The crash occurred on the South Fork Salmon River Road about 18 miles west of the town of Yellow Pine, Idaho. Fire crew personnel were being shuttled four nautical miles from the top of Williams Peak to Krassel USFS Helibase. The aircraft was completely destroyed on impact with an immediate post-crash fire. The accident investigation discovered six five-gallon “cubies” (potable water containers) and other refuse along the original flight path. This aircraft was equipped with open-top cargo baskets on both sides of the fuselage. Cargo was retained in the baskets with elastic straps. Although the investigation is still pending, there is the theory that material came loose in flight from the cargo basket and contacted the tail rotor causing a catastrophic failure.

The post-crash response by personnel on the ground was very organized and followed a local established written crash rescue plan. An operational deficiency that occurred was the decision to have two lifeflight (HEMS) helicopters respond without an adequate communication plan in place or incident coordinates provided to them. Although a safe incident helispot had been established at a nearby ranch, the lifeflight aircraft failed to utilize this site and selected a more hazardous site directly on the road adjacent to the crash site. There was no actual operational need for the lifeflight helicopters at the scene, since it was immediately obvious that all involved had suffered fatal injuries.

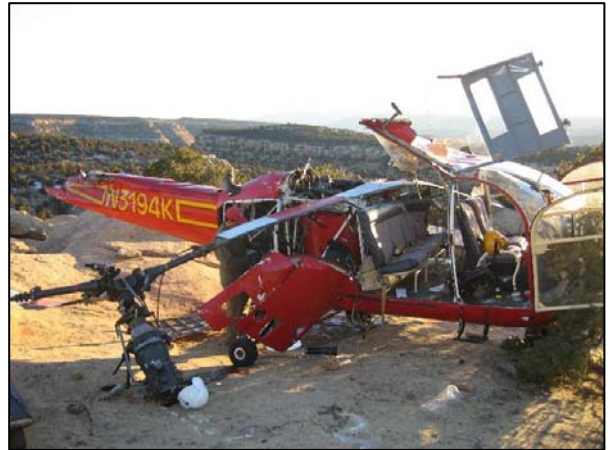
Crash - Grand Staircase-Escalante National Monument, Utah

An Aerospatiale SA-319B, Alouette III crashed on December 14, 2005 during a landing on slickrock terrain. As the pilot touched down in a “bowl shaped” landing site, the tricycle landing gear contacted unevenly with the right landing wheel upslope and the nose wheel low. Initially the pilot stated the landing felt normal, but as he reduced the collective a violent side-to-side motion of the helicopter commenced. The pilot said that he pulled the collective up to lift the helicopter off the ground and “suddenly it self-destructed.” This “ground resonance” event completely separated the aircraft transmission and rotor system. Five of the personnel aboard exited the aircraft under their own power however; an occupant struck by a rotor blade was unconscious and remained buckled in his seat. The Pilot and three passengers were uninjured, but two passengers had sustained serious injuries.

The accident occurred at 1550 Hours and the injured patients were promptly evacuated in the remaining daylight by two lifeflight helicopters responding from Page, AZ (30 minutes flight-time). However, the remaining uninjured personnel were then transported by the two lifeflight helicopters at night using night vision goggles (NVG). This high-risk transport from a hazardous landing zone, which was not imperative, was a deficiency in operational decision-making. Originally the helicopter was manufactured in France in 1972, under contract for the French Army Air Force, and after it was decommissioned, it was sold to a company in the United States in 2002. The investigation has identified several maintenance deficiencies including: improper tire inflations, improper main landing gear hydraulic shock strut pressures and differential functioning of the main rotor blade drag dampers.

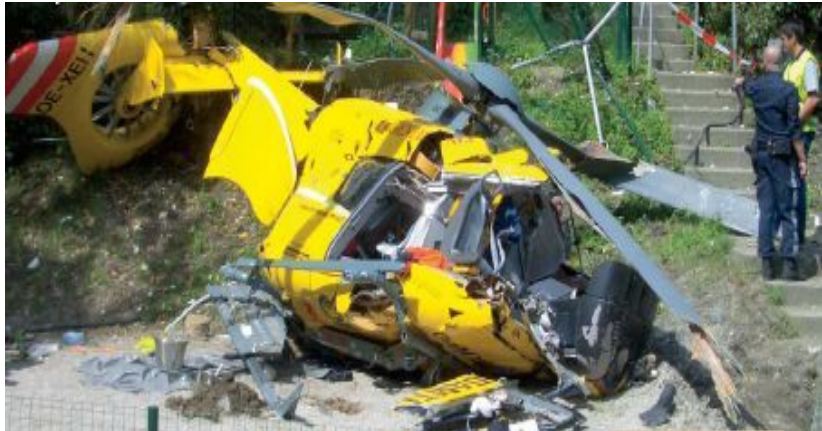
Crash- Hospital Landing- Salzburg

During a landing approach to a rooftop heliport on May 1, 2006 at UKH Salzburg (Accident Trauma Center, Salzburg, Austria) an OAMTC EC-135 crashed and was completely destroyed on impact. The aircraft with a crew of four (typical crew staffing for an OAMTC EC-135 is three personnel) was transporting

a motorcycle accident victim to the six-story hospital for treatment. While on short final approach to the rooftop, and five meters above the pad, the aircraft suddenly made a 120° turn to tail left (nose veered right). At the time the aircraft was at a relatively low speed and the area winds were three knots. The pilot, thinking there was a tail rotor failure, reduced pitch to react to the emergency as trained. The aircraft tail boom hooked part of the helipad perimeter safety mesh, causing the aircraft to drop off the side of the building. The aircraft fell 25 meters to the ground below. In spite of the severe impact to the carbon-fibre fuselage, the cabin remained relatively intact. All personnel survived the crash. The pilot suffered a crushed leg and windshield shards in the eye. The flight doctor, who was wearing a flight helmet, sustained a concussion. The original patient sustained no additional injuries.

- Weight and balance within operating limits.
- Pilot was proficient- reacted properly as trained on simulator
- No evidence of technical defect to engine, rotor or transmission.
- The cause of the erratic behaviour of the aircraft is still unknown.

Discussion: There have been previous reports of possible phenomenon where “vortices” created by the main rotor tips then get transferred back to the tail rotor system. There is the conclusion that this could lead to a loss in tail rotor effectiveness.

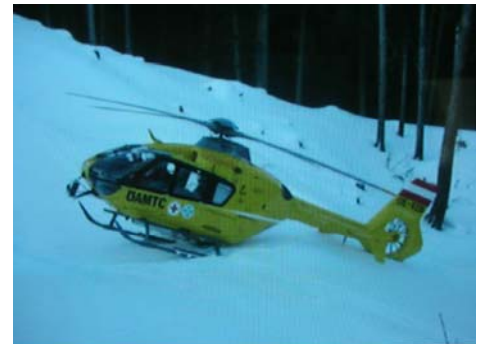
Tail-boom strike- snow landing

After shutting down the helicopter during a snow landing to pick up an injured skier, an OAMTC EC-135 broke through the hard snow below the back of the skids. The aircraft including the tail-rotor were not damaged from this settling. The pilot was able to restart the helicopter, level the helicopter and take off normally.

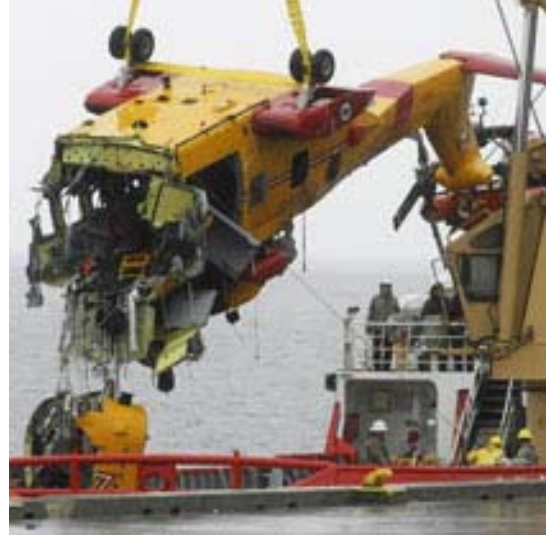
EH-101 Hoist training Accident

A Canadian Forces EH 1001 crashed into the sea during a training exercise on Canada's east Atlantic coast. The incident occurred while the helicopter was conducting a hoist operation onto a Coast Guard vessel. Three crewmembers died and four others were injured in the incident. The crewmembers in the back of the helicopter that died were tethered to the aircraft with their harnesses and a lanyard. They were also wearing Mustang flotation suits. Once the aircraft was in the water, the increased buoyancy from the flotation suits may have contributed to their failed egress of the sinking helicopter. Following this incident crewmembers in the back no longer wear flotation suits during hoist training. At this point, it does not appear that there were any mechanical malfunctions. The incident is still under investigation by the Canadian Forces.

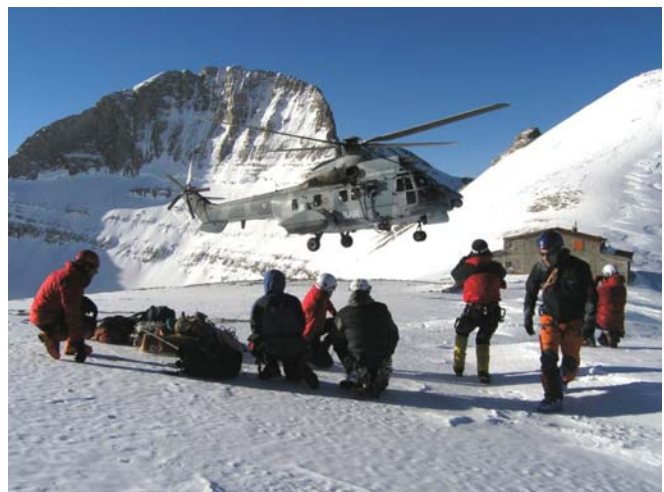
Visibility issue – Super Puma

In 2004 rescuers were delivered to a rescue scene for an injured climber. Rescuers deployed out of the aircraft upon landing and off to the left hand side of the rotor disk, while the aircraft remained running. The aircraft remained in place for a considerable period without leaving. Finally the rescuers radioed the pilot and asked why he would not leave. He replied that he could not see them. There was a visual dead spot caused by the structural design of the windshield of the Super Puma, which has a large vertical metal bar that hampers the pilot's visibility of a landing zone.

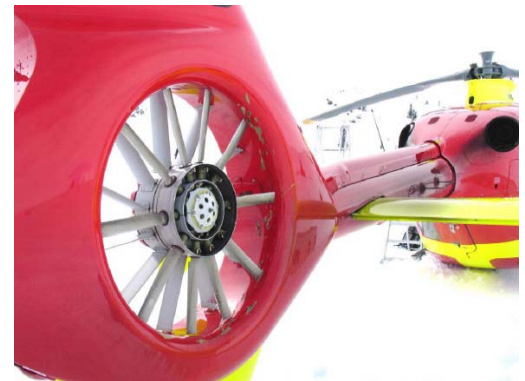
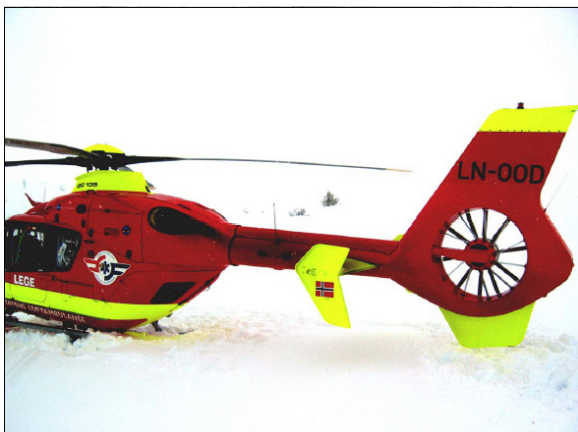
Tail boom strike - Snow Landing Incident

On April 13, 2006 a Norsk Luftambulans EC-135 responded to a “snow scooter” (snowmobile) accident. The flight doctor had already been deployed at the scene initially and the helicopter was returning for the patient pick-up. On approach the pilot decided he would attempt to use a closer helispot. The landing was attempted with a fast approach as the aircraft crabbed sideways. During the landing the tail boom “stinger” made contact with the snow and dragged along for a distance. Unknown to the pilot, during this landing, snow was sucked into the fenestron tail rotor system causing considerable damage. It was only during a walk around by the pilot, following shutdown, that the damage was discovered. No personnel were injured. The aircraft repairs took three months.

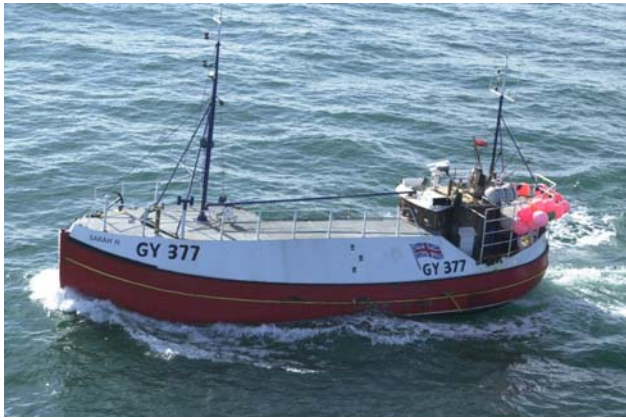
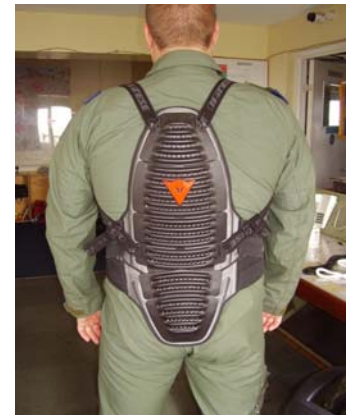
Sea King Hoisting Entanglement

An RAF Sea King Mark III assigned to RAF Valley Base was involved in small boat hoisting training off the UK Coast on August 12, 2005. A small fishing vessel, the "Sarah H", was incorporated in the training exercise. The rescue helicopter crew requested "parallel decks" with the fishing vessel underway. Typically the helicopter will crab along at an angle above the vessel, which permits better visualization of the vessel by the flight crew above. The "winchman" (rescuer) was lowered down over the water and then moved horizontal

toward the boat. Control of the aircraft movement was transferred to the hoist operator utilizing the *auxiliary hover trim* (AHT is horizontal flight control located at the hoist operator's door position). The boat below had begun to yaw. The aircrew lost sight of the winchman and vessel below. The winchman and hoist hook assembly became entangled in the foremast (A-frame rigging at the front of the vessel). A call of "cut, cut, cut!" was made, but this did not get executed. The hoist cable snapped and the winchman fell to the deck of the vessel. The winchman, who was wearing a back protector, sustained a fractured pelvis, fractured wrist and eye injury. The hoist cable snapped back at the hoist operator with a "face full of cable."

RAF Report: *"A relative movement between ZA105 and Sarah H developed very quickly, probably as a result of confused sea swell, leading to winch cable becoming trapped around vessel's foremast, such that when the boat and helicopter diverged the cable was strained beyond its ultimate load and snapped."*

The involved hoist was an older model that was not equipped with a slip clutch. Had this been a newer rescue hoist with a slip clutch it is likely the cable failure would not have occurred. The hoist cable has a rated strength of 3330lbf strength and was tested to 3923lbf. An operating recommendation was made for hoist operators to employ flight helmet safety visors.

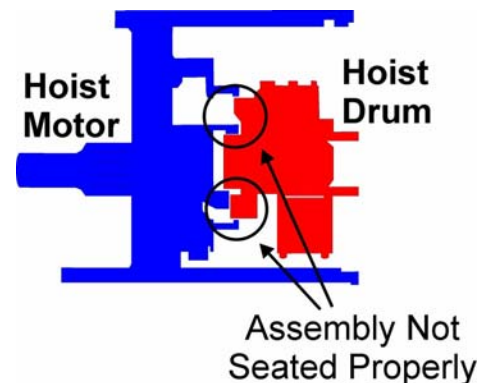
Hoist Mechanical Failure- RAF Sea King

During a wet winching drill in the ocean for fixed wing pilots on February 14, 2006 a rescue hoist suddenly dropped personnel into the water. Two 50-foot hoisting evolutions had already been completed prior to the incident. During a raising a "slight jolt" was experienced with the load 15 feet above the water. The

hoisting was halted and an attachment carabiner was reset by the winchman. The hoisting resumed when a larger jolt was felt. The winchman signalled for a return to the water. The hoist operator selected down on the controls, when suddenly the hoist unspooled dropping the winchman and pilot trainee to the water below. The cable was recovered into the aircraft by hand. On shutdown the hoist cable could be off the drum by hand.

The involved rescue hoist was a hydraulic model hoist and its “limits and fits” were found to be out of tolerance. Due to improper installation (incorrect seating of brake assembly), following maintenance on November 8, 2005, a gap had developed where the hoist drum gears interfaced with the motor. Prior to the accident, 53 successful hoisting evolutions were conducted on this hoist following the maintenance work.

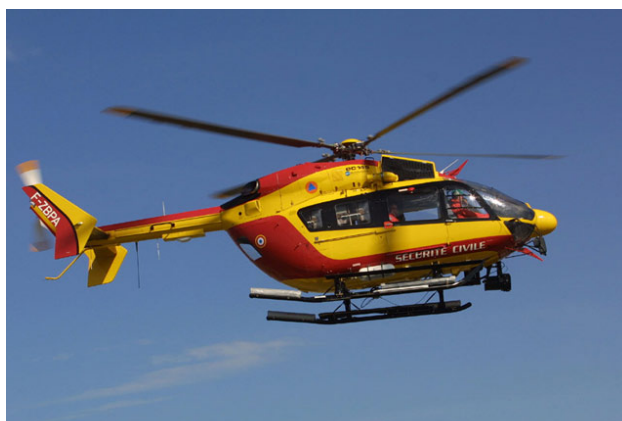
Crash- Sécurité Civile - June 9, 2006

A sécurité Civile EC145 crashed while hoisting on high angle terrain during a training operation in the Pyrenees. The crash happened close to the same location as the similar incident in 2003. Three crewmembers died in the accident. One crewmember survived but suffered severe injuries. The accident has been investigated but no definitive cause has been determined. The aircraft was destroyed in the crash and there was little left to investigate for conclusive findings. The investigators have come up with four possibilities as the cause of the accident.

- Tail rotor strike on cliff.
- Mechanical failure
- Rockfall hitting the tail rotor
- Loss of tail rotor authority with full left pedal.
