# AIR RESCUE REPORT

International Commission for Alpine Rescue

# IKAR-CISA

**October 6 - 10, 2010 - Visoké Tatry, Slovakia**

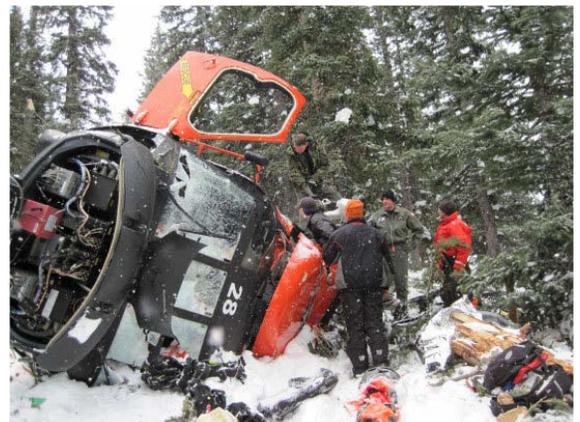
- MARCH 3, 2010- An HH-60 Jayhawk crashed at 2865 meters (9,400 feet) in the Uinta Mountains (UT), while returning from a security detail associated with the Vancouver Winter Olympics. The aircraft, along with a second helicopter, was en route to its Home base in Elizabeth City, NC and had refueled in Salt Lake City UT. The crew of five survived the accident with three sustaining serious injuries. According to the US Coast Guard, "snow and wind affected visibility."

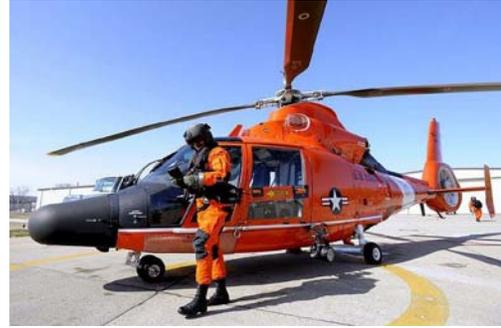
- APRIL 20, 2010- An HH-65C from Air Station Detroit (MI) crashed into Lake Huron, during a night hoist training exercise with a 12 meter (41-foot) utility boat. The accident occurred at 9:45 p.m. as the pilots flew visually unaided. Three crew members survived without serious injuries when the helicopter crashed in 15 meters (50 feet) of water and sank.

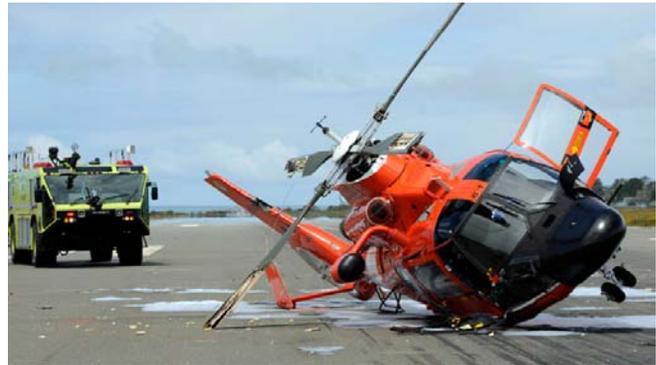
- APRIL 29, 2010- An MH-65C (newer version of HH-65 Dauphin) was severely damaged while taxiing at the Arcata/Eureka Airport. The aircraft was assigned to the Air Station Humboldt Bay, which has experienced the following accidents over the past 16 years. On July 12, 1994, an HH-65A crashed into a cliff on Shelter Cover in foggy conditions while responding to a report of a grounded sailboat. The four crew members died. On June 8, 1997, an HH-65A wrecked at sea about 64 km (40 miles) off Cape Mendocino, while approaching a sailing vessel that had lost its rudder. All four crew members died. On Feb. 11, 2006, an HH-65B had lowered a rescue swimmer in the surf at Samoa Beach for a rescue effort involving an overturned motor boat, when the chopper crashed from a hover into the surf. The three on board the helicopter suffered minor injuries. Two of the four on board the boat died.

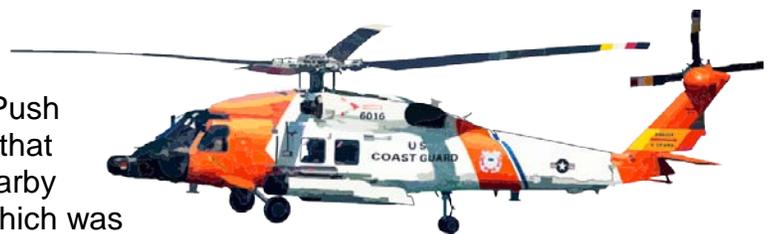
- JULY 7, 2010- A HH-60 Jayhawk crashed in the Pacific Ocean on the coastline near La Push (WA), when it struck power lines that reached from the mainland to nearby James Island. The power line, which was located between 76-122 meters (250-400 feet) AGL, provided power to a lighthouse. Three of the four crew members died in the accident. The aircraft was en route to Sitka (AK).

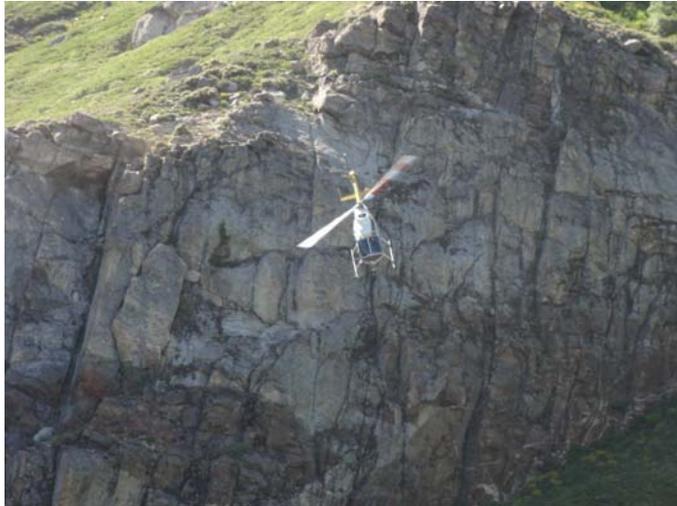
On July 19, 2010 a Bell 206 L3 (Long Ranger) operated by El Aero Services crashed adjacent to Angel Lake (NV) in the Ruby Mountains, while supporting a rope rescue operation. The accident occurred as the aircraft was extracting three Elko Fire Department firefighters, who were providing mutual aid support to the Elko County Sheriff. The three firefighters plus gear weighing 338 kg (857

pounds) and were inserted with a toe-in landing to perform a rope rescue of female, who was stranded on a 52 meter (170 foot) cliff. The aircraft staged at a nearby campground during the rescue operation. Following the rope rescue evolution, two firefighters walked back to parked helicopter from the base of the cliff. The helicopter then flew, with the other firefighters aboard, to pick up

the third remaining firefighter with gear. During the departure from the cliff, according to the NTSB, *“Witnesses observed the helicopter lift off from the cliff face, and make a turn to the right. The helicopter moved very fast down the cliff face, disappeared below the tree line before coming back into view prior to impact with the ground.”* The pilot suffered serious injuries; however the three fire fighters were not injured. At the time of the accident air temperature was 24 Celsius (75 degrees) and light gusty winds at 16 km/h (10 mph). The accident was photographed by campers watching from an adjacent campground.

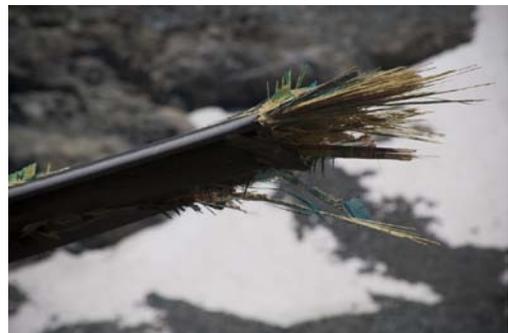
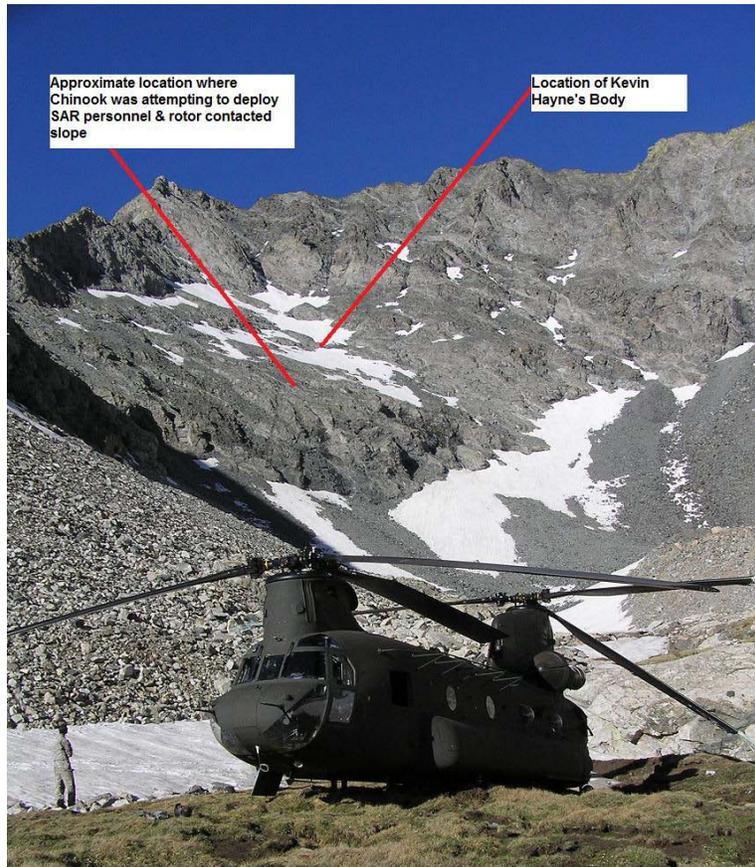
On June 15, 2010 a Colorado Army National Guard CH-47 Chinook sustained a rotor strike and crashed, while performing a rescue operation on Little Bear Peak, which is a “four-teener” peak in south central Colorado with an elevation of 4,278 meters (14,037 feet). The aircraft was in the process of inserting Alamosa Volunteer Search and Rescue (AVSAR) personnel in response to climbing fall. At 0900 hours an 18

was still alive, made an abrupt decision to change plans and land as close as possible. As the rear ramp of aircraft was moved towards a rock outcropping, two spotters checked rotor clearance from their position on the rear ramp. Just as the ramp was about to contact the ground, the rear rotors struck the mountain side with a “very violent shaking.”

The aircraft dropped 305 meters (1000 feet) in 20 seconds and crashed near the location where rescuers were originally going to be inserted. Although the CH-47 was significantly damaged, no personnel on board sustained injuries. The AVSAR personnel continued with the recovery operation of the fallen climber, while the flight crew was later extracted by two HH-60 Blackhawk helicopters. Following the air crash, the staged Flight for Life A-Star helicopter was

launched for reconnaissance, mutual aid assistance was requested from the surrounding county SAR teams and the incident commander requested relief. The after-actions review of the incident highlighted the following; a thorough and formal mission briefing is absolutely essential, adequate pre-planning and training with outside agencies, lack of onboard communication for the SAR personnel prevented any discussion on the attempted change in landing zone and the importance of having a crash rescue plan identified. The CH-47 was dismantled at the crash scene and flown out with a salvage operation that took several weeks.

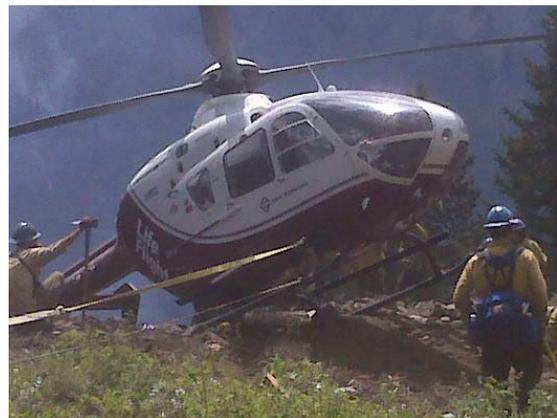
During the rescue of an injured firefighter from the Deer Park Fire with the Sawtooth National Forest (ID) an aeromedical helicopter fell backwards off an improvised landing zone on the fire line. On August 10, 2010 a firefighter lookout was struck by a

91 kg (200 lb) rock sustaining a left femur fracture. He was transported in a litter over very rugged terrain to a helispot, which was improvised on a steep ridgeline. A touchdown pad was constructed with logs surrounding the perimeter on the slope. A Lifeflight Network (ID) EC-135 responded for the medical evacuation. During the landing, helispot personnel discovered they could not communicate with the aircraft, due to a narrow-band versus wide-band conflict in radio programming. When the pilot landed toward the back edge of the pad, he was signaled to move forward however he was reluctant to do so because of nearby obstacles. The weight of the aircraft on the exposed edge of the touchdown pad caused it to collapse, during the spool down of the helicopter. The helicopter tipped backwards coming to rest on the enclosed Fenestron tail rotor. The pilot was the only person on board, as the medical providers had already exited the aircraft. A second landing zone was constructed uphill on the ridgeline and an AS 350 B2 contract fire helicopter was brought in to complete the medical evacuation. The EC-135 was pulled upright with the brute force of available firefighters and inspected on scene by a company mechanic, where it was found to be airworthy. The U.S. Forest Service published a formal incident review known as a *facilitated learning analysis* (FLA), which identified areas for improvement including;

- **Improve and Standardize Emergency Medical Standards, Training and Equipment**
  - Configure agency helicopters with extraction capability
- **Establish Better Communication Standards with Cooperating Partners**
  - USFS radios are primarily set to narrow band, but they do have the capability of transmitting on wide band. Lifeflight air ambulances tend to be wide band and setting these two the same will enhance the success of communications.

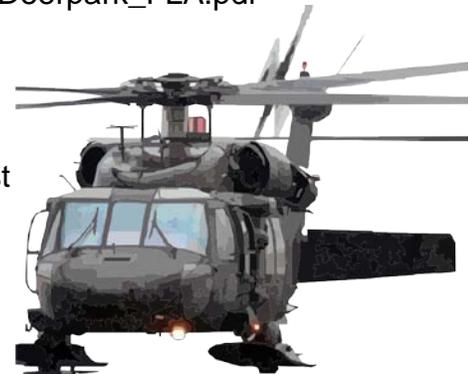
On August 10, 2010 a Sikorsky UH-60 helicopter with the Alaska Air National Guard slid and rolled on its side sustaining heavy damage following a landing on the Knik Glacier (AK) east of Anchorage, which occurred during an operational SAR response. The aircrew of three was uninjured in the accident, during a rescue effort to reach five subjects who survived the crash of a Piper PA-32 aircraft two days earlier. The private aircraft went down on August 8<sup>th</sup>, while sightseeing above the glacier. The following day rescue aircraft were unable to respond due to 112 km/h (70 mph) winds, and four pararescuemen struggling against white-out conditions reached the crash survivors with two sleds loaded with food, water shelter and additional snowshoes in the event an aerial rescue could not be carried out. On August 11<sup>th</sup> two HH-60 helicopters managed to successfully extract all personnel following the accident.

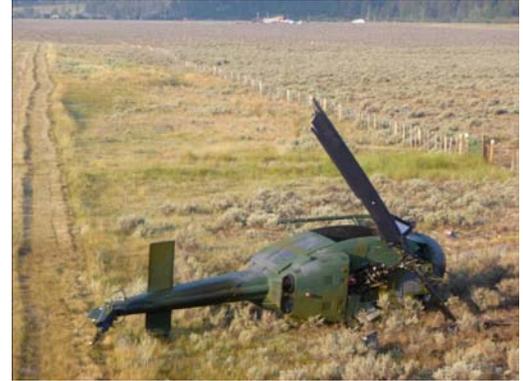
The 341<sup>st</sup> Missile Wing located at Maelstrom Air Force Base, Great Falls (MT) reported a UH-1N sustained a “hard landing” on August 9, 2010 at an unimproved landing strip near Wise River (MT) during a rescue mission. The incident began on August 8<sup>th</sup>, when a 16 year-old male with the Montana Conservation Corps suffered an 18 meter (60 foot) fall down a slope, sustaining a head injury, while he was hiking on a day off. The accident occurred at 2926 meters (9600 feet) in the Pioneer Mountains, in the southwest corner of Montana.

Following the accident at 1800 hours, USFS Dispatch was notified and requested St. Patrick Life Flight from Missoula (MT) 160 km (100 Miles) away. The lifeflight crew was provided with coordinates, which turned out to be a trailhead far from the actual accident scene. After landing below the accident site at Lion Lake (2682 meters- 8800 feet), the aeromedical crew reached the patient following an arduous climb. The care providers were at the patient’s side at 2100 hours, which followed sunset at 2048 hours. The patient was not suffering any altered level of consciousness and had been moving around at the accident scene following their injury. It was recognized that no safe extraction of the patient would occur that night, due to the very steep terrain. A plan was made to remain in place with the patient. At 2200 hours a request was made through USFS Dispatch for the US Air Force to respond 257 km (160 Miles) for a hoist rescue, with the assumption that this would occur at first light. The 341<sup>st</sup> Missile Wing at Maelstrom Air Force Base is the only SAR hoist capability in Montana. At 0345 hours on August 9<sup>th</sup>, the USAF UH-1N arrived and at 0410 hours inserted a flight nurse via hoist, which provided the first opportunity for direct communication with the aircraft from the ground. The aircraft, normally crewed by five personnel, included two pilots, a crew chief and a flight nurse, who was pregnant and on her first SAR assignment. The stretcher was inserted via hoist and the patient packaged. The aircraft, using its spotlight, kicked debris on the rescuers with rotor wash at the accident scene in the 9 meter (30 foot) wide canyon with 18 meter (60 foot) walls. The patient was hoisted out at 0430 hours. According to witnesses, there was “nothing out of the ordinary” during patient extraction. The aircraft then orbited and prepared to extract the nurse. As the helicopter positioned in a hover, cross-ways to the canyon, there was a loud “odd screeching noise” and the helicopter suddenly banked away from the scene. The aircraft reached the Wise River Airport, 21 km (13 miles) away and sustained heavy damage during the landing. It is evident that the aircraft sustained a tail rotor strike at the accident site.

- Poor communication from scene hampered situational awareness.
- Sheriff had lack of operational control during interagency response.
- US Air Force crew configuration was substandard.
- Mission pressure to conduct a high-risk night hoisting operation.

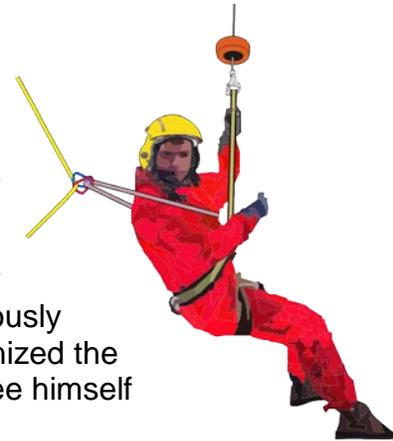
An incident with potential occurred during a daytime hoist training exercise with a Royal Norwegian Air Force Sea King on May 18, 2010. The training exercise involved extraction of two rescuers who were suspended on the cliff from a hanging belay. The Westland Sea King prepared to hoist one rescuer from a hoisting height of 37 meters (120 feet). During the hoist extraction, two non-locking carabiners on the rescuer's shoulder gear sling became inadvertently connected to the belay line on the cliff face. With the rescuer dangerously entangled with the belay line on the ground, the hoist operator recognized the situation and began to reverse the hoist. The rescuer managed to free himself from the gear sling and immediately swung out away from the cliff.

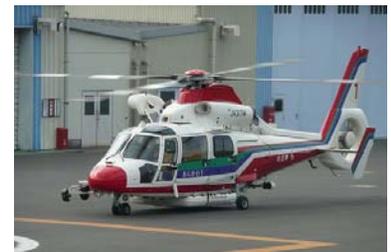
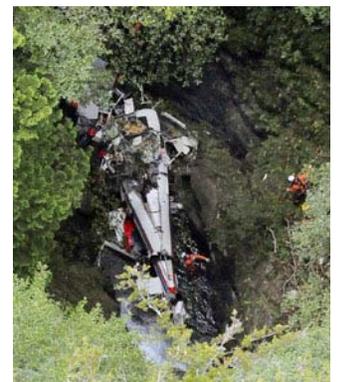
On July 25, 2010 a Japanese fire-rescue helicopter (JA31TM) crashed during a mountain rescue operation near Tokyo, resulting in five fatalities. The AS365N3, owned by the Saitama Prefectural Government, had lowered two rescue workers to the ground just prior to the accident. The two rescuers, an air rescue team member and a firefighter, were inserted via hoist from a 30 meter (98 feet) hover. They later told investigators that the helicopter descended when the two were one meter above the ground, then they suddenly dropped another 50 centimeters. They also said they heard a flip-flop sound that they had never heard before. The survivors said the weather at the time was fine at the accident site and there was no sign it would worsen. At the time of the accident, the helicopter was responding to a 55-year-old female who had fallen near a waterfall. The crash occurred in a mountainous area around 11 a.m. about 4 km (2.5 miles) southwest of the Karisaka tunnel on National Route 140, which is 75 km (47 miles) northwest of Tokyo. The five who died were the pilot, copilot, two prefecture aviation safety workers and a rescue worker from a local fire department. The pilots were from Honda Airways Co. (subsidiary of Honda Motor Company), which operated the helicopter for the Saitama Prefecture. The pilot had worked for the company for more than 20 years. There is speculation that the aircraft began "settling with power" caused by temperature and altitude.

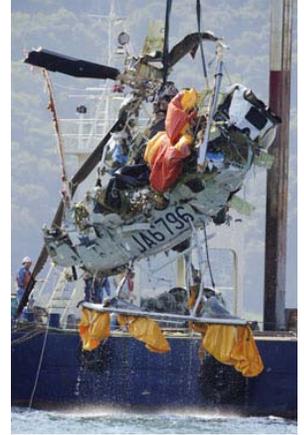
A Japanese Coast Guard Bell 412 EP helicopter suffered a fatal wire strike accident on August 18, 2010 resulting in the deaths of all five crew members aboard. The Coast Guard helicopter “Akizuru” crashed after its landing skids apparently hit offshore power lines

reaching Sanagi Island in the Kagawa Prefecture of southwestern Japan. The accident occurred in clear weather during daylight hours with the helicopter flying 50-100 meters (165-328 feet) AGL. The coast guard’s regional office initially told the media that the helicopter crashed during a “patrol flight,” but later on revised its statement saying the helicopter went down in between demonstration flights for a group of apprentices aboard a patrol boat. In the public controversy that followed, the head of the Japan Coast Guard's regional headquarters in Hiroshima and his deputy were dismissed for “intentionally and systematically concealing information” relating to the fatal crash. At the time of the accident, the co-pilot was seated in the captain’s seat as part of training for certification as a captain.

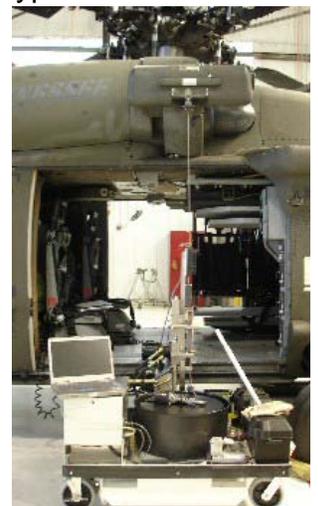
Zephyr maintenance system

A Department of Defense aircraft maintainer Virginia Air National Guard in Sandston, VA was servicing the hoist cable of a HH-60 Blackhawk internal hoist, when they suffered a traumatic injury causing the loss of three fingers. The maintainer was using a garbage can as a collection container to temporarily store hoist cable as it was spooled off the hoist cable drum for inspection. The maintainer was alone at night conducting the inspection. As the cable was retracted from the garbage can back into the hoist, the worker was putting his hand into the container to rearrange the cable. Apparently his hand became entangled and caught up in the cable approaching the bell mouth of the hoist. In the time it took for the hoist to decelerate, his fingers sustained crushing injuries from the hoist. Following the

accident, agency inspection procedures have been modified. Similar incidents have happened in France with two cases causing injuries. A number of hoist operators have adopted an automated system developed by Zephyr that reduces the risk of such injuries.

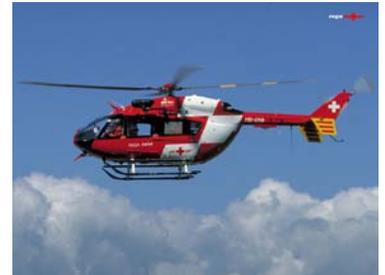
A doctor was hoisting down to an accident site from an EC145 when the downwash of the helicopter blew down a large branch. One of the by-standers helping the victim was injured by the falling branch.

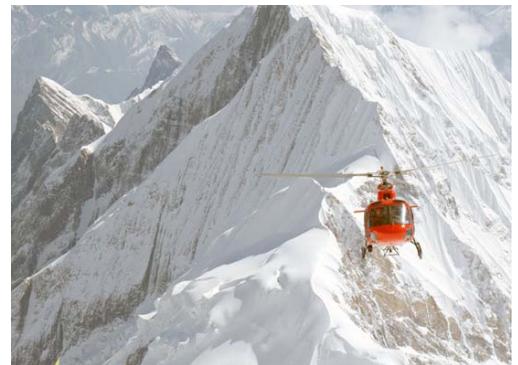
At the time of writing, November 7, 2010, a rescue helicopter crashed in Nepal during a rescue operation. Sadly, the pilot, Captain Sabin Basnet and technician, Purna Awale both died in the crash. The crew flying an AS350 B3 aircraft were responding to two stranded Japanese climbers who had fallen ill on Ama Dablam (6812 m). The crew was able to land at nearly 6300 metres and rescue the first of the two climbers. When the crew returned to pick up the second climber, they crashed while attempting to land in what is believed to be high winds. The main rotor struck a serac during the attempt to land and then fell 1200 metres down the east face. The bodies of the two crew members and the second climber were recovered by another helicopter crew the following day.
