# AIR RESCUE REPORT

International Commission for Alpine Rescue

# IKAR-CISA

October 2 - 7, 2012 – Krynica, Poland

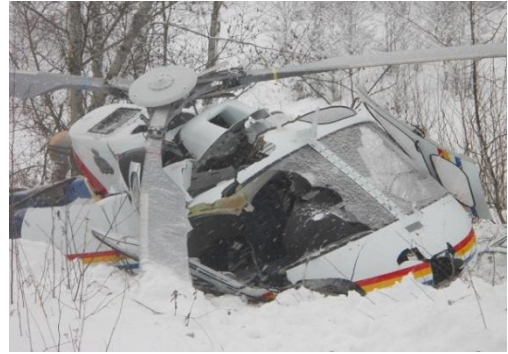
### **Canada, crash AS350B3**

During a Class D training exercise with police tactical teams, an AS350B3 crashed killing the pilot who was the lone occupant. The training had been suspended due to wet snow. Eventually, as conditions did not improve, the pilot departed for Vancouver with a vertical departure due to confined space. At 80 feet AGL, the engine quit and the helicopter crashed.

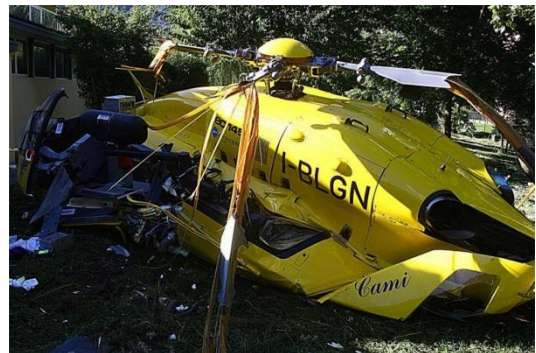
### **Italy, EC145, wire strike, crash**

During takeoff, a HEMS helicopter struck wires and crashed. The crew of two (pilot and engineer) were only slightly injured. The helicopter was destroyed.

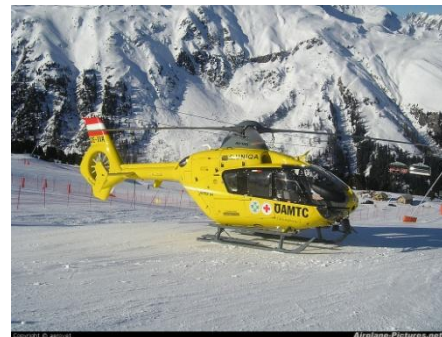
### **Austria, EC135, near miss**

In order to pick up a patient during a HEMS operation, the pilot landed in the snow covered yard of a house. The yard was covered with a lot of snow and the pilot did not realize that he was actually landing on top of a swimming pool. As he began to lower collective to shut down he realized he was on water covered in snow. He lifted off and repositioned the helicopter.

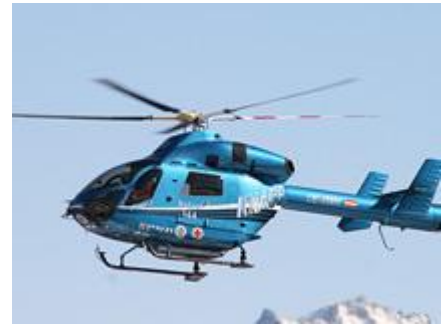
### **Austria, MD902, release of Class D load**

During a recovery operation for a crevasse victim using a fixed line, three rescuers were released from the hook. This was the second day of the operation. On day one, the victim had been located and declared deceased by the physician at the accident site. At the end of day one though, it had not been possible to extricate the victim. On day two, with high winds and poor visibility, a police helicopter that was used on the first day of the operation was grounded due to weather. A second HEMS helicopter was dispatched to the scene and attempted to insert a crew of three to the crevasse site including two rescuers and one police officer. The pilot was unable to get the crew right to the site due to low ceiling. As he was attempting to place them as high as possible, he started to lose visibility with the cloud layer lowering. As he thought the rescue team was on the ground or close to it, he released the load in order to escape. The three people were higher above ground than expected. When they impacted the ground from an unknown height, the two rescuers were injured and the police officer was fatally injured. The helicopter landed without further incident. They were evacuated by ground rescue teams. The crevasse victim was recovered the following day.

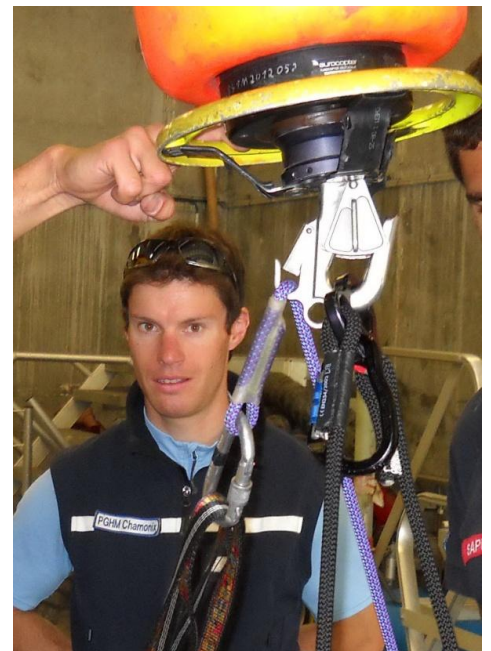
### **France, EC145, entanglement, near miss**

During a hoisting operation at about 3500 metres late in the day (9PM), 3 exhausted climbers were being evacuated from the Gervasutti Ridge of the Tacul North Face. One rescuer was hoisted down to the anchor consisting of slings wrapped around a horn. The plan was to hoist two people at a time and ferry them to the cold du Midi below where one other rescuer had been dropped off. When the first two people were hoisted up, the leashes from the other two climbers got caught on the secondary hook of the Goodrich hoist. The anchor slings were lifted up and all four people ended up hanging on the hoist. Given the elevation and power requirements, the pilot was unable to maintain a hover. He was faced with either trying to take get all four people down safely or jettisoning the load. He was able to get all four down to the col and land without further incident. The hoist and engine limits were exceeded but no damage ensued. There was a lot of discussion on entanglement issues and how to prevent them.

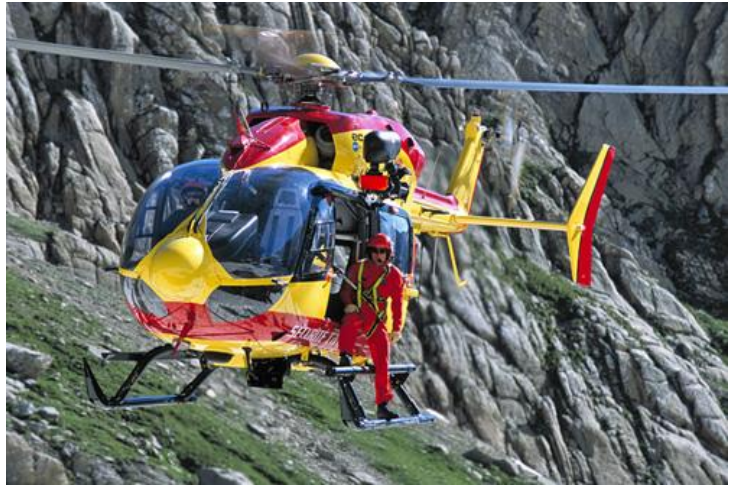
### **France, EC145, rotor wash incident**

A rescuer and a doctor were injured by falling trees during a hoisting operation. A climber had fallen on a via ferrata. His lanyard broke during the fall and he fell into the trees below. One rescuer was hoisted down into the forest to attempt to locate the victim. Once on the ground the rotor wash caused a tree to fall onto the rescuer. He sustained serious injuries. Subsequently, a doctor was hoisted down in a different location nearby to tend to the

injured rescuer. After the rescuer was packaged with the doctor as attendant, the helicopter returned to extract them both. As the helicopter was hovering, another tree came down further injuring the rescuer as well as the doctor. The evacuation of both was then done by ground but this was complicated by the steepness of the terrain. The original victim was located deceased and also evacuated by ground. The investigation that ensued revealed that rock scaling done during the creation of the via ferrata had created considerable damage to the base of the trees below the route. This root damage made them more susceptible to falling. Both of the injured crew have recovered.

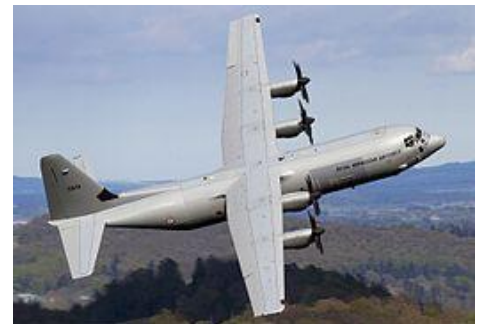
### **Norway, C-130, crash**

Although this was not a helicopter crash, it is noteworthy because of the scale of the response. This was a major search with joint coordination between Sweden and Norway. A C130, Super Hercules of the Norwegian Air Force was dispatched while participating in a military exercise. The aircraft disappeared from radar over the Kebnekaise mountain range near Kiruna, northern Sweden. A major search was undertaken with over 100 searchers, snowmobilers and skiers. After three days of searching in poor weather, the wreckage was found by another P3-Orion fixed wing aircraft. Initial attempts to access the site by Danish helicopters, one Norwegian Sea King and two Swedish helicopters were unsuccessful due to weather. Some of the remains were eventually recovered including the cockpit voice recorder. All five crew members on board were killed. The incident is still under investigation.

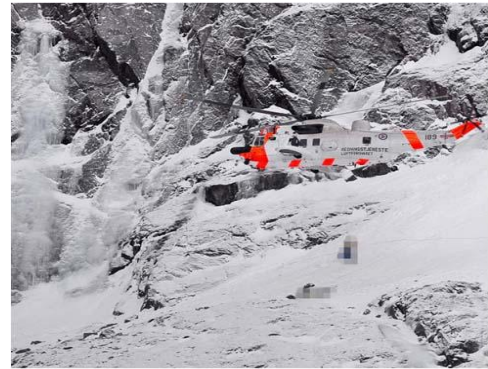
### **Norway, Sea King, jettison of hoist cable.**

During a complex rescue for two missing ice climbers, the Sea King crew cut the cable during an attempt at a hoist extraction. When the accident site was found, it was determined that the climbing party had been hit by massive Rockfall. They were located at the base of the waterfall and presumed deceased. Due to the steepness of the terrain and the risk of further Rockfall and icefall, rescuers were hoisted a few hundred metres below. They then climbed in to the accident site. A super long line extraction using the two hoists on board and with ropes rigged at the accident site was attempted. One victim (deceased) was in the stretcher but not yet attached to the helicopter. As the helicopter was hovering, the cloud base descended and enveloped the cockpit. The hoist hook had been lowered. The crew cut the cable and descended to the left in IFR conditions. The aircraft was able to land safely. The recovery was completed the following day in good weather.

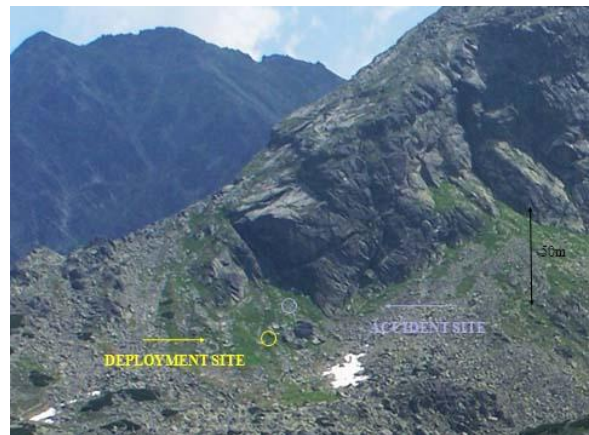
### **Poland, Sokół W-3A, rotor strike**

TOPR SAR was responding to a call of an injured climber who had sustained a 50 metre fall on the west face of Kościelec at 1850 metres. The crew consisted of two pilots, a hoist operator, a paramedic and a rescuer. The pilots decided to deploy the two rescuers below the face with a hover exit procedure rather than through hoisting. As they were approaching the site and about 1.5 metres AGL, a rock from above hit the main rotor blades. The shock was felt by the whole crew. The pilots aborted and landed uneventfully below. The blades sustained considerable damage. The victim was evacuated by ground. A set of blades from the Polish Border guard was sent in four days later using an MI-8. It is speculated that the rock was dislodged by people on the route above the hovering helicopter.

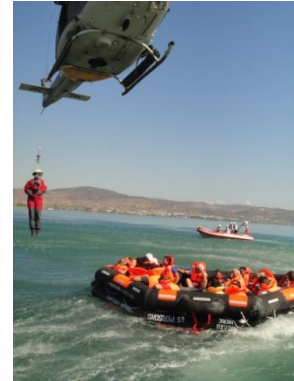
**Greece, BH205, hoist cable failure**

During a hoisting exercise over a small vessel, the cable on the hoist failed as the rescuer was just above the vessel. There were no injuries. The cause of the hoist failure is unknown.

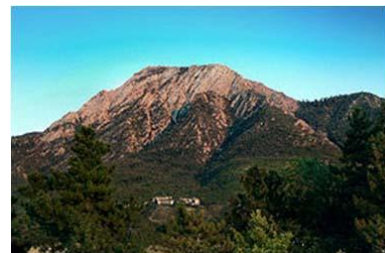
**United States of America, AS350B2, Crew fatality**

A rescue crew with the department of public safety responded to injured hikers on the Mt. Olympus trail near Salt Lake City, Utah. The aircraft was unable to lift off with the whole crew and the victims. Tactical flight Officer Aaron Beesley was left at the scene and was to be picked up on a second evolution. When the crew returned he was found deceased at the bottom of a 20 metre cliff. It is speculated that he fell while trying to retrieve a pack.

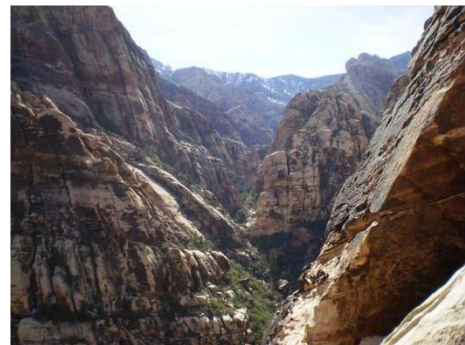
**United States of America, Bell HH-1H, rotor strike**

A crew from Las Vegas Metro Police Aviation was evacuating stranded hikers from a canyon during a training for SAR personnel. The first evolution was done with a toe in. Upon returning, due to changing winds and the aircraft running out of left pedal, the pilot elected to perform a one skid landing on the right. Upon departure, the main rotor blades struck the ground but he was able to fly away without further incident. Crew Chief fatigue may have been a factor.

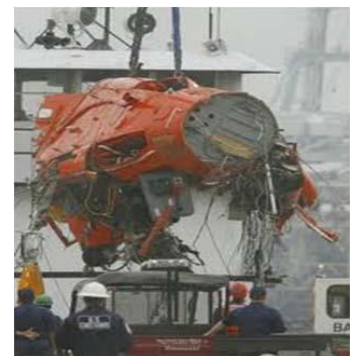
**United States of America, AS365, Crash**

During a US Coast Guard training mission off the coast of Alabama, the crew encountered poor visibility resulting in the pilot losing reference. As he turned to the right to try and regain reference, he impacted the water. It is estimated that the helicopter impacted the water at 70 knots from 200 feet AGL with a descent rate of 1500 FPM.

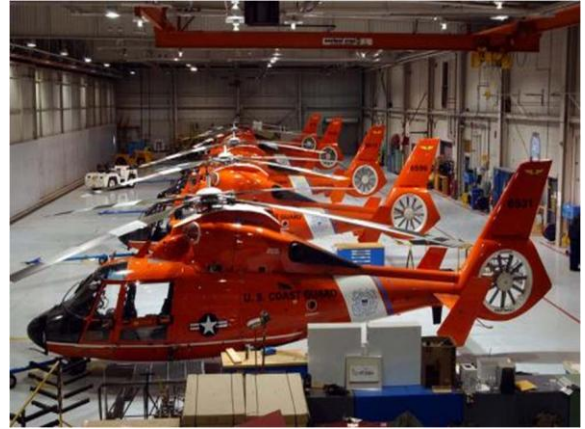
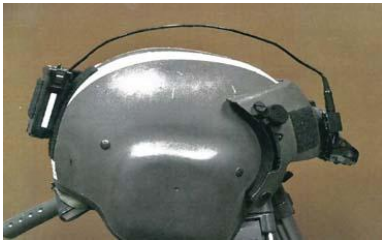
**United States of America, AS365,**

While responding to a victim in the water near Los Angeles California, a US Coast Guard helicopter had the number one engine shut down after establishing a hover. The pilot in command immediately initiated one engine inoperative (OEI) procedures and was able to transition to forward flight. The Co-Pilot initiated a restart of the #1 engine and the crew flew successfully to local airport. The engine shut down was initiated by the Co-pilots NVG cord on the helmet getting caught in the engine control switch.

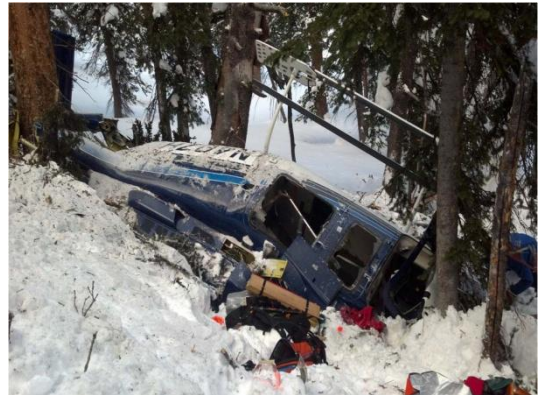
**United States of America, BH 407, crash**

During an operation for injured snowmobiler, a crew of three aboard the contracted Teton County Wyoming SAR helicopter crashed. As the pilot was establishing a hover, he experienced an unexpected yaw which he thought he corrected. The helicopter then began to spin rapidly and crashed into the trees below. The pilot was able to get out and crawl to a ridge to call for help. One of the other crew members was injured and one was killed in the crash. Due to communication issues, it took 75 minutes for help to get to the crash scene.

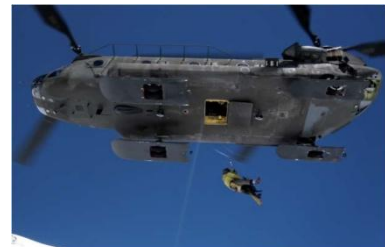
**United States of America, Boeing Chinook, rescuer fatality**

During the rescue of 4 injured climbers on Mt. Rainier in Washington, a rescuer fell 2400 feet to his death. The climbing party of four had sustained a fall on steep ice. After hoisting of the first victim, the helicopter was delivering a stretcher for the second victim. The rescuer went to receive the litter and it is believed that the rotor wash knocked him off balance.

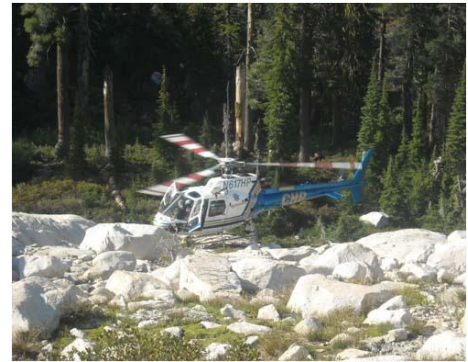
**United States of America, AS350B3, rotor strike**

During the evacuation attempt for an injured hiker in the Trinity National Forest, a rescuer was struck by the main rotor blades as he was walking away from the helicopter. The California Highway Patrol helicopter was shutting down near the victim at the time. The rescuer had taken off his helmet and was critically injured. He was immediately treated by the physician on the crew. The helicopter had not sustained damage and was able to fly the injured rescuer to the hospital. The rescuer has survived.

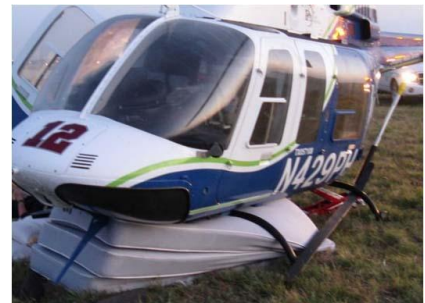
**United States of America, BH407, near miss**

During a HEMS mission in San Antonio Texas, the helicopter struck a tower and sustained substantial damage to the landing gear. The pilot requested an emergency landing at the hospital on top of mattresses but was denied. This procedure was done in a nearby field and the helicopter landed safely.

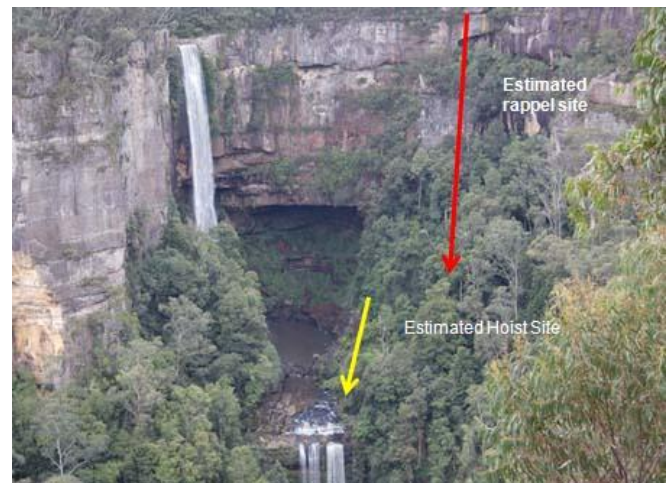
**Australia, AW 139, rescuer jettison, fatality**

During the rescue of an injured canyoneer at Carrington Falls in Buddero National Park, a rescuer was fatally injured after possible contact with terrain while being extracted via hoist. The helicopter crew had previously determined that they were unable to insert the rescuers via hoist because of terrain. One of the rescuers accessed the location by rappelling into the steep terrain. The victim was moved to an area where extrication via hoist was determined to be an option. The incident occurred while the rescuer and victim were being hoisted. It is believed that after contact with the terrain, the helicopter crew lowered the rescuer and victim to the ground. The rescuer was unable to detach from the hoist cable forcing the helicopter crew to cut the hoist cable. The second rescuer then rappelled to the accident site and began caring for first rescuer. Unfortunately the first rescuer succumbed to his injuries before he could be extricated. The recovery and evacuation of the original victim and rescuer's body was completed the following day.
