AIR RESCUE REPORT

International Commission for Alpine Rescue

October 16-19, 2013 – Bol, Island of Brac – Croatia

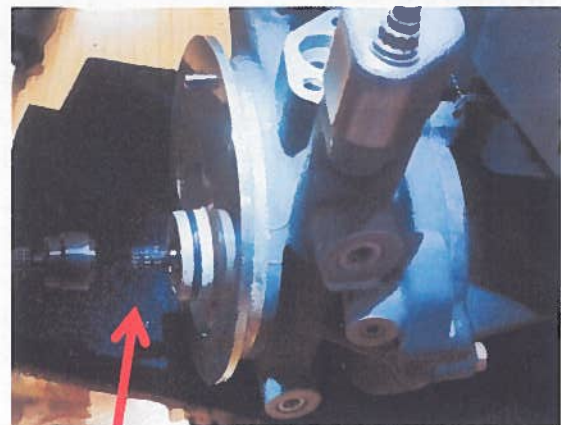
Austria-Engine Failure-Karlheinz Burtscher

OAMTC EC135T1, HEMS flight, start-up and pre take-off check was normal. Post take off normal until slight yaw with needle split and caution light. Engine failed during cruise flight. Declared emergency, performed a single engine emergency landing that was uneventful. On the ground restart, engine failed at 50% N1. Root cause- worn spline on the fuel pump drive system between the HMU and Reduction Gear Train.

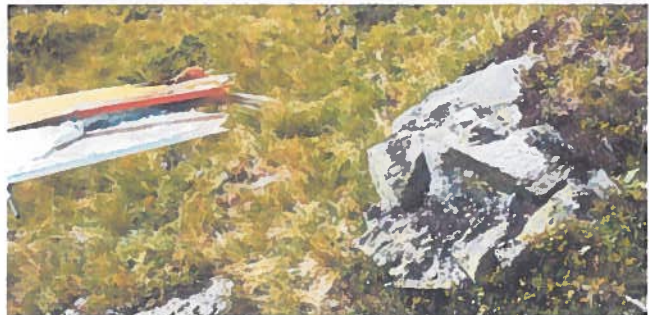
Austria-Main Rotor Blade Strike-Karlheinz Burtscher

OAMTC EC135, HEMS flight, Pilot had landed the helicopter on a narrow uphill path to drop of the HEMS crew. Pilot decided to reposition the helicopter with 120 degree turn to the right. HEMS crewmember was standing in front of the helicopter to guide the pilot via radio. During the maneuver the main rotor struck a rock that was outside the pilot's field of vision.

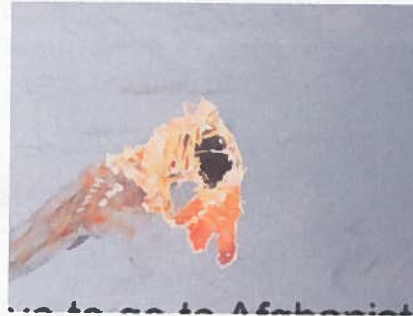
Austria-Blade Bullet Hole-Karlheinz Burtscher

During preflight a bullet hole was found in one of the main rotor blades.

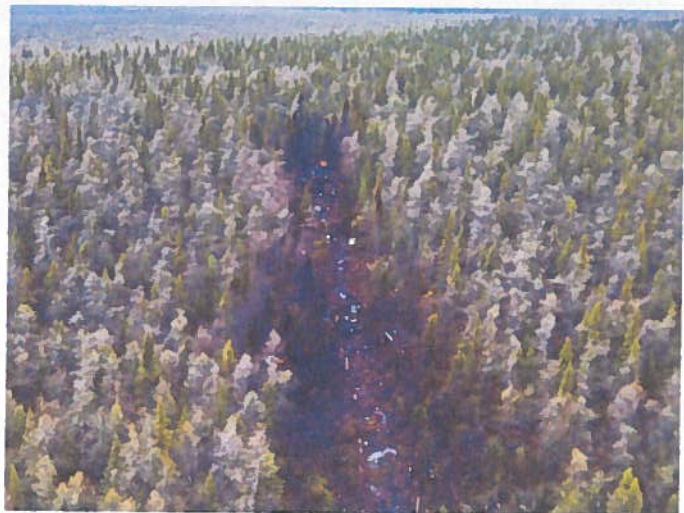
Canada-HEMS Accident-Brian Webster

Sikorsky S-76 crashed one minute after take-off from airport (1 km) during HEMS flight. All personnel (two pilots and two paramedics) killed. Weather was 3 degrees C, overcast and light rain. Time of crash was midnight. No NVG being used. SAR response came from armed forces base in Trenton (830 km away). Cause of crash unknown at this time.

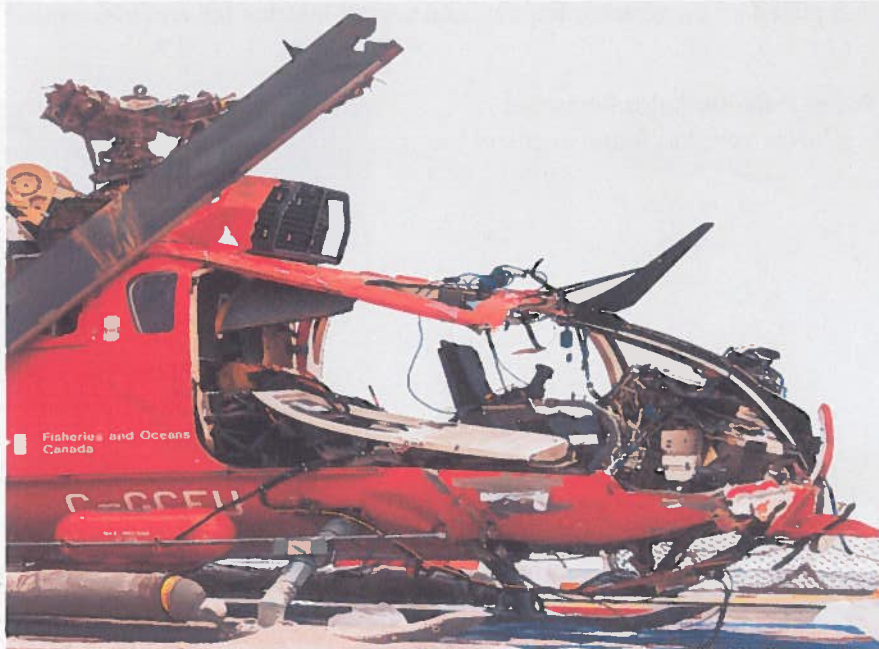
Canada-Accident-Brian Webster

Canadian Coast Guard BO105 (3 crew members, all fatalities) on ice research flight crashed through the ice. All crew members died due to hypothermia.

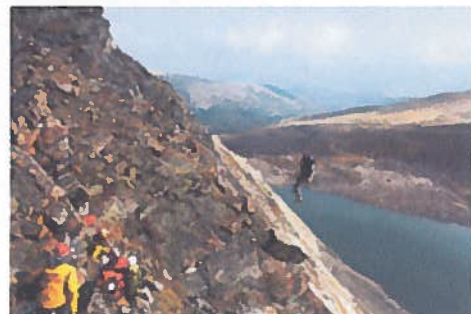
United States (Colorado)-Hoist Incident-Casey Ping

A Colorado National Guard UH-60 requested to extract patient that had fallen from Mount Bancroft. The patient was initially unconscious and became hypothermic while waiting for rescue. Mountain rescue personnel had been inserted by HEMS aircraft ~200m below the accident site. Hoist extrication was requested due to patient condition and difficult extrication in exposed terrain. The National Guardsmen was being inserted via the Jungle Penetrator and sustained a fractured lower leg. The National Guardsmen was able to assist with the litter extraction of the patient. Mountain rescue personnel were unaware of the injury until this point. The mountain rescue team was able treat and splint the Guardsmen which allowed him to be extricated via hoist.

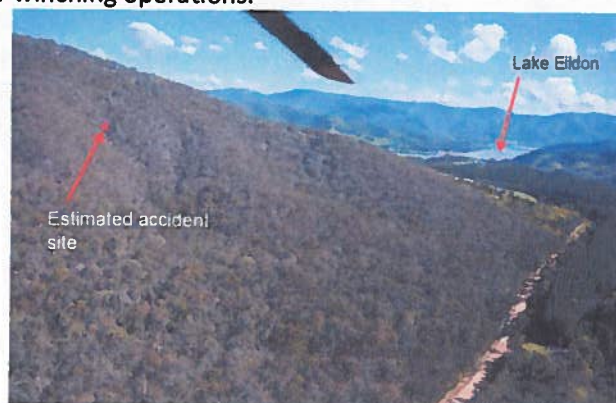
Australia-Hoist Accident-Casey Ping

The crew of a Bell 412EP helicopter was tasked to pick up a male patient who was reported to have fallen in the hills around Macs Cove, near Lake Eildon, Victoria (Vic.). The crew was informed that, due to the difficult terrain and the size of the patient, a winch extraction would likely be required. The patient was located in a heavily-wooded area in steep terrain about 1-1.5 km from the nearest road. The trees in the surrounding area were up to 60 ft. high and the crew noted numerous dead branches that could create a hazard for winching operations.

The crew located a suitable area into which to winch the paramedic to assess the patient's condition. They discussed likely retrieval options and decided that a stretcher winch would be too dangerous due to the steep terrain, surrounding vegetation and the possibility of fouling. Due to the small winch area and the possible fouling hazard, the crew elected for a double-lift extraction with the patient in a rescue/retrieval strop (strop). The paramedic and air crewman were unable to get the winch portable radio to work, so they decided that the paramedic would use hand signals to indicate whether a winch extraction would be required. On arrival, the crew noted that some trees had been cleared to create a larger winching area and that the patient had been moved to this area. After about 5 minutes the paramedic signaled to the crew that he was ready to winch and the crew positioned the helicopter over the winching area in an approximately 80 ft. hover, about 20 ft. above the tree canopy.

Initially, the winching procedure appeared to proceed normally. The air crewman reported that the paramedic appeared to have his arms and legs wrapped around the patient, as is the normal procedure. When the paramedic and patient were approximately 30–40 ft. above the ground, the air crewman noticed that they had moved towards the edge of the winch area and close to the upper branches of the trees. The paramedic stated that he came in contact with the branches and had to use both hands to fend off as he came through the tree canopy. The helicopter was moved back and right about 5 ft and the winch continued. The air crewman reported that once the paramedic and patient were clear of the canopy, at about 15 ft. below the aircraft, he noticed that the patient was moving or wriggling.

The air crewman stopped the winch for a control check, and shortly after resuming the winch, noticed that the patient's arms were not in the usual position in the strop and that the paramedic appeared to be shouting at the patient. The air crewman elected to continue winching in, and informed the pilot that the patient was slipping. As the paramedic and patient reached the height of the helicopter's right skid-landing gear, the paramedic was facing the helicopter and the patient was facing outwards. The paramedic reported attempting to pin the patient against the skid in an attempt to stop him slipping. The air crewman continued winching until the paramedic's head was level with the middle of the door opening. At this stage the air crewman informed the pilot that he could see the patient slipping further. He dropped the winch pendant and reached down, grabbing the patient's shoulder in an attempt to stop his fall. The air crewman stated that by this stage the patient appeared to be unresponsive and limp.

Despite the crew's efforts, the patient slipped out of the strop and fell to the ground, sustaining fatal injuries.
