# AIR RESCUE REPORT

International Commission for Alpine Rescue

**October 6-9th, 2014 – South Lake Tahoe, Nevada – United States**

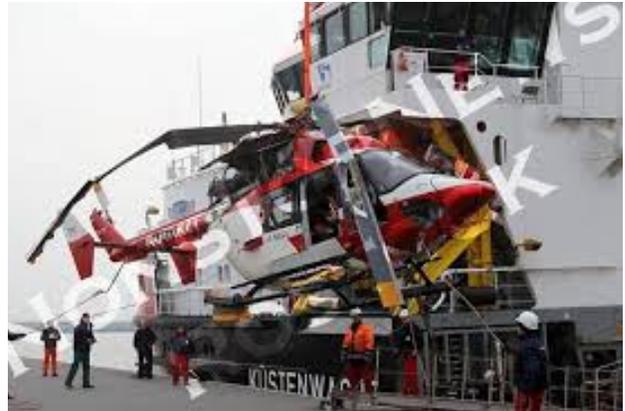
BK117 training flight, night over water hoist training, loss of reference resulting in the aircraft crashing into the sea. Discussion about the aircraft capabilities and number of personnel needed for over water, deep water night hoisting.

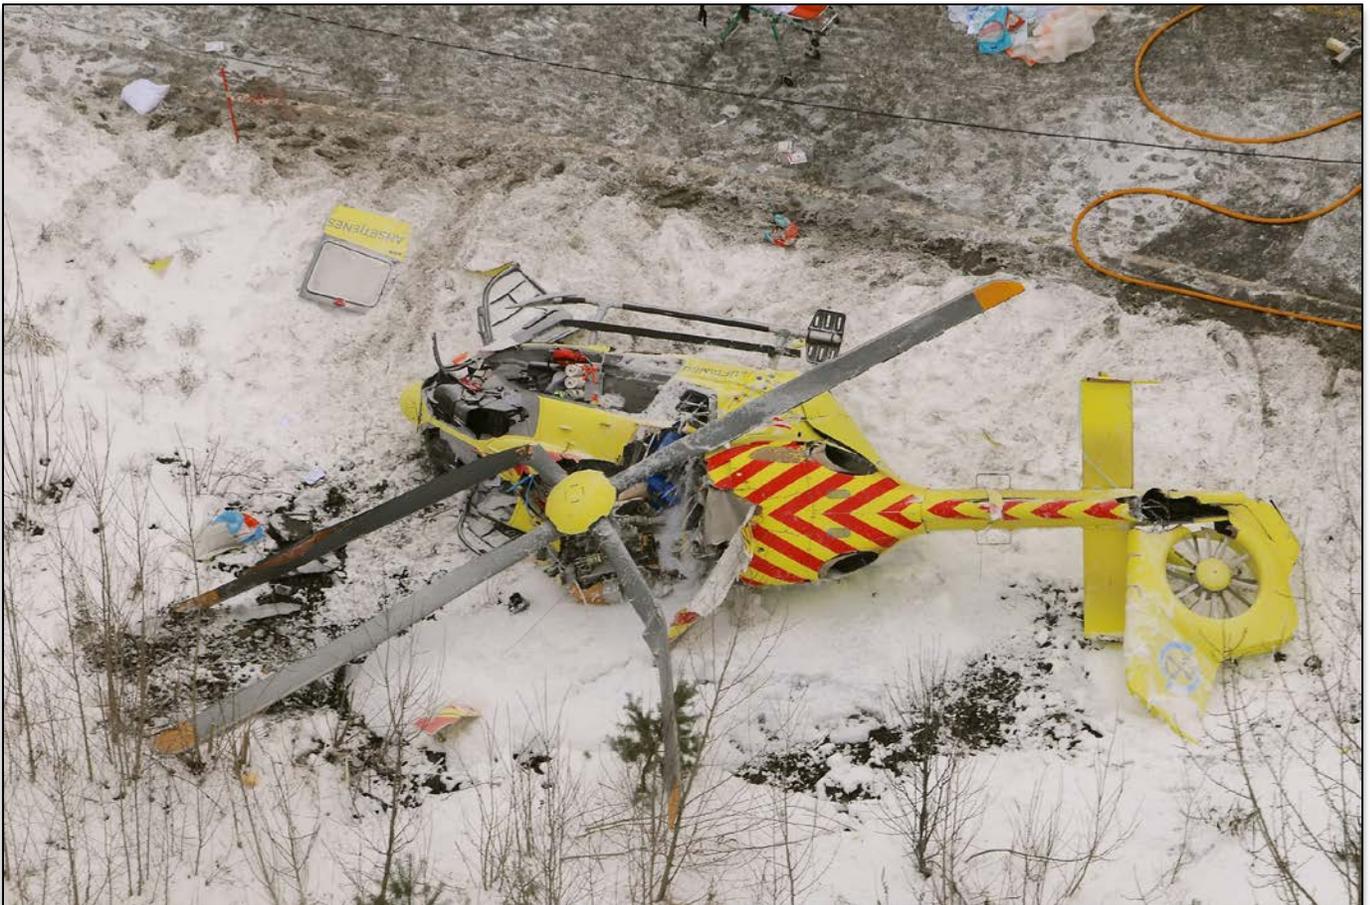
Norwegian Air Ambulance HEMS Accident. On January 14, 2014 a Norwegian Air Ambulance EC135 was responding to an accident scene. During final approach the aircraft struck a series of electrical lines. Contact with the power lines resulted in loss of control of the aircraft and it landed Left side down. The pilot and doctor were fatally injured. The paramedic was critically injured but survived. Review of the incident included communications difficulties between the ground personnel and the aircraft, multiple sets of wires in the vicinity of the accident, power line poles that were obscured by trees and incomplete wire maps. Ground personnel identified the evolving threat but was unable to communicate to the crew because of radio infrastructure changes. This led to a discussion about standardized signals and recommendations for ground personnel that could be recommended by ICAR. Should include abort signals.

Next year a workshop on the subject “Air – Ground Collaboration” will be held with the goal of editing some key points to address to third persons on accident scene (Police forces, Firefighters, etc..)

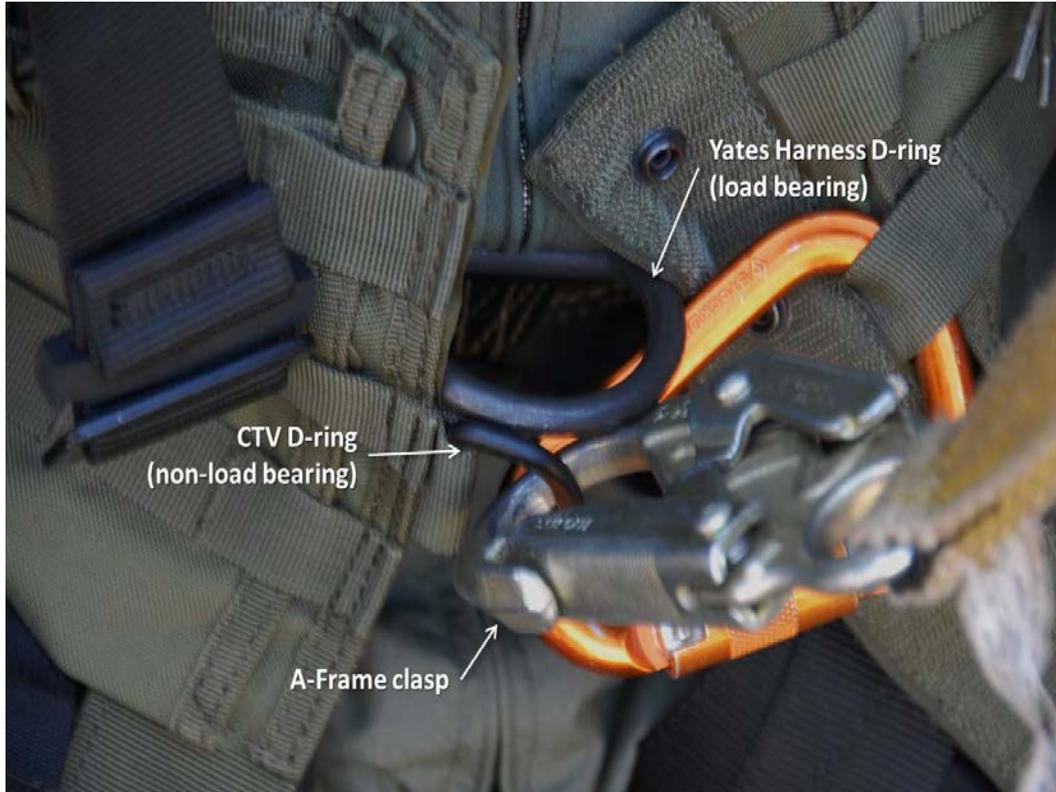
California Air National Guard Hoist Accident- Accident report released. Victim attached hoist hook to non-load bearing plastic ring that was next to load bearing ring. Plastic ring failed short after the victim left the aircraft.

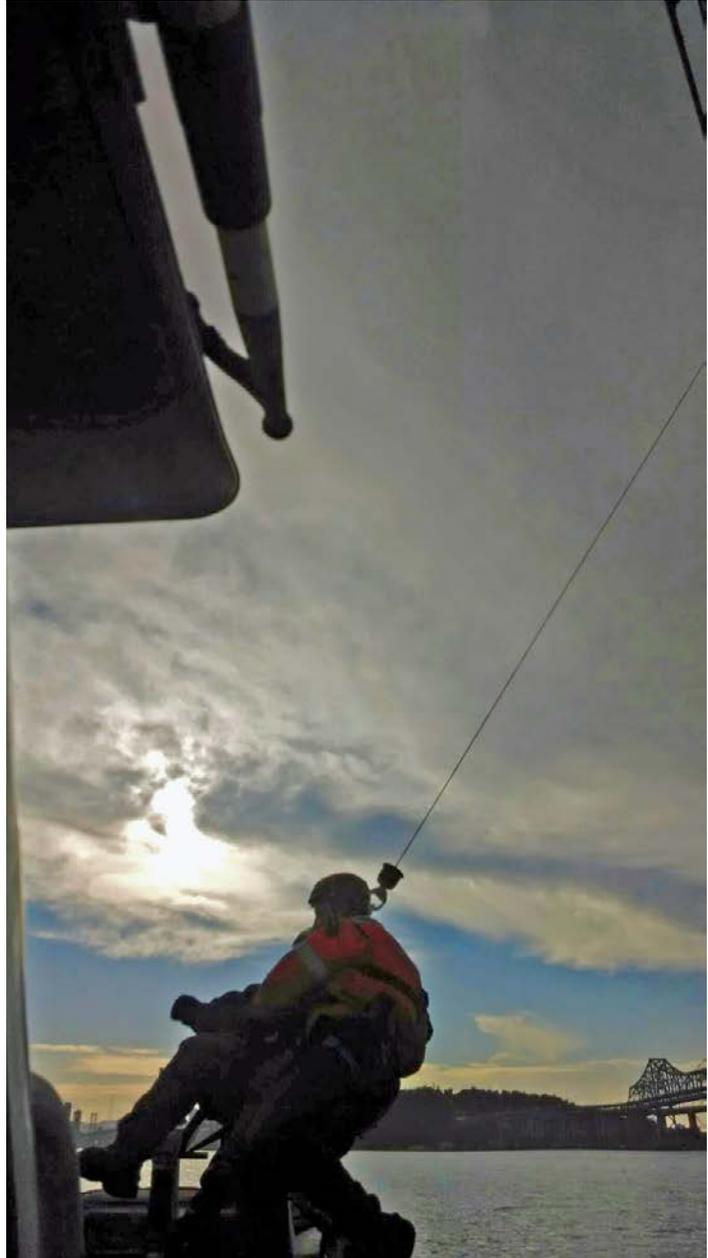
They practiced locally and determined the mission could be completed. Once onsite they evaluated the boat and removed some hazardous equipment. During the first hoist some issues were identified. Those were corrected and the second hoist commenced. During the extrication the rescuers harness became snagged on the bow of the boat. The helicopter and boat direction were no longer aligned resulting in significant downward pull being placed on the aircraft. The hoist operator was unable to deploy hoist cable and the aircraft was pulled downward and the Right. The emergency jettison switch was mounted on the hoist (internal). The hoist operator was attempting to reach the jettison button but aircraft movement impaired his ability to reach the button.

A second crew member in the cabin reached the jettison button as the aircraft was in close proximity to the water surface. Both pilots indicated that they could not activate the emergency jettison as they were fully engaged in trying to fly the aircraft. It appears that at almost the same time the rescuer's harness becomes free from the snag. The rescuer and victim are pulled off the boat and into the water. They are pulled through the water at significant speed for a short distance. The rescuer was injured during this sequence and needed the victim to activate his manually inflated flotation. They were removed by boat. The rescuer was off work for some time but there were no other injuries or damage.

After action review conducted by Sac Metro Fire Department identified

1. Practice cable cut for all crew positions
2. Position of the cable cut switch
3. Lack of clutch for rescue hoist
4. Nylon between rescuer and hoist ho

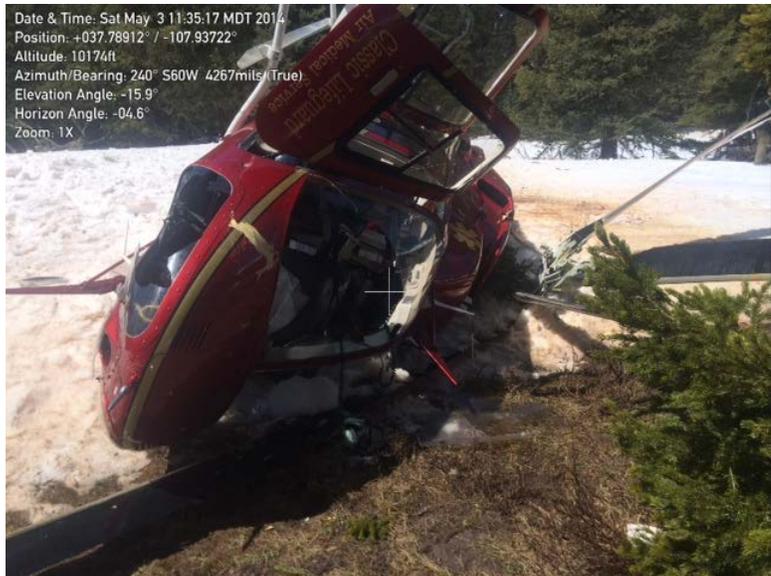
HEMS Bell 407 assisting local Sheriff's Office for search of missing skier in the San Juan Mountains. At ~10,000 feet MSL, 400 feet AGL the engine noise changed and vibration increased. Engine chip light illuminated along with FADEC degrade. The pilot initiated a precautionary landing. On final approach ~150 AGL the engine failed. During the short run on landing the aircraft rolled onto Left side. The crew was able to self-extricate without injuries.

The engine had recently been overhauled and was recently installed in the aircraft (<150 hours).

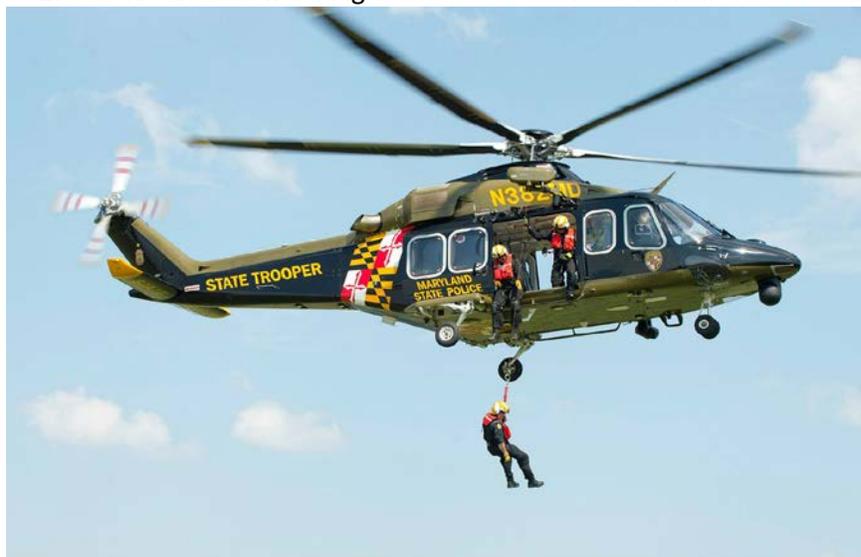
Maryland State Police (AW139) requested to extricate an elderly female patient who was injured in a fall from horse. During extrication, the commercial hoist tagline device failed at ~50 feet. The hoist continued and resulted in significant litter spin. As the litter approached the aircraft, forward airspeed was initiated, which reduced the spin rate. The litter was brought in the aircraft and the patient was transported to the hospital. There were no injuries or damage to the aircraft.

The after action review conducted by Maryland State Police identified

1. Replaced weak link with another manufacture
2. Commence forward flight as soon as the litter is clear the obstacles

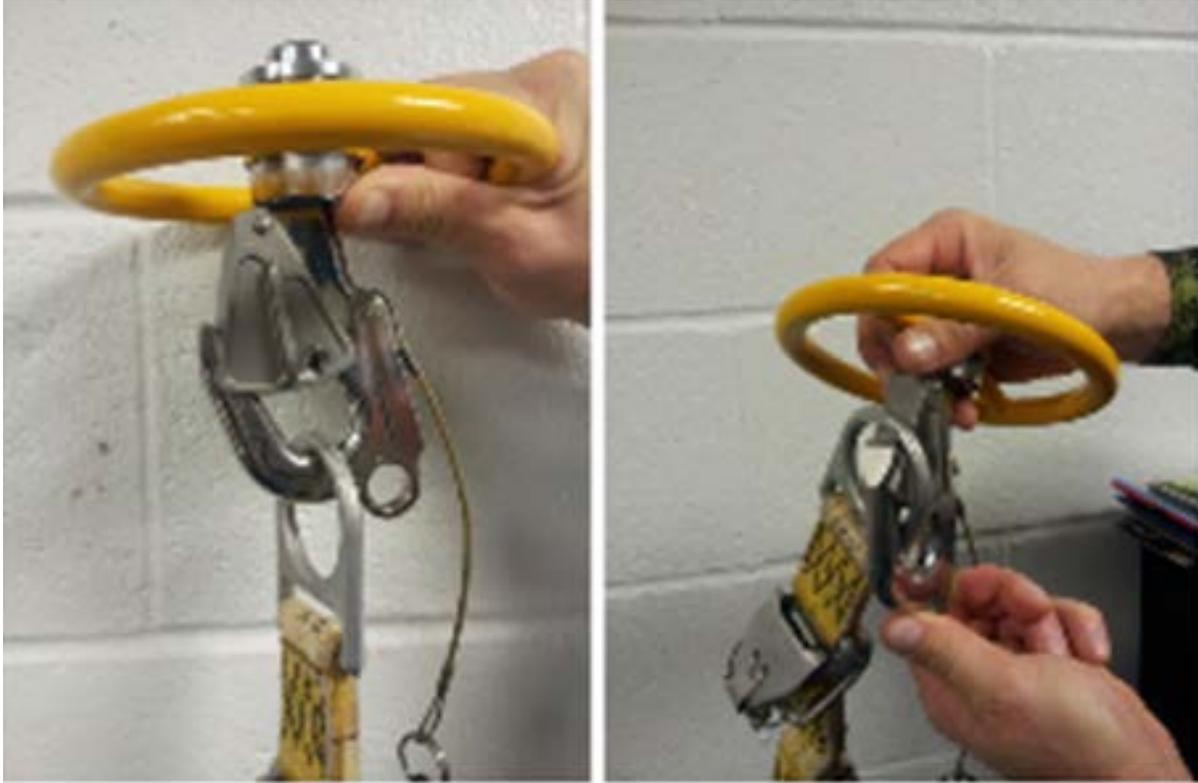
Seconds later, the SAR Tech fell to the ground and landed flat on his back. The SAR Tech then stood up and indicated to the FE that he was not injured. The FE reeled in the hoist hook and then brought the SAR Tech up using the back-up hoist. After returning to a staging area, the entire crew then decided to terminate the training mission.

The investigation is focusing on technical causes, specifically a phenomena known as dynamic rollout, in which the rescue harness connecting D-ring can misalign with the hoist hook and allow the D-ring to disconnect. A Flight Safety *Flash* bulletin was immediately sent to all RCAF hoist users to identify this hazard.

Hoist Fall Recommendations- Conduct a workshop next year to address hoist/aircraft fall issues. They are too many losses and incidents around the world while hoisting. The goal of the workshop will be to address some key points for hoisting in order to avoid mishaps by increasing awareness of the crews.
