IKAR AIR RESCUE REPORT 2015

Killarney, Ireland

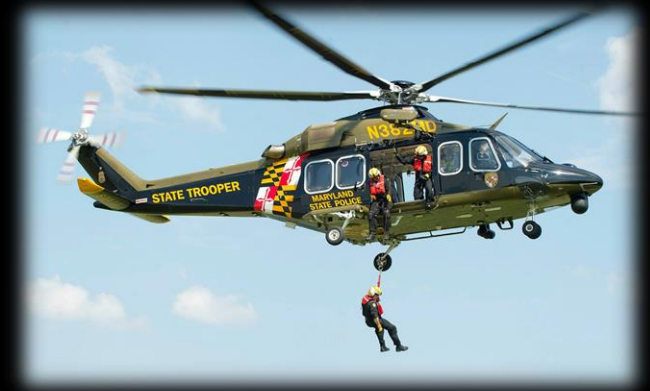
Maryland State Police "Sheared Cable"

- During a night training evolution
- Planning on a Basket only drop to a confined area
- Hoist operator was using the hoist light as a search light when the bridge of his finger raised the shear cover shearing the cable

- Discussions with manufactures
- Switch “Guard”
- Hoist light is a hoist light and not a search light
- Hoist operator verbal and visual confirmation
- Once evolution started – NO manipulations made

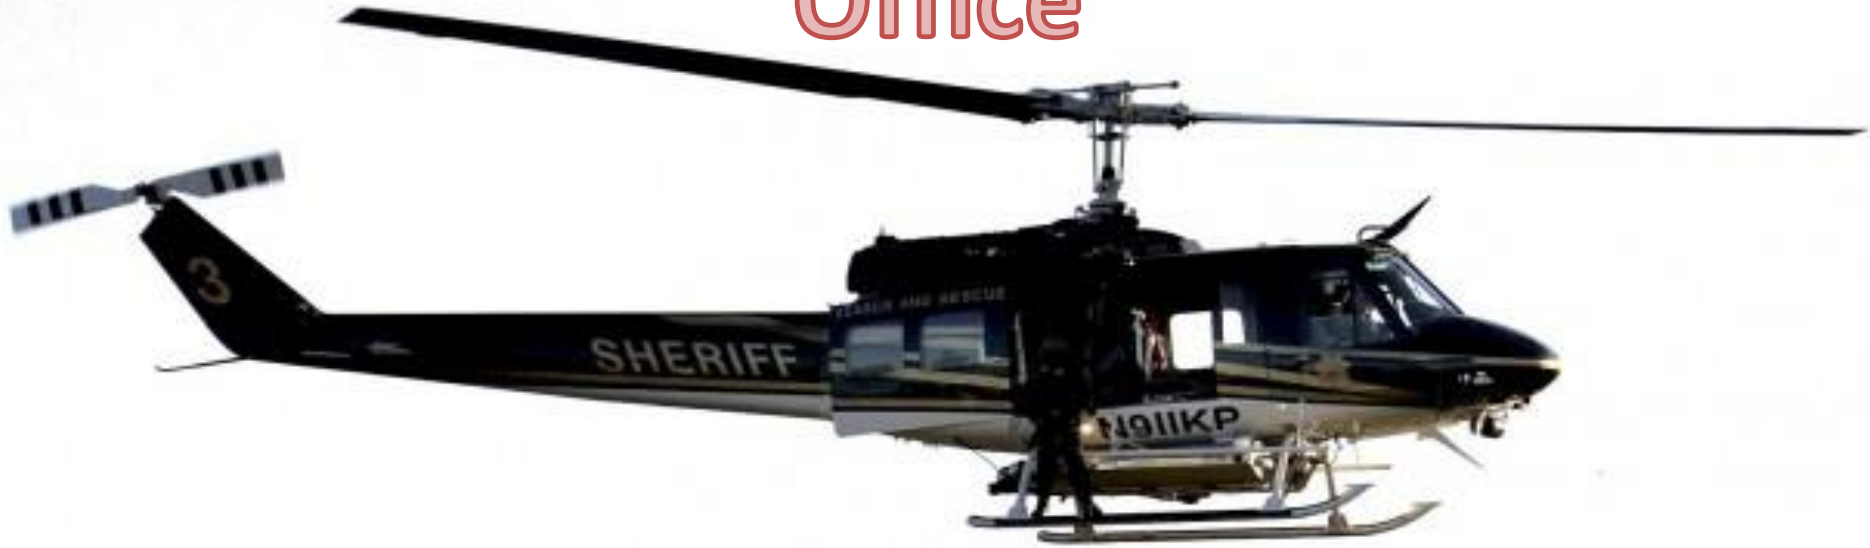
Santa Barbara County Sheriff's Office

- **Alerted the pilot who overrode the hoist DOWN**
- **Hoist lowered faster than normal**
- **Subject landed faster than normal**
- **Hoist was removed from service**

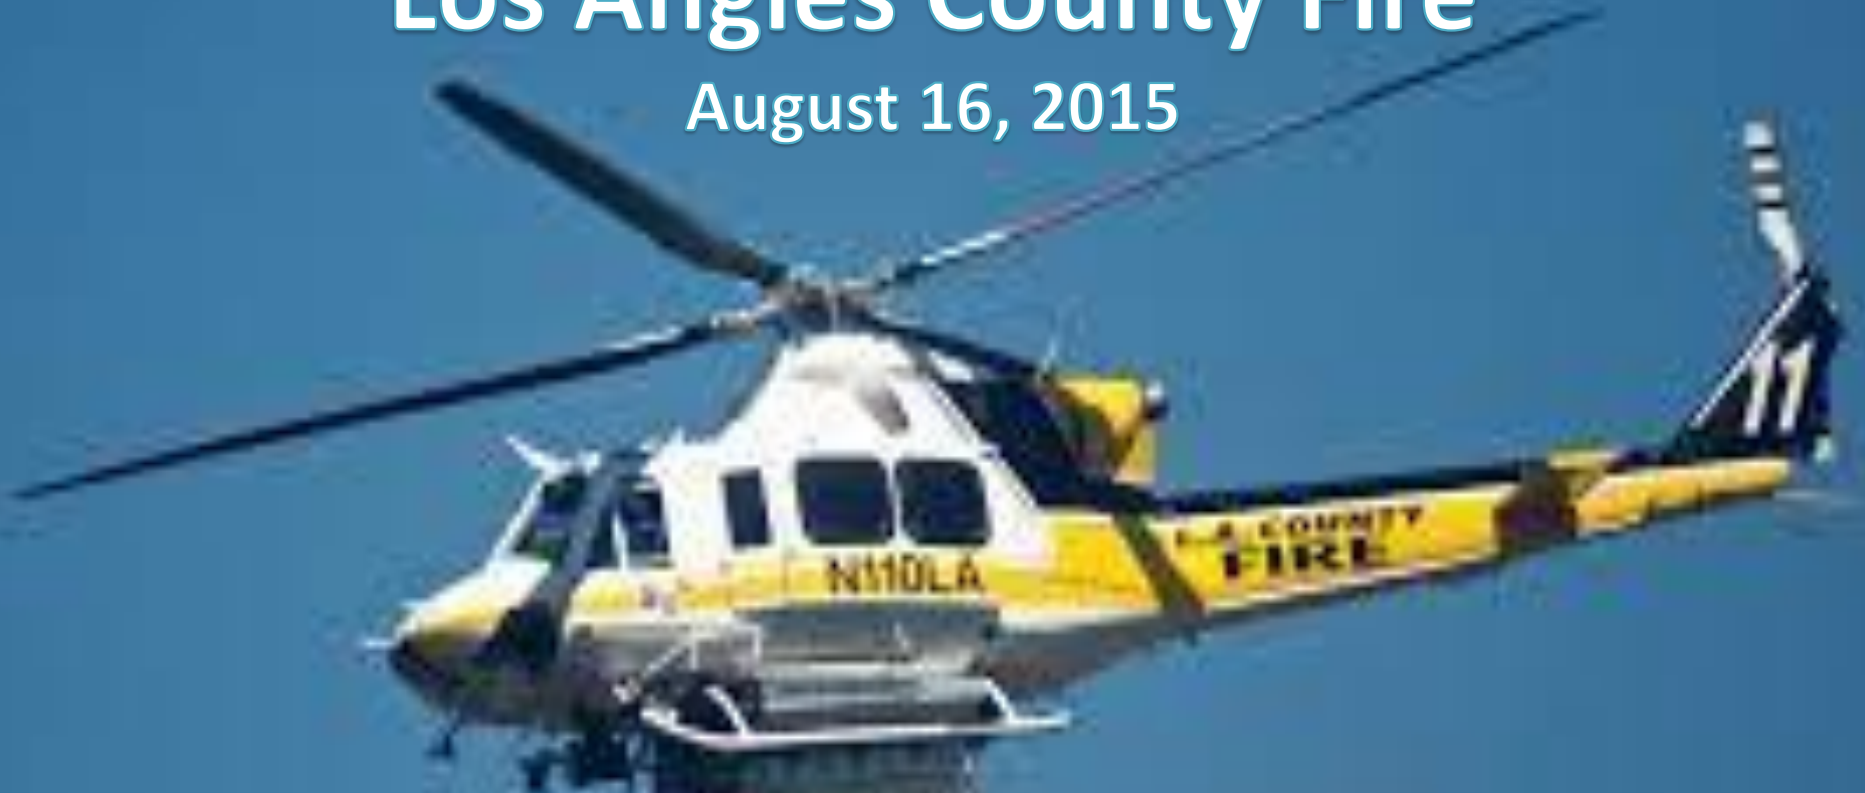
Los Angeles County Fire

- Montebello Fire
- HeloCo
- Dual Engine Failure
- 3 on board minor injuries

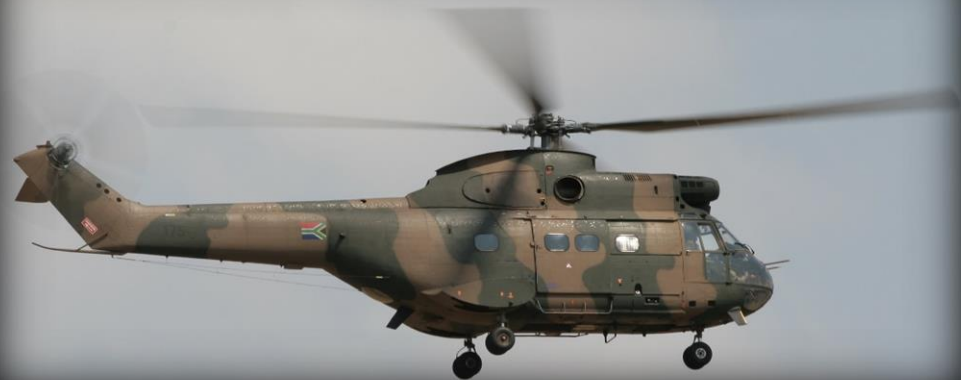
MCSA

- Victim failed to connect himself to the hoist hook
- Inadequate safety checks
- Checked the number of carabiners that should be connected to the hoist hook
- Failed to account for an extra carabiner attached to rope bag

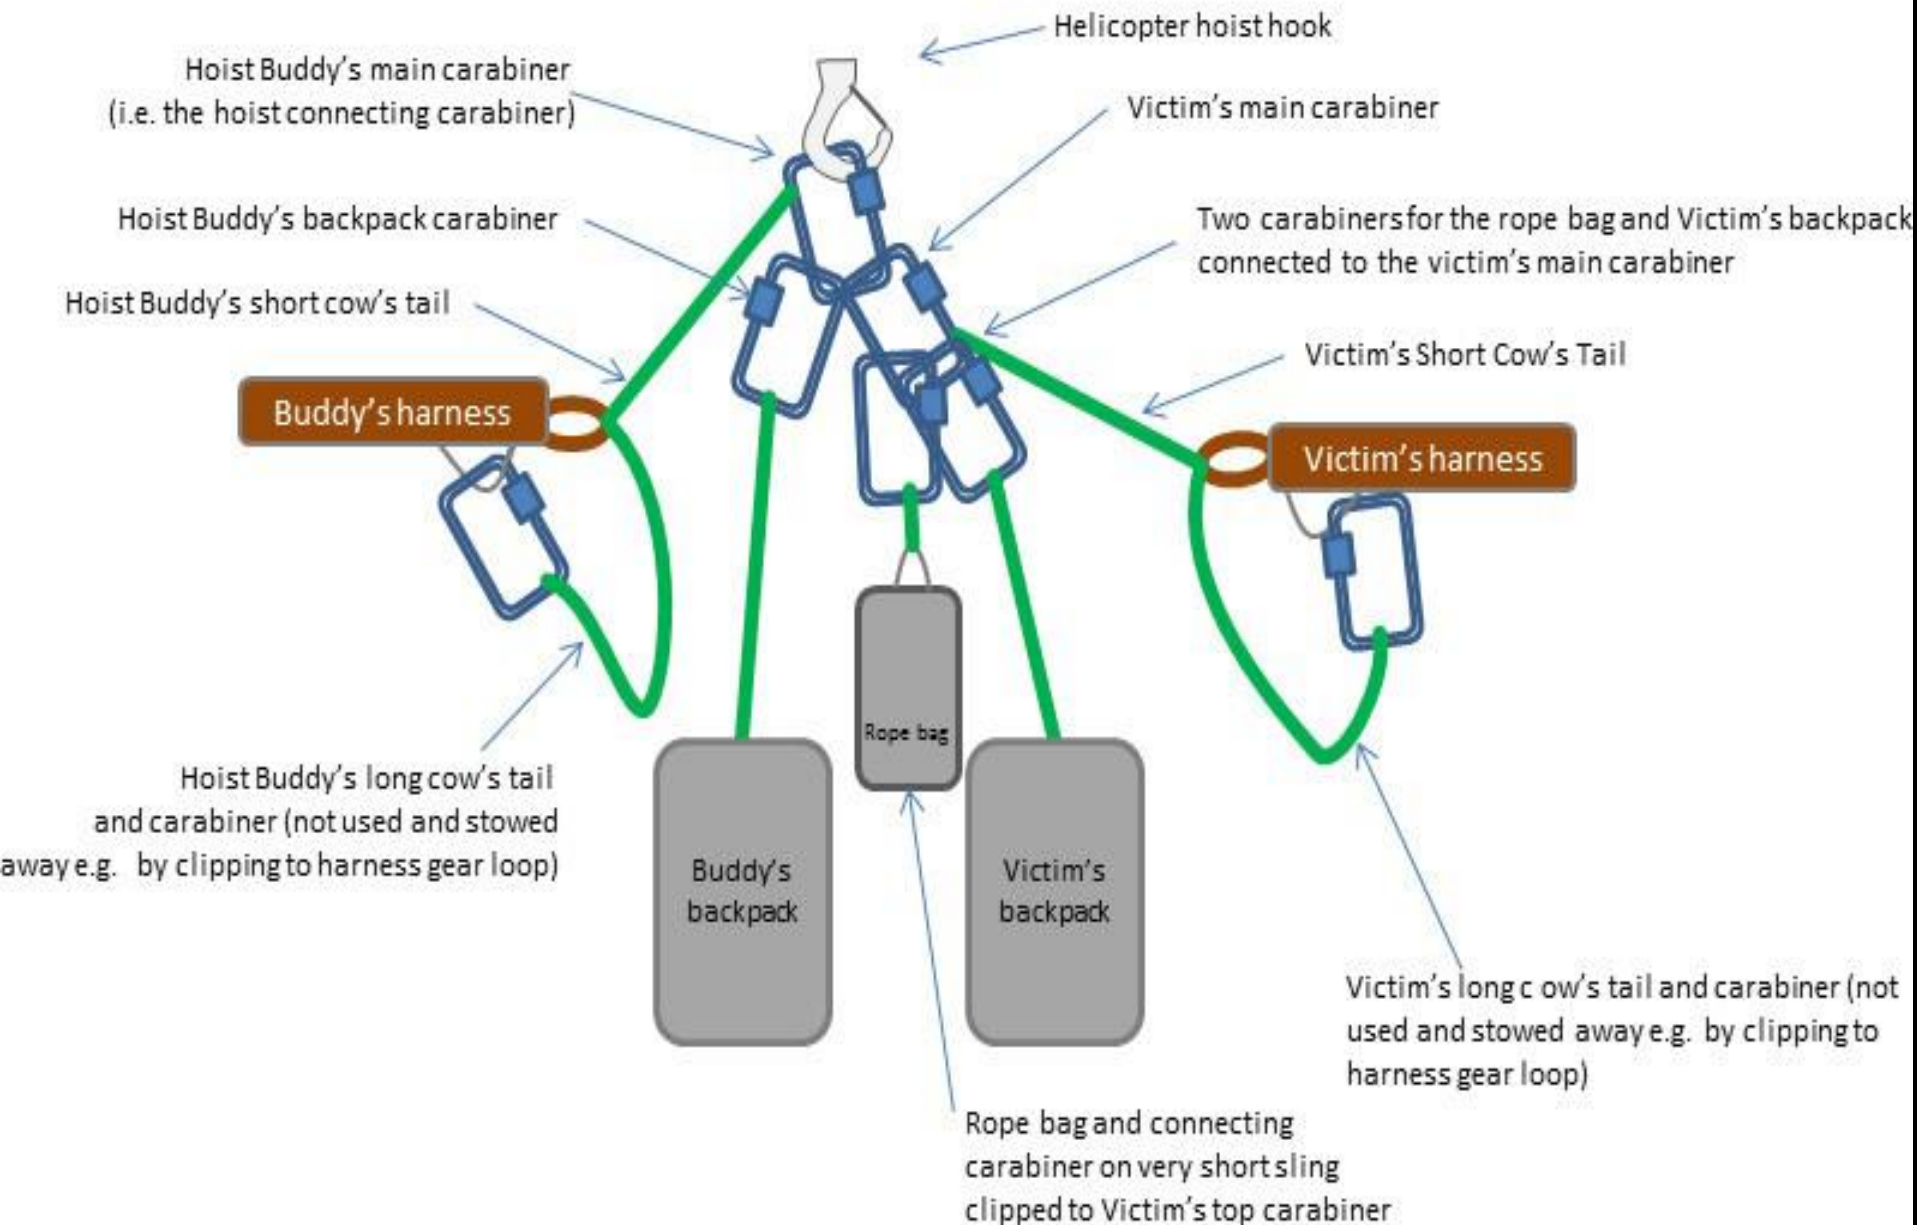
Hoist configuration with the five primary connecting carabiners as expected by the hoist buddy

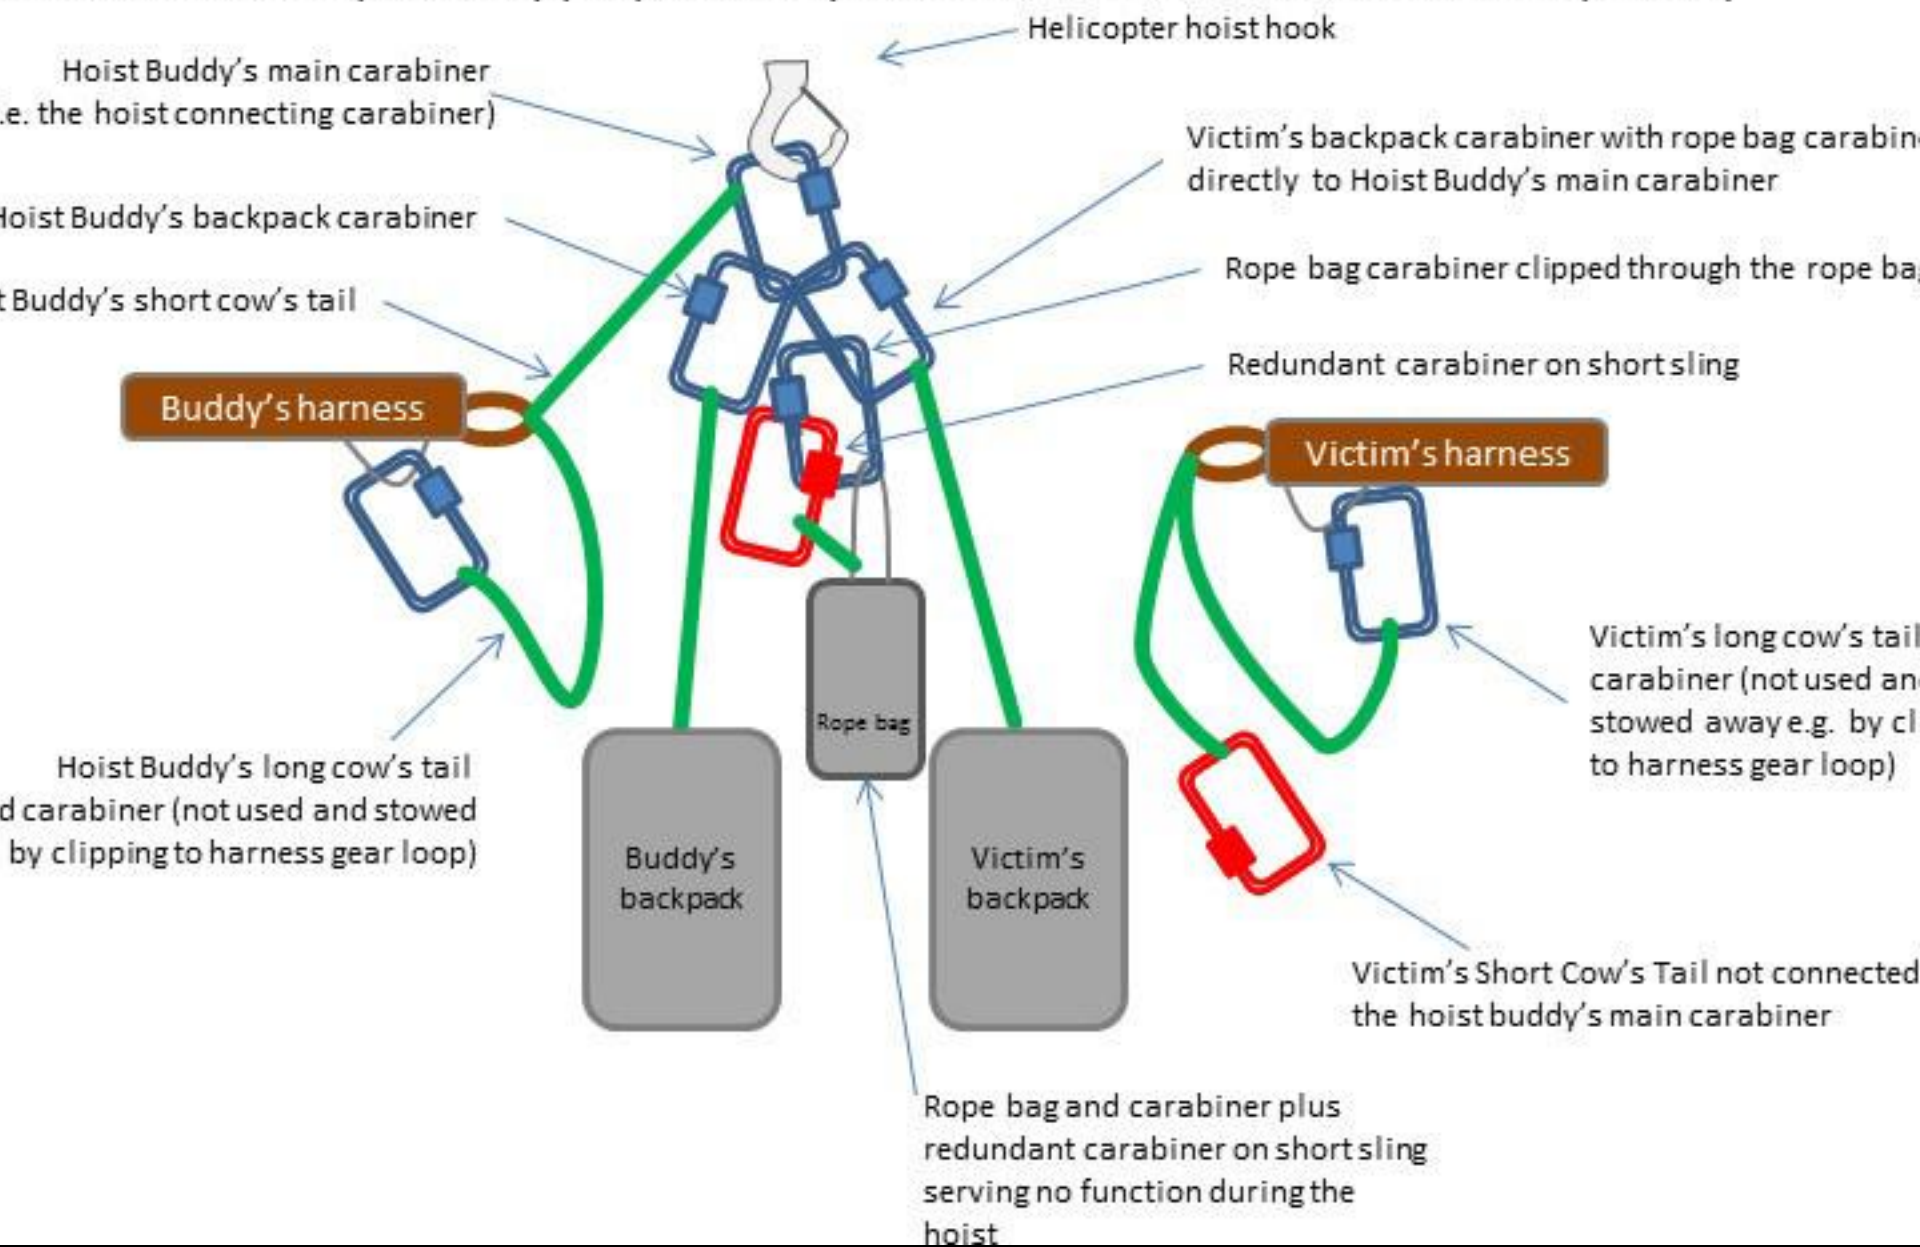
Diagram illustrating the actual hoist configuration showing 5 carabiners connected to the hoist which excludes the Victim's main hoist safety connection carabiner (for illustrative and explanatory purposes only based on interviews and submitted photos)
