# **U.S. AIR RESCUE REPORT**

#### Charley Shimanski; U.S. Delegate October 18-20, 2017 – Chamonix, France

# 2018 USA AIR RESCUE REPORT

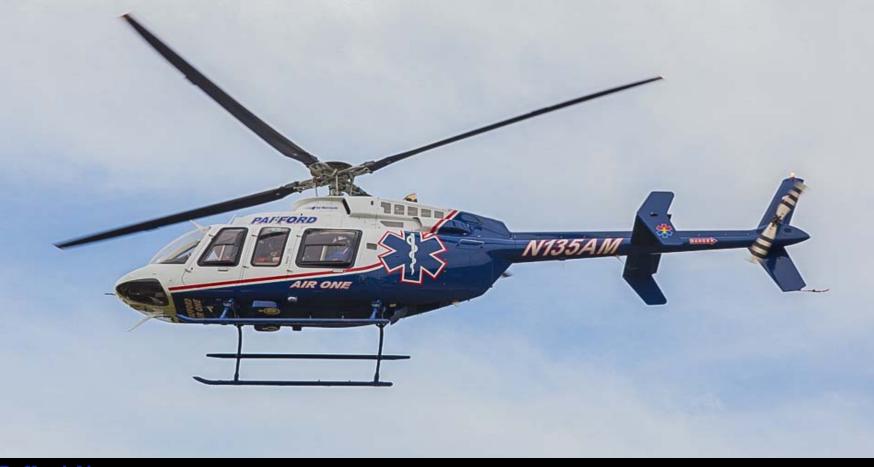
#### A witness reported hearing geese get loud right before the helicopter flew over a reservoir.

### "Several bird carcasses were located in the wreckage of the helicopter."

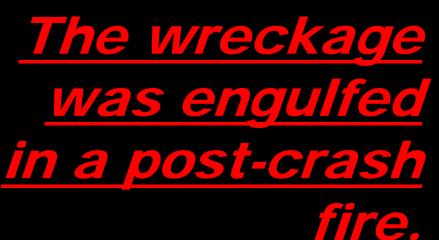
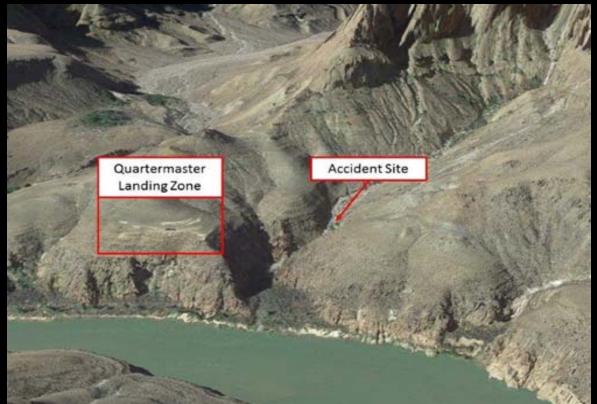
- The EC130 B4 was destroyed when it crashed on an approach to land.
- Three passengers died.
- The pilot and three passengers sustained serious injuries.

The helicopter was not equipped with a <u>crash-resistant fuel system</u> required by a 1994 FAA regulation.

A loophole exempts newly manufactured helicopter with certificates approved before 1994.  "Papillon will retrofit our tour fleet with crash resistant fuel systems"

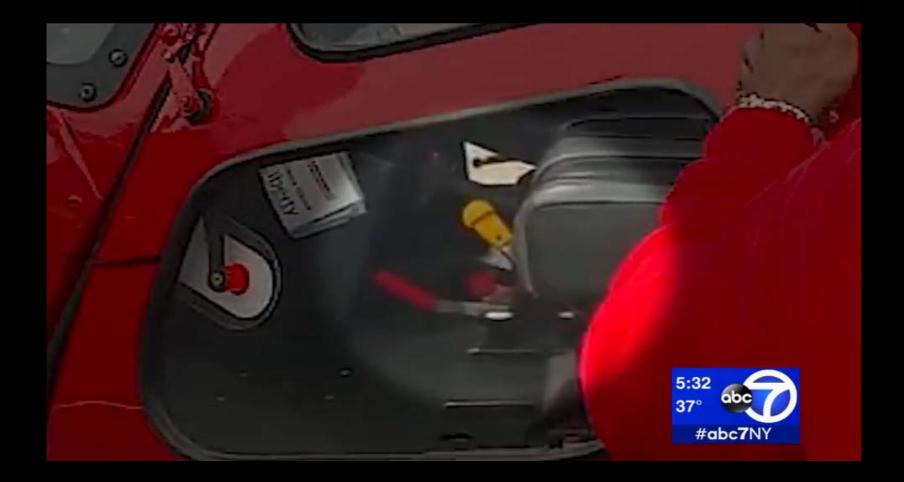
- attempted to restart the engine (failed)
- tried the starter again (failed)
- checked the fuel control lever (normal)
- activated the floats (2 failed)
- <u>reached down for the emergency</u> <u>fuel shutoff lever, it was in the off</u> <u>position</u>

## The front seat passenger's tether was underneath the emergency fuel shutoff lever.

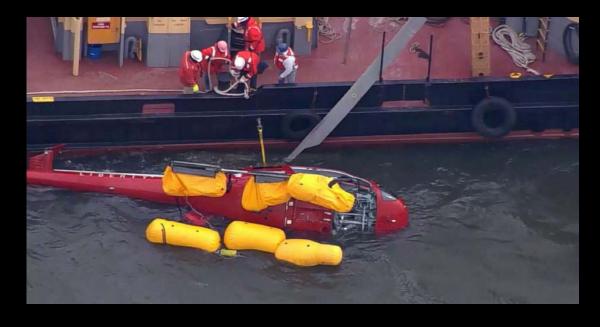
Pilots had earlier raised concerns about the tethers that secured the passengers.

They noted it was <u>difficult for</u> <u>passengers to disconnect the carabiners</u> that connected the tethers to the harnesses.

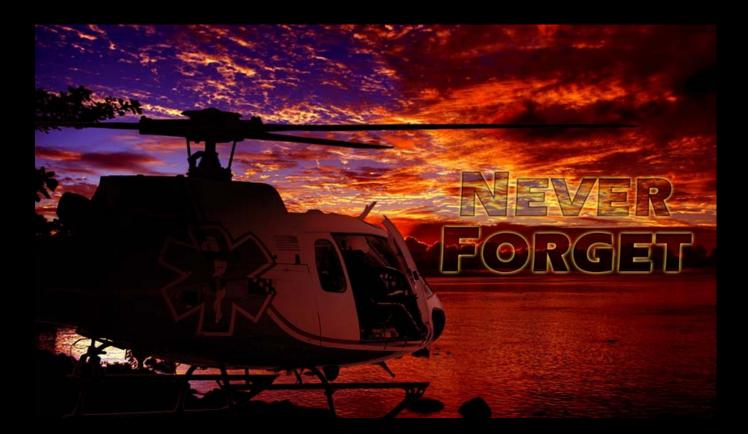
# The helicopter's cabin was crushed, its rotors were sheered off and there was a debris trail for 80 metres.

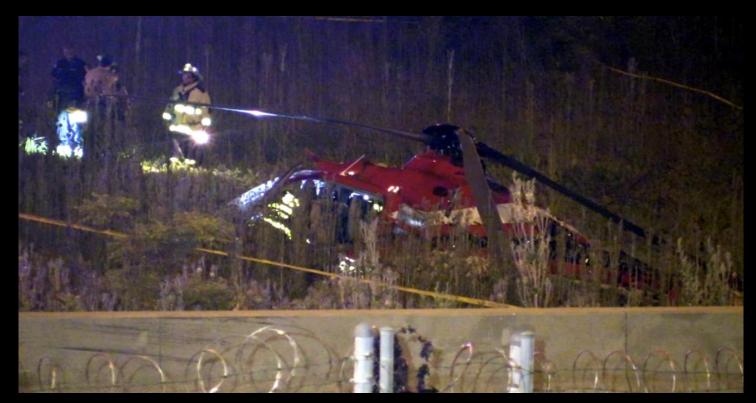
# The EC135 P1 impacted terrain at 2115 hrs during an autorotation following a dual engine failure

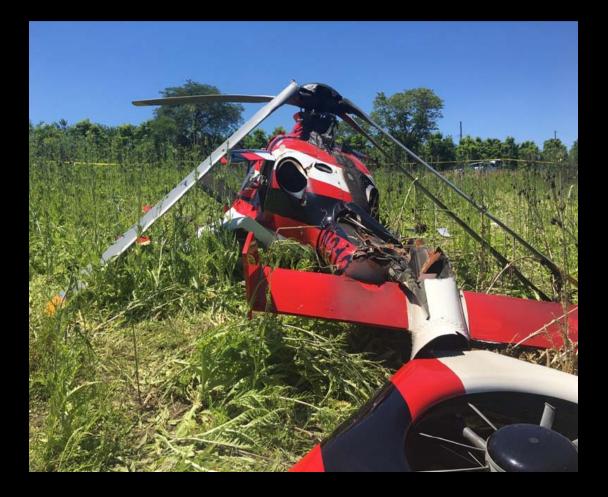
Surveillance video from a train platform showed a fire near the right engine in flight.

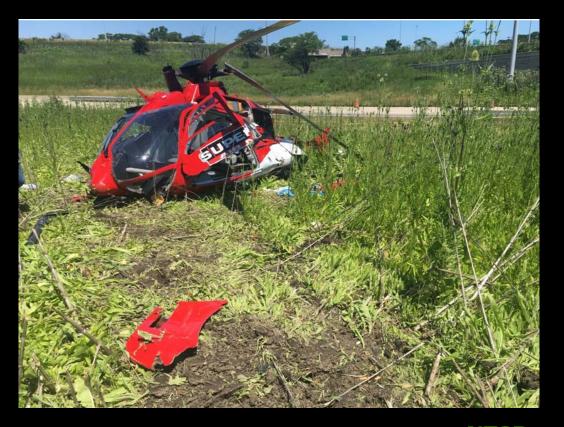
The pilot and paramedic sustained minor injuries, the flight nurse sustained serious injuries, and the patient was not injured.

# The helicopter sustained substantial damage to the fuselage, tail boom, and main rotor blades.

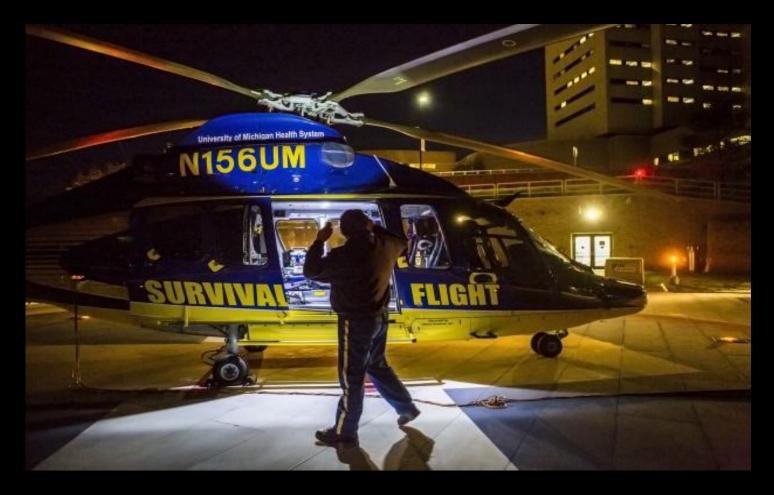
After a ground run, one of the Survival Flight AirBus EC-155's <u>tail rotor drive shaft</u> <u>disengaged from the main gearbox output</u>, leaving the tail rotor drive decoupled from the main gear box.

The 3 aircraft were immediately grounded pending further inspection.

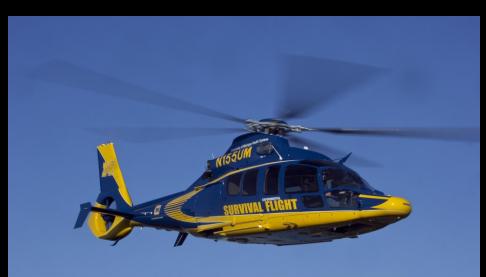
Per AirBus, this incident occurs only on the ground.

# Airbus Safety Bulletin ASB <u>EC155 63A013</u>

Compliance with this ASB prevents this problem in the event of failure of the shurlock nut.
