2019 USA ACCIDENT/INCIDENT REPORT

Charley Shimanski; U.S. Delegate
October 8-12, 2019 – Zakopane, Poland

Rescue Helicopter Crashes Trying to Rescue a Helicopter Crash Casualty October 3, 2019 – Polk County, Florida

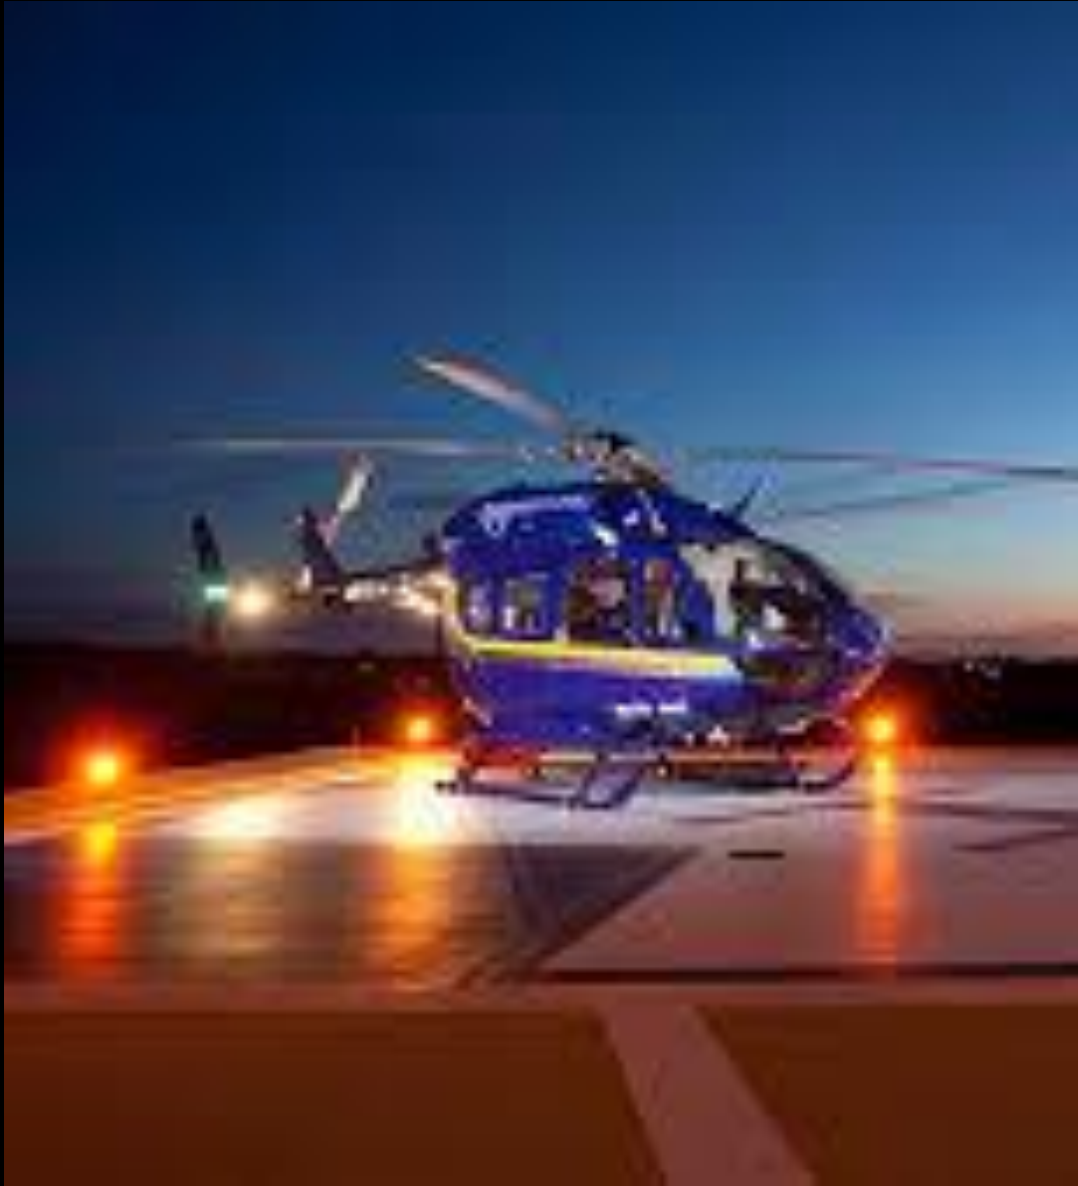
Crew was responding to a scene call. The decision was made to land at an *alternate landing zone in front of the fire station* instead of a pre-established landing area one mile away.

- **The approach was made under NVG.**
- **The pilot stopped his approach 3 feet above ground to avoid an unreported obstacle at the leading edge of the landing zone.**
- **The tail rotor made contact with the top of a fire truck parked to block the street at one end of the landing zone.**

The pilot lost tail rotor control and the aircraft nose spun to the right. The pilot immediately lowered the collective and impacted the ground.

The aircraft rotated approximately 225 degrees before coming to a complete stop. The pilot performed an emergency shut down and the crew exited the aircraft.

The ground party did not establish landing zone using common practices to set the proper size and identify obstacles. It is imperative that... aviation programs provide landing zone safety training.

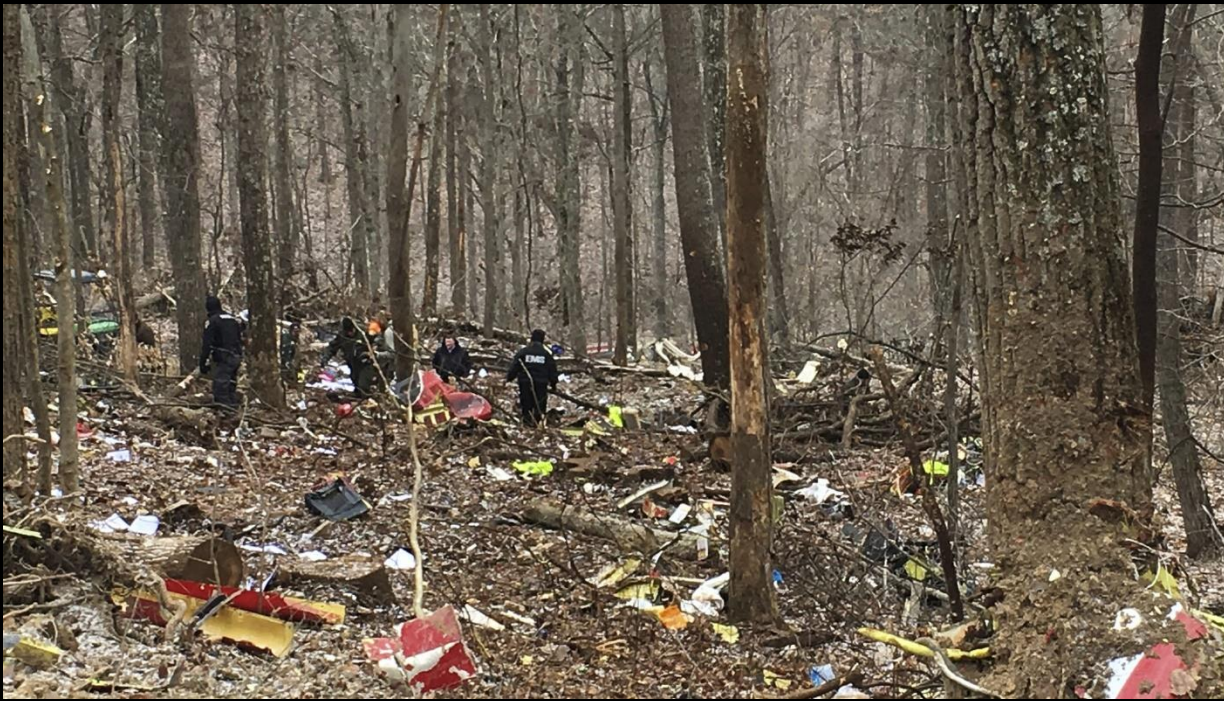
The wreckage extended about 600 ft downslope on a heading of about 345°. One main rotor blade had separated from the main rotor hub and was embedded in a tree.

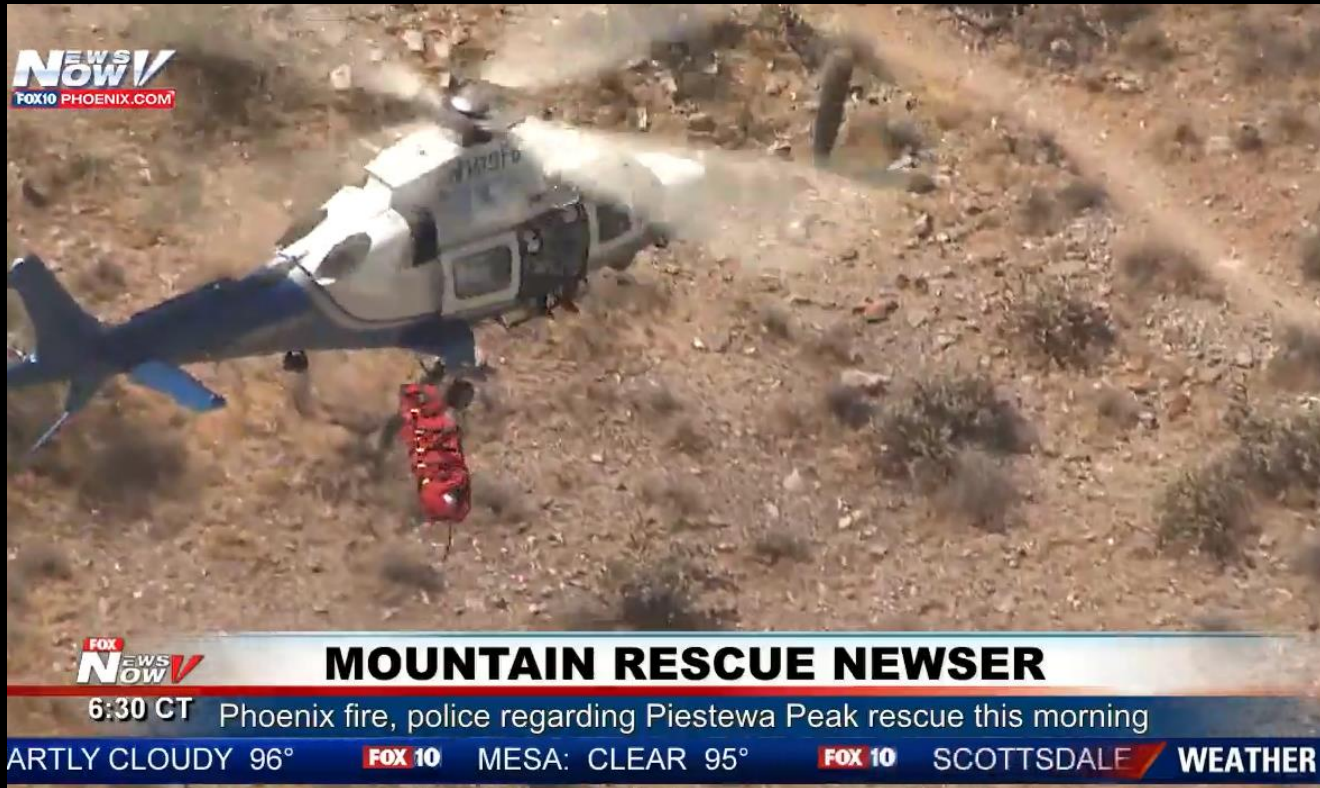
**The rescued woman spun in the basket for roughly a minute before the spinning subsided and the crew safely delivered her to an ambulance.
The litter spun 175 times**

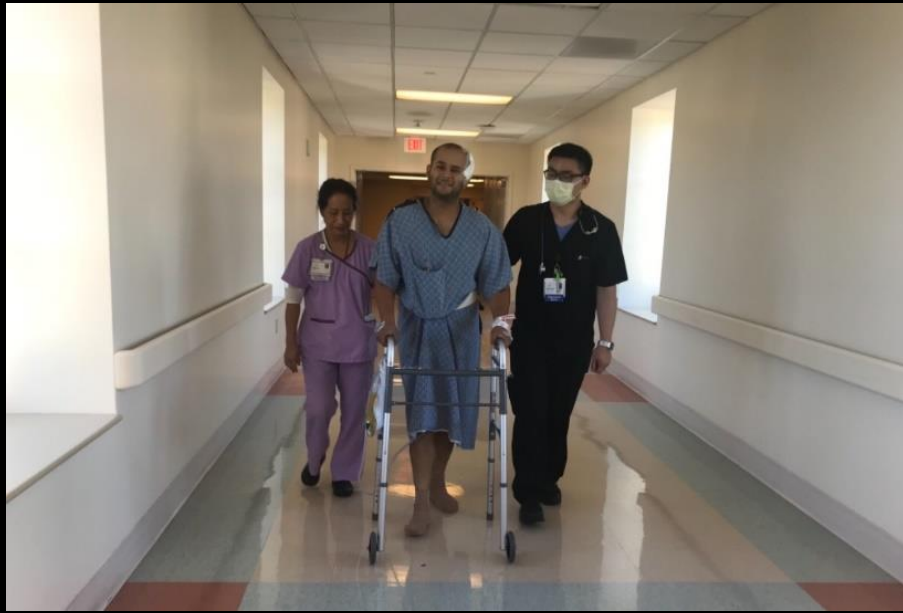
While the medevac helicopter was preparing to hoist the patient out, it is believed that the helicopter's rotor wash knocked over a dead tree, striking Firefighter Garay and his partner on the head.

Both engine crew members were transported to hospital via helicopter. Firefighter Garay was in the hospital's Intensive Care Unit (ICU) and was treated for a subdural hematoma.

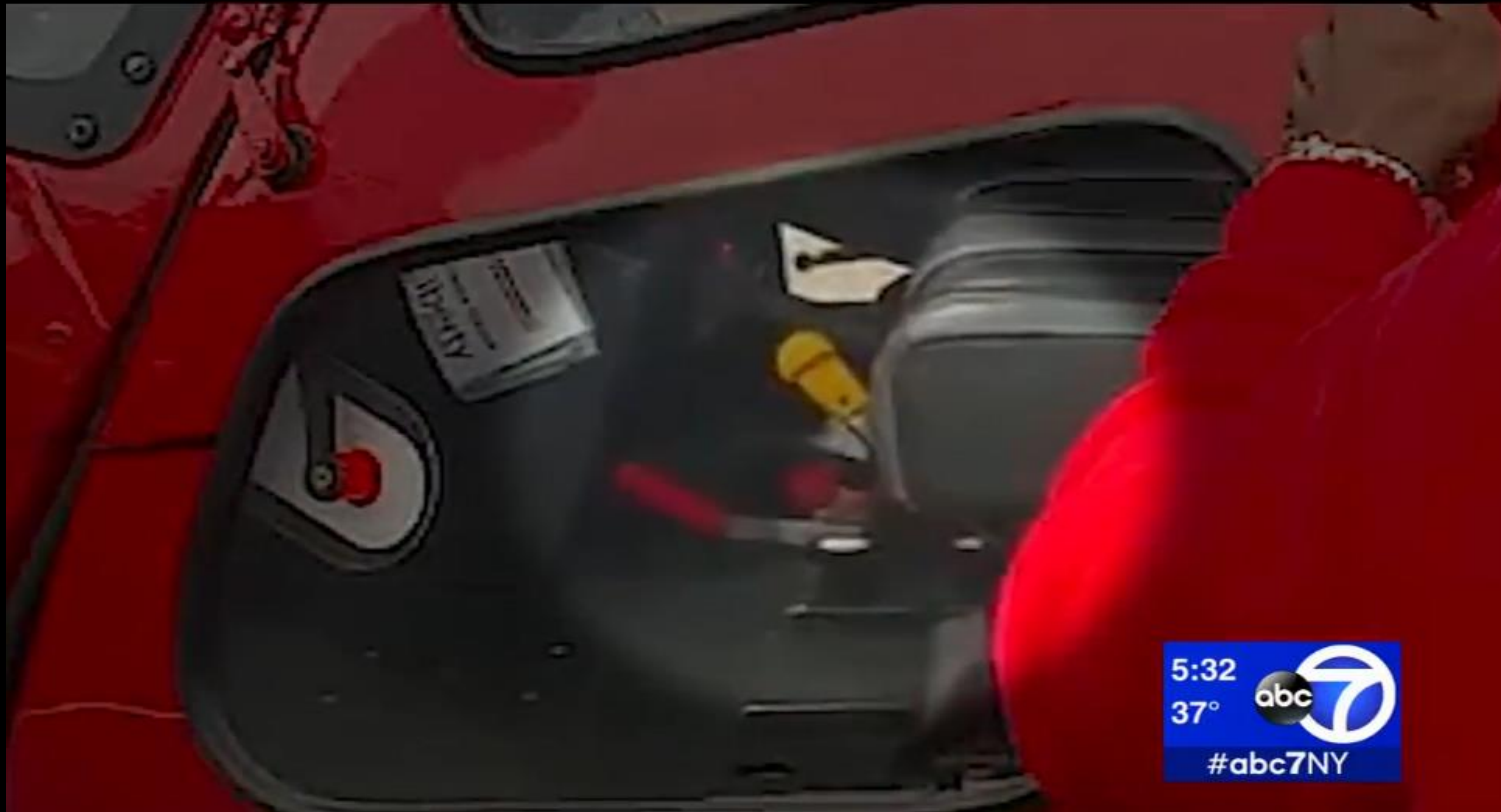
The front seat passenger's tether
was underneath
the emergency fuel shutoff lever.
