# Helicopter Hoist

## ICAR 2019, Zakopane

# Starting Point: Occurrence in February 2013

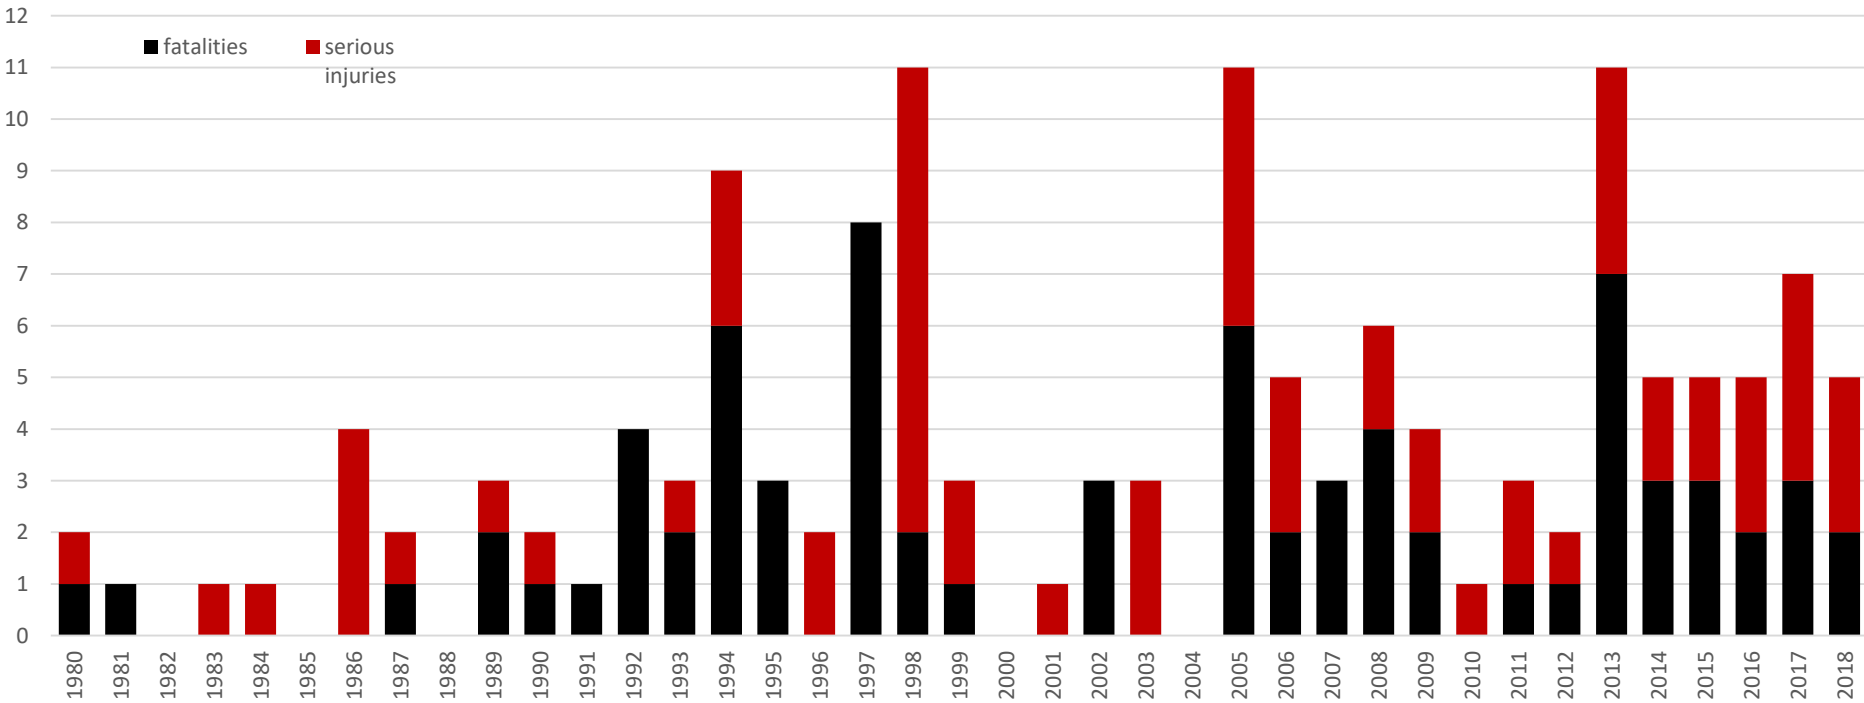
Fatalities and serious injuries potentially linked to hoist design
