AIR RESCUE REPORT

International Commission for Alpine Rescue

October 19-22, 2016
Borovets, Bulgaria

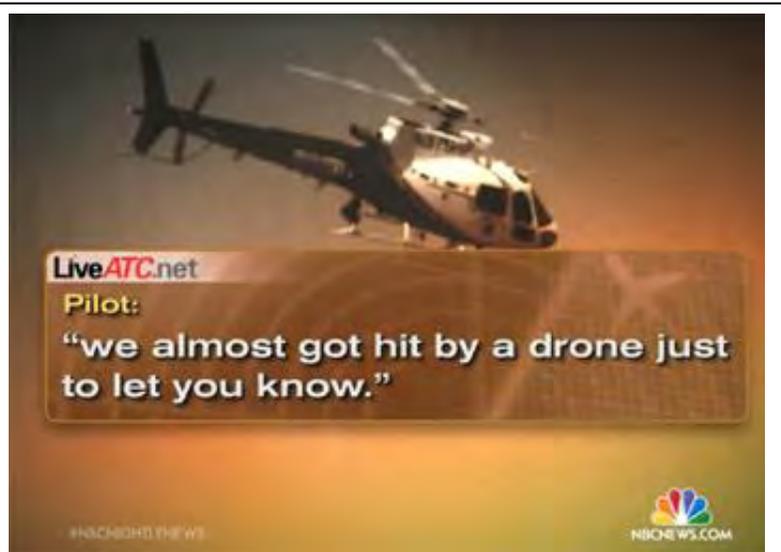
A HEMS helicopter in Fresno, California (USA) had a near miss with a drone in 2016.

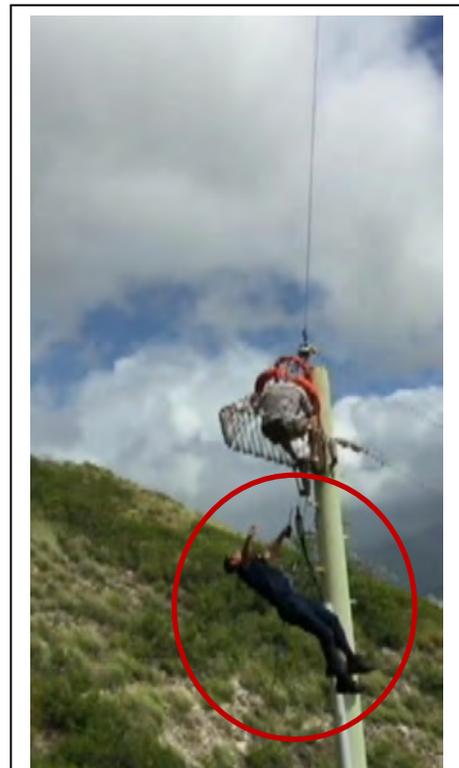
Assisting a hiker with a medical emergency, rescuers loaded the patient into a rescue basket. The basket contacted a utility pole, causing the firefighter to fall 30 feet. The patient remained in the basket and was transported to a landing zone.

Firefighter falling from Rescue Basket during short haul operation in Hawaii.

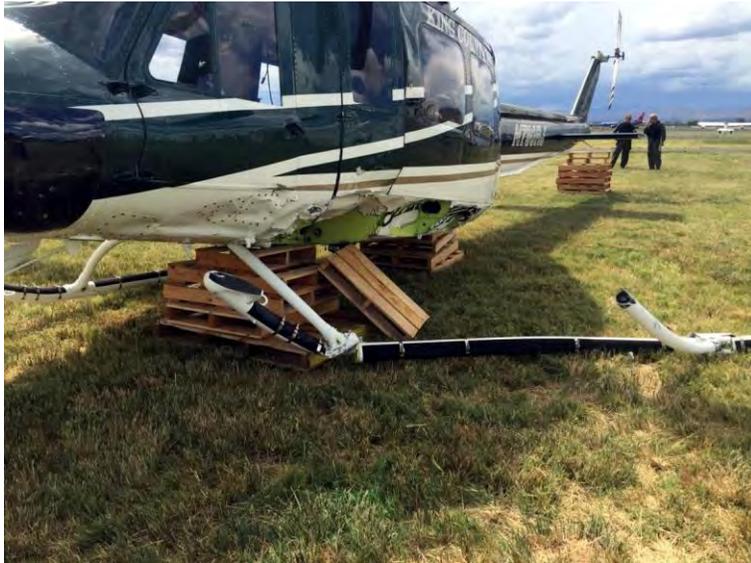
However, as he was using too much left pedal, he decided to abort the approach and execute a second approach from south to north. On the second approach, below effective transitional lift, at an altitude of about 100 feet above ground level, and pointed towards the mountain, the helicopter yawed to the right and then accelerated into a fast right hand spin.

After one and a half spins, the helicopter impacted the ground, bounced back into the air, and continued with a straight and level flight away from the mountain.

Damage to the King County Sheriff's helicopter sustained during contact with the ground. Pallets were arranged at a local airport to allow for a safe landing with damaged skid.

Firefighters arranged wooden pallets to balance the damaged helicopter on landing.

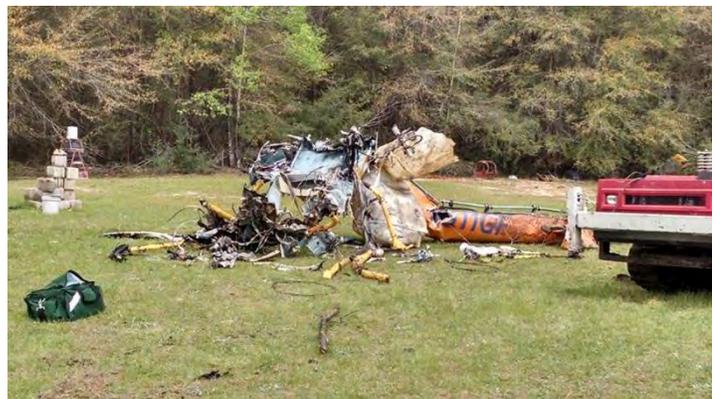
The wreckage was heavily fragmented with only the aft fuselage being generally recognizable.

The LifeFlight Communications Center did not receive its normal 15-minute check-in. Satellite tracking showed the helicopter was still at the LZ, which they knew to be incorrect. The wreckage was eventually located in a swampy, heavily wooded area. The wreckage was heavily fragmented with only the aft fuselage being generally recognizable.

The engine and transmission were separated from their mounts. A 10 by 20 foot crater was present. The debris path exhibited a 45-degree descent angle through trees. 80-100 foot trees exhibited impact damage and evidence of blade strikes.

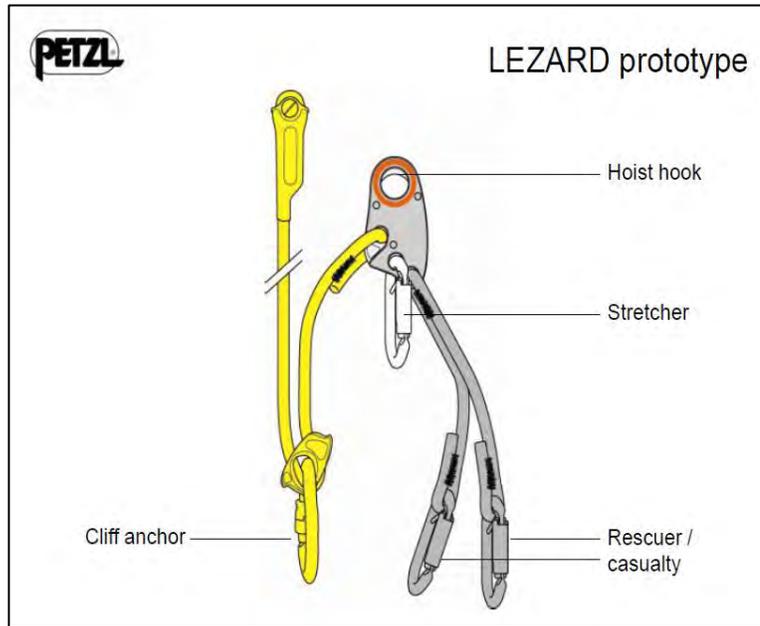
The Petzl Lizard (aka Le Lezard) is a lanyard that creates an interface between the rescuer, helicopter and the anchor. The attachment to the anchor is automatically releasable (when the lanyard is attached to both the anchor and the helicopter) in a situation where the helicopter must fly.

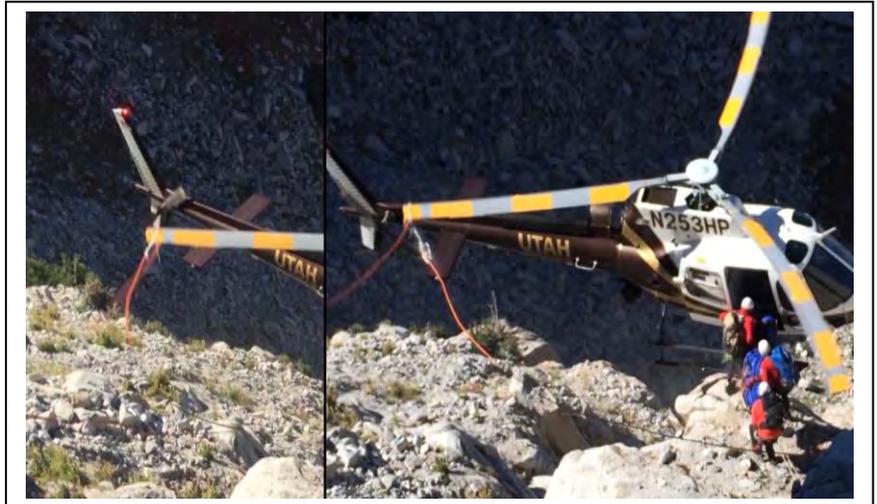
One of the recovery team had secured himself to a rope that was anchored above the tip path plane of the helicopter.” While the rescuers approached the aircraft to load the litter, that rope – still attached to the terrain above – was pulled taught into the plane of the rotor disk, and was caught by the main rotor blade – ten inches from the blade tip. The rope was then pulled rearward by the main rotor blade and made contact with the tail rotor. The pilot did an extraordinary job of maintaining control of the aircraft and maneuvering away from the rescuers on the ground. He regained control, and then made an emergency landing at a lower altitude.
