SAFETY CHECK AIRBAG INFLATION SYSTEM 3.0

SAFETY FIRST: Mammut asks customers to check that the cartridge is screwed into the airbag inflation system completely up to the stop.

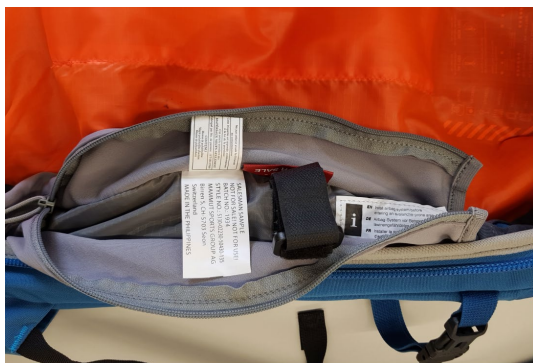
You can find the batch number of your avalanche airbag in the main compartment of your backpack in the area of the cartridge fixation..

Figure: Batch number label in the area of the cartridge fixation of the avalanche airbag

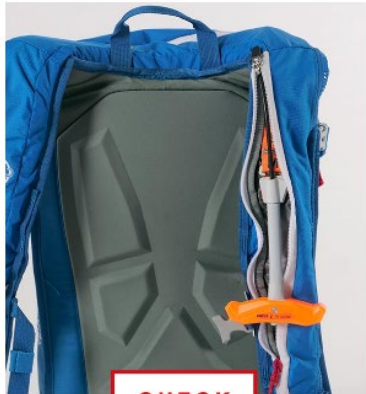
CHECK

Not affected are all Mammut and Snowpulse systems of Generation 2.0 with red handle or Generation 3.0 neon-coloured deployment handle of the seasons winter 16/17, winter 17/18, winter 18/19 or winter 19/20.

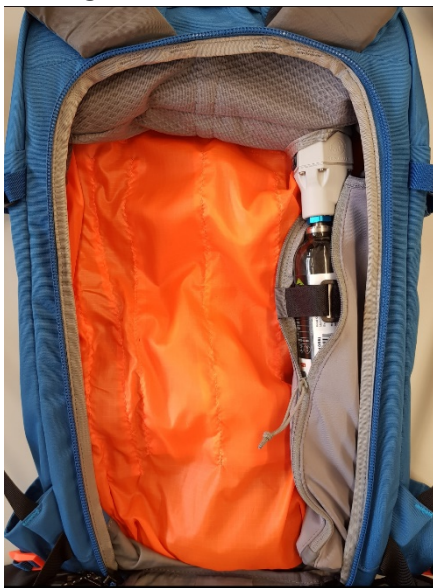
1. If it is one of the mentioned items with 3.0 system, please open the main compartment of the backpack to have access to the mechanism of the airbag inflation system (lateral cartridge fixation)

Figure: avalanche airbag with opened backpack main compartment and cartridge fixation

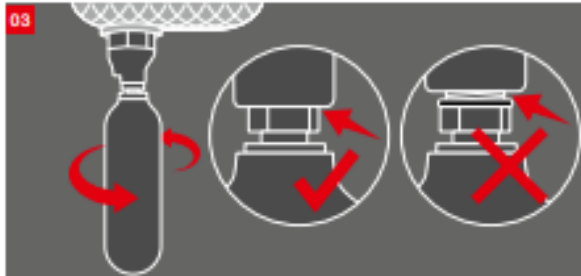
IMPORTANT: the cartridge is completely screwed in when the black rubber seal of the cartridge is no longer visible!

Figure: correct installation of the cartridge in the mechanism of the airbag inflation system

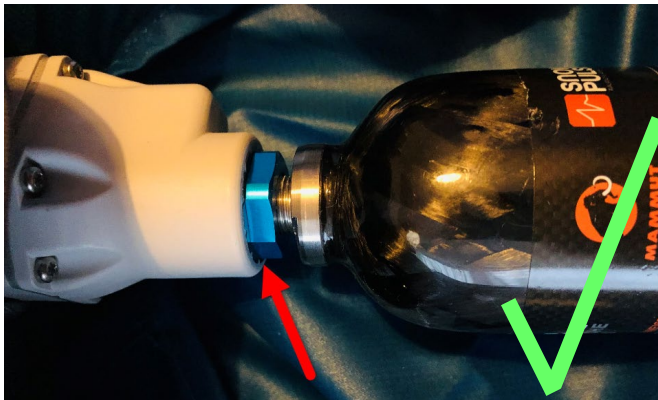
Figure: correct installation of the cartridge in the mechanism of the airbag inflation system – black rubber seal is not visible

If the cartridge is screwed all the way into the mechanism of the Airbag Inflation System and the black rubber sealing ring of the cartridge is no longer visible, the cartridge is correctly installed in the mechanism of the Inflation System. Your airbag is fully functional after the cartridge has been correctly installed in the Airbag Inflation System and the rucksack is ready for use again.

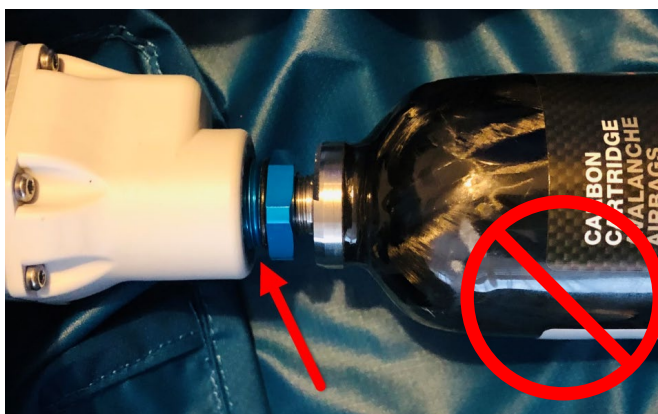
Figure: INCORRECTLY installed cartridge in the mechanism of the airbag inflation system - black rubber seal is still visible.

If the cartridge **CANNOT** be screwed all the way into the mechanism of the Airbag Inflation System and the black rubber ring of the cartridge is visible, the airbag inflation system is fault.

If the cartridge is incorrectly installed in the mechanism of the airbag inflation system, the airbag balloon will NOT inflate correctly after deployment. Due to its incorrect function, the airbag cannot effectively protect the user from partial burial or burial in the event of an avalanche.

The affected airbag system may no longer be used and must be returned immediately to Mammut Customer Service for a free replacement!

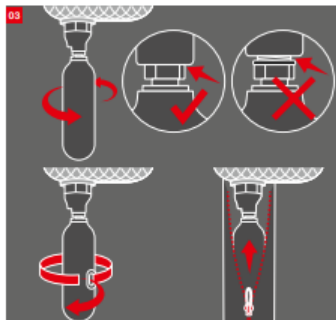
Figure: correct installation of the cartridge in the mechanism of the airbag inflation system and the cartridge in the avalanche airbag backpack

Note: For instructions on how to correctly install the cartridge in the mechanism of the airbag inflation system and backpack, please refer to the airbag user manual on [mammut.com](https://www.mammut.com/us/en/service/user-manuals/avalanche-airbags/):
