FATAL ACCIDENT
EC 145
20 mai 2016

Investigation report BEAD-air

BEAD-air-G-2016-008-A

Date de l'évènement	20 mai 2016
Lieu	Massif du Vignemale (Hautes-Pyrénées)
Type d'appareil	EC145
Immatriculation	F-MJBB / n°9014
Organisme	Gendarmerie nationale
Unité	Détachement aérien de la gendarmerie de Tarbes

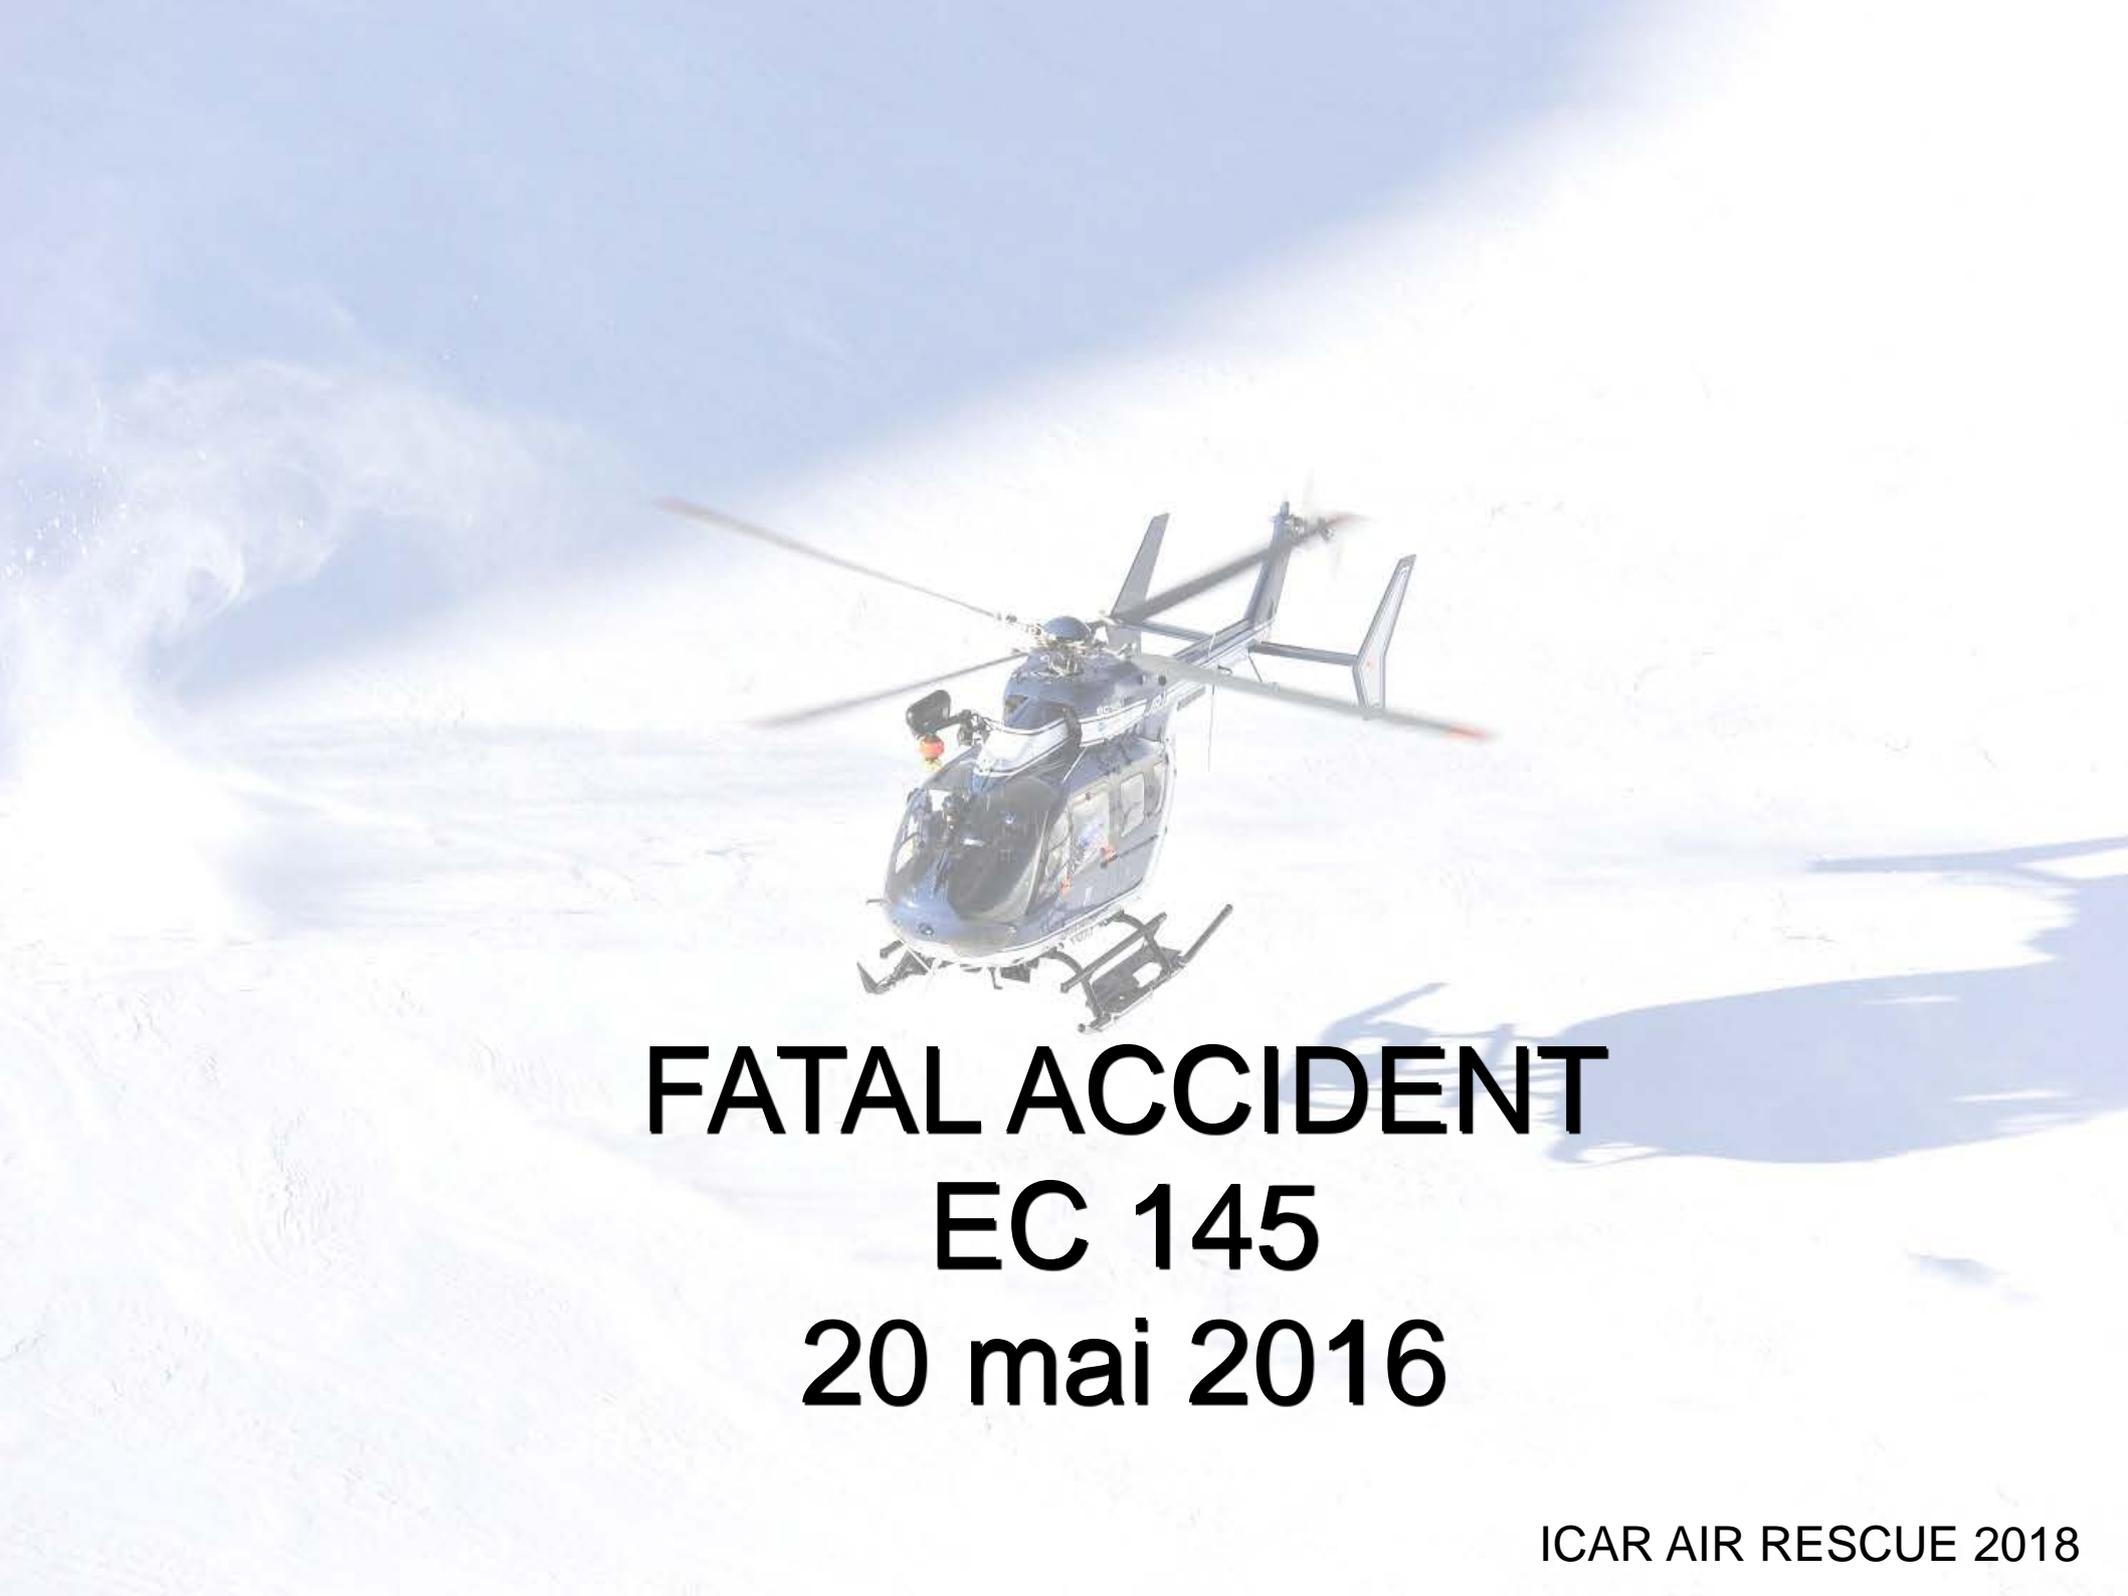
A blue EC145 helicopter is shown landing on a snowy mountain slope. The helicopter is viewed from a high angle, and its shadow is cast on the snow. The background is a vast, snow-covered mountain range under a clear blue sky.

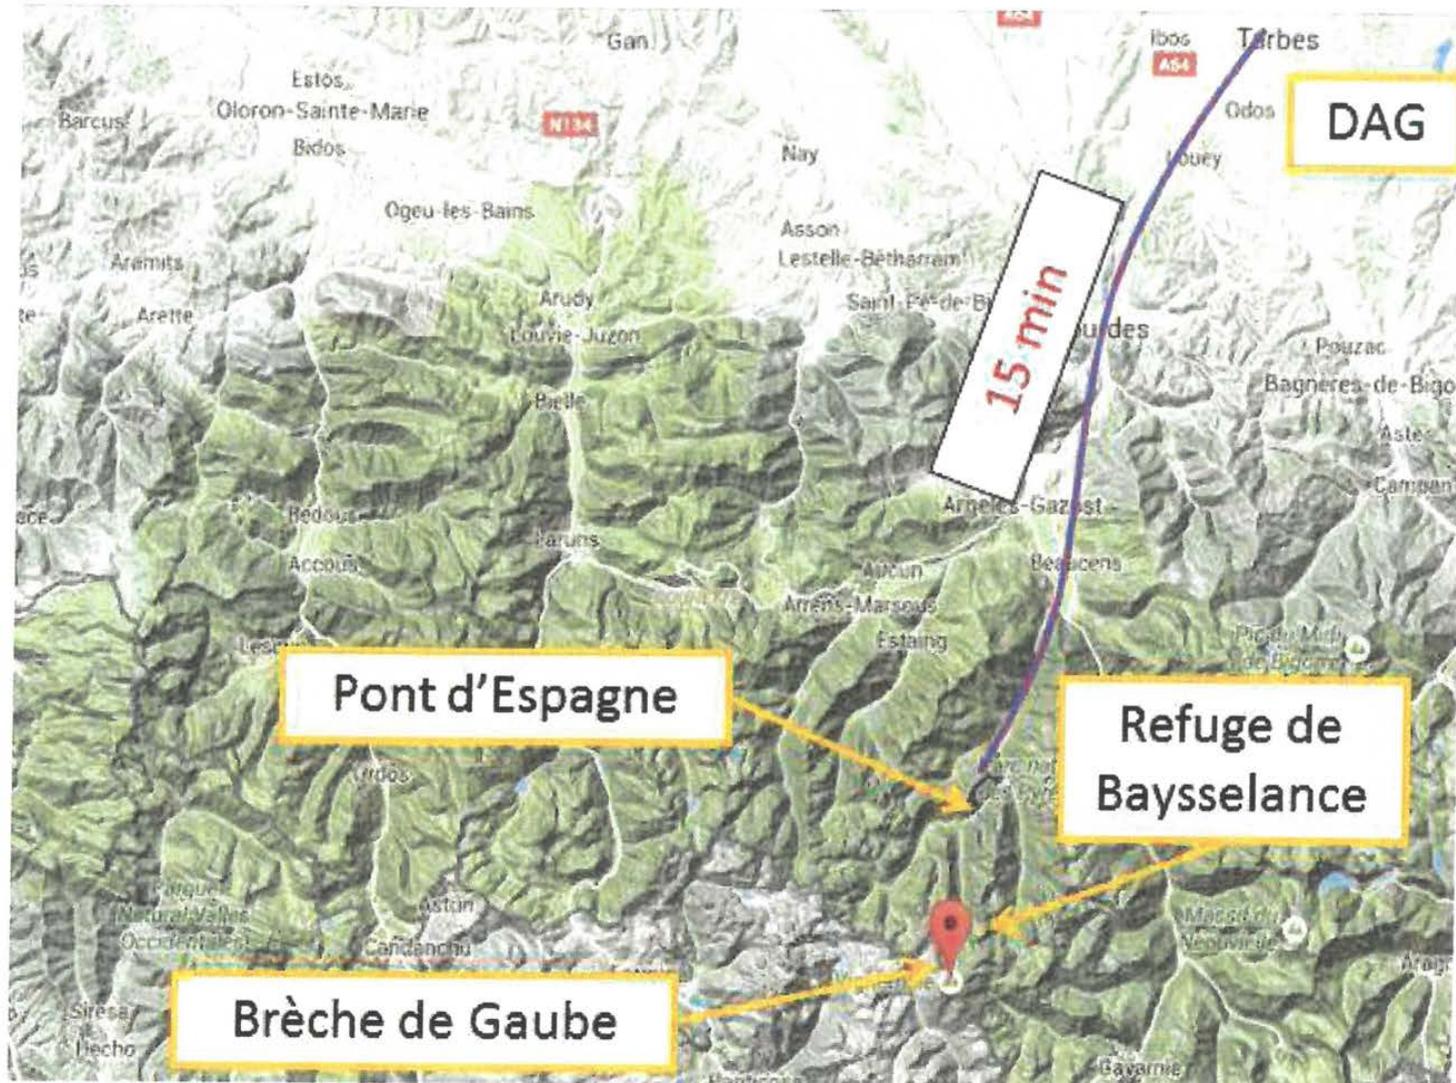
Localisation des points de poser

Landing in the pass off the breach of Gaube
(10350ft), embark two rescuers

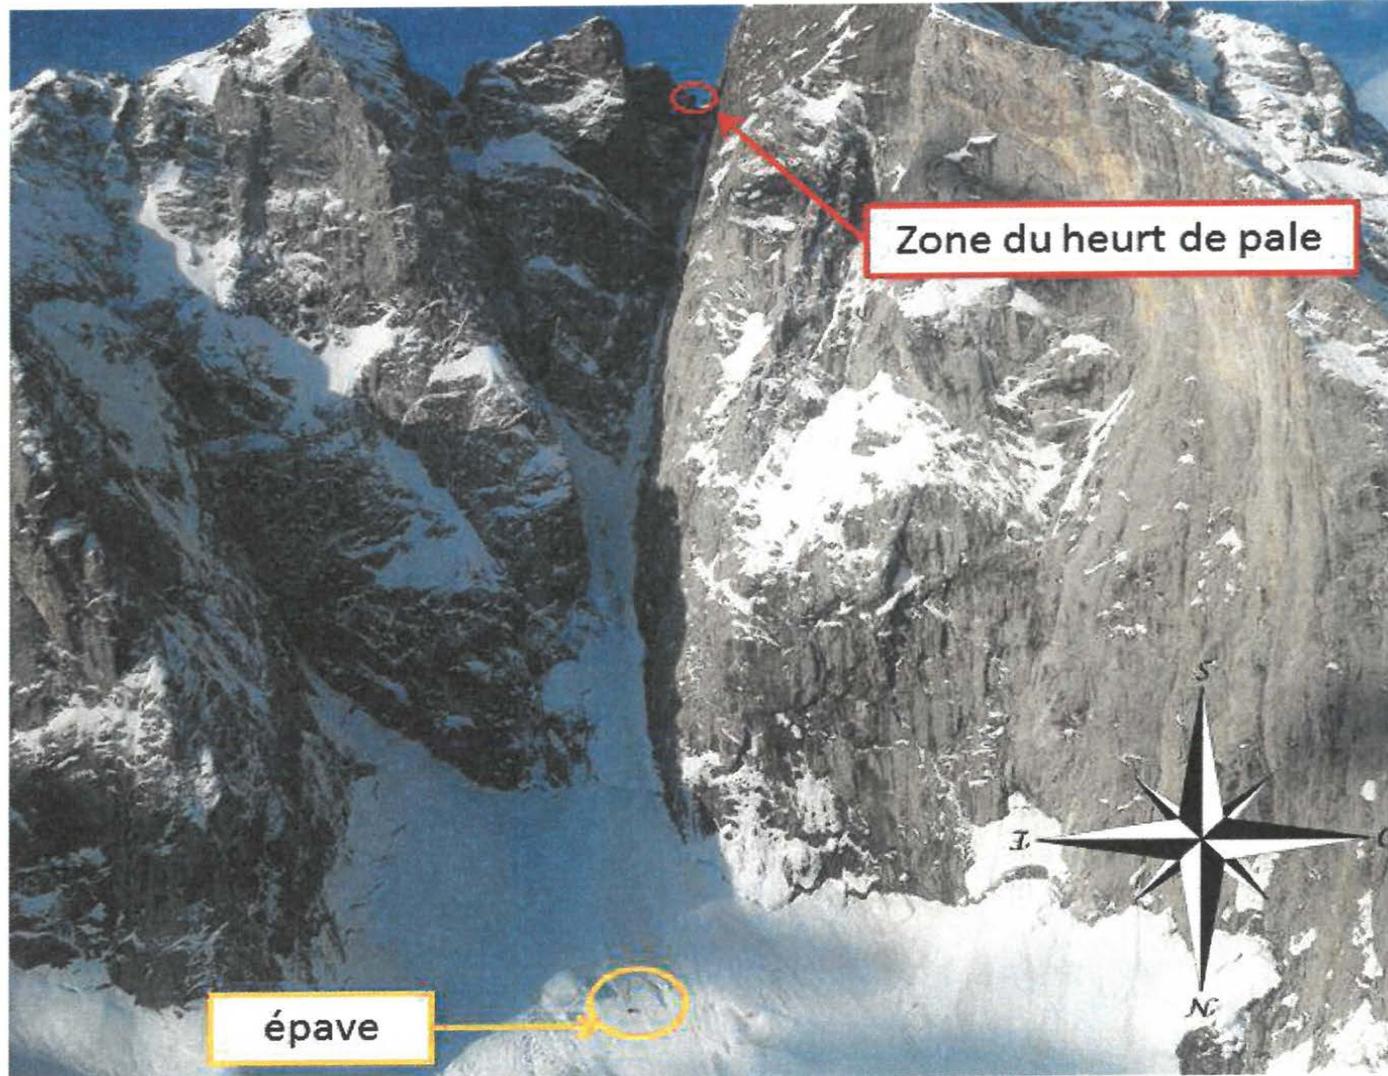
Vue générale du site

The helicopter crashes 600 meters lower

Helicopter destroyed

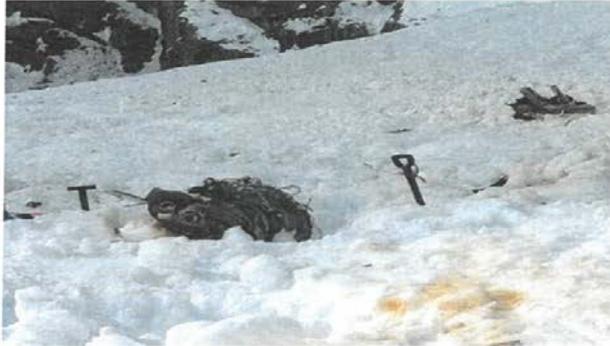
Vue du moteur gauche

- No mechanical failure, neither motorization nor transmission
- No anomaly of the commands of flight
- No unfavorable or meteo phenomenon

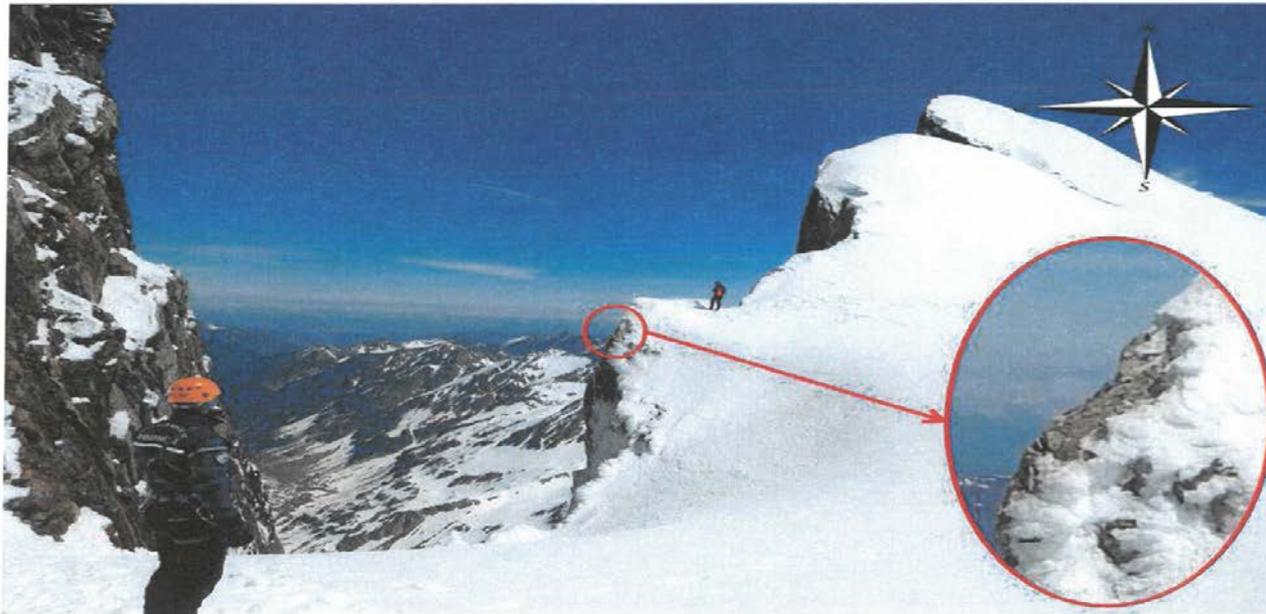
Vue de la zone heurtée par les pales

The blades of the main rotor strike the relief

Un morceau du patin gauche est retrouvé dans le couloir.
Des traces de heurts de pale sont observées au niveau de la brèche.

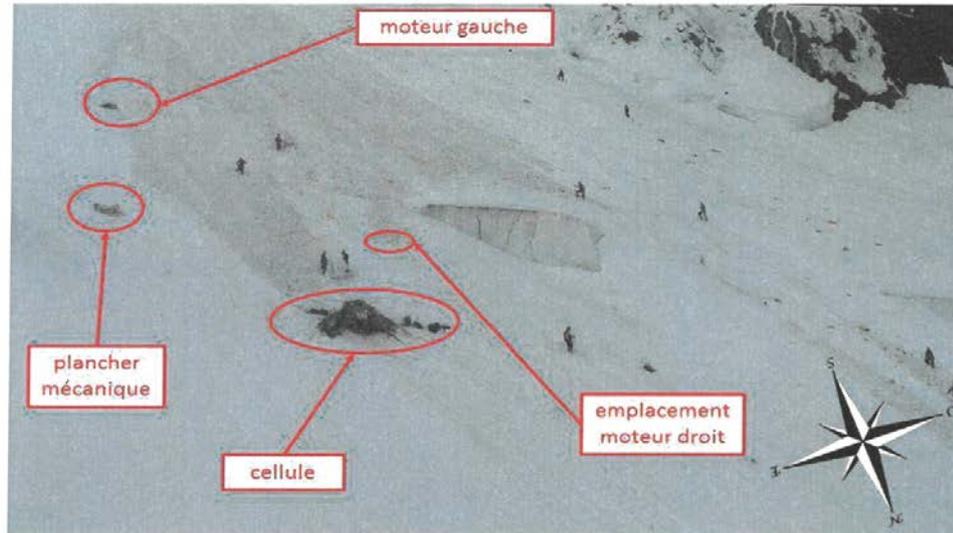
Répartition des principaux débris

La cellule est disloquée et compactée.

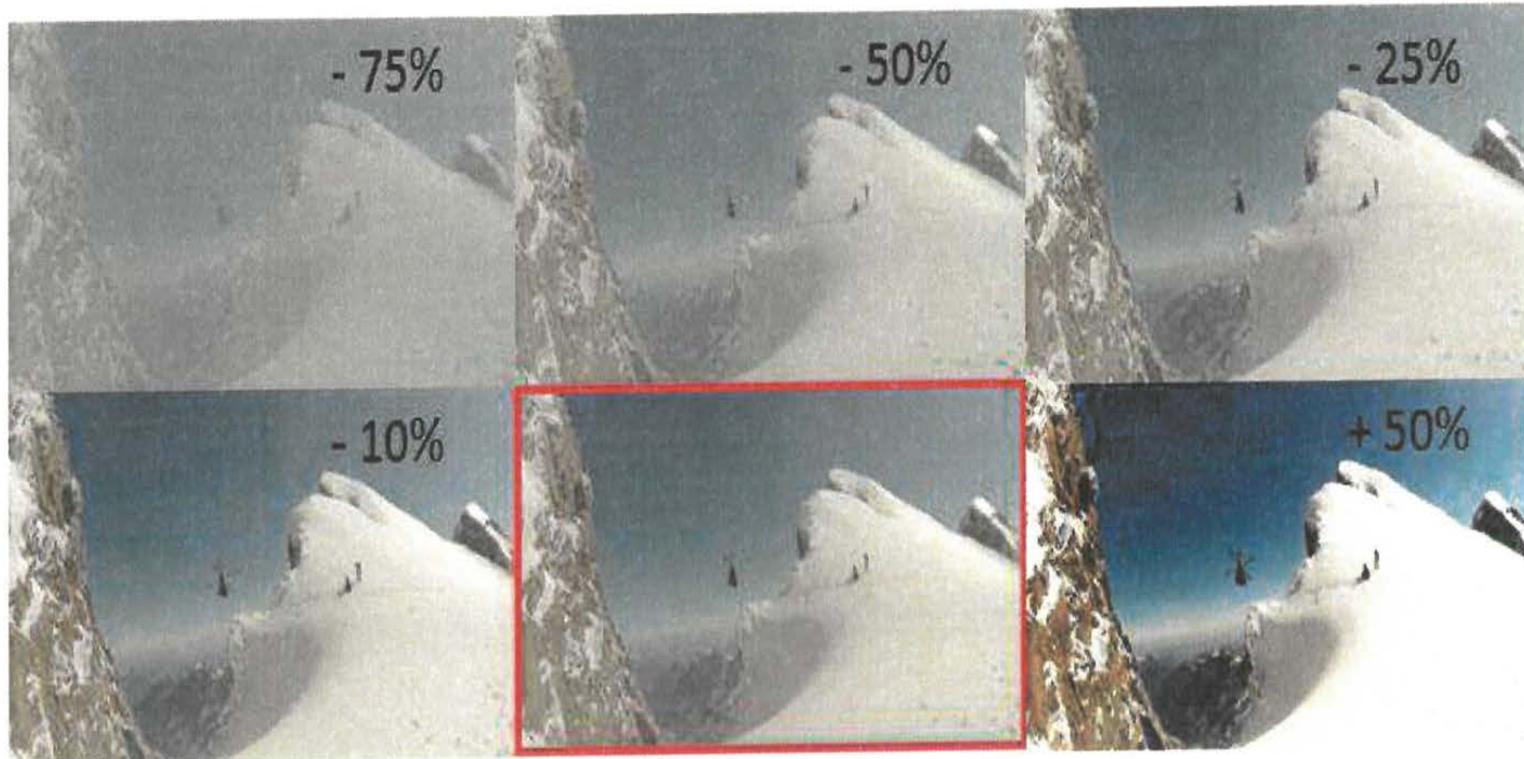
2- Imprecise representation of the relief

Illustration de l'effet du contraste sur l'acuité visuelle (la photo encadrée est celle produite par l'appareil le matin de l'évènement)

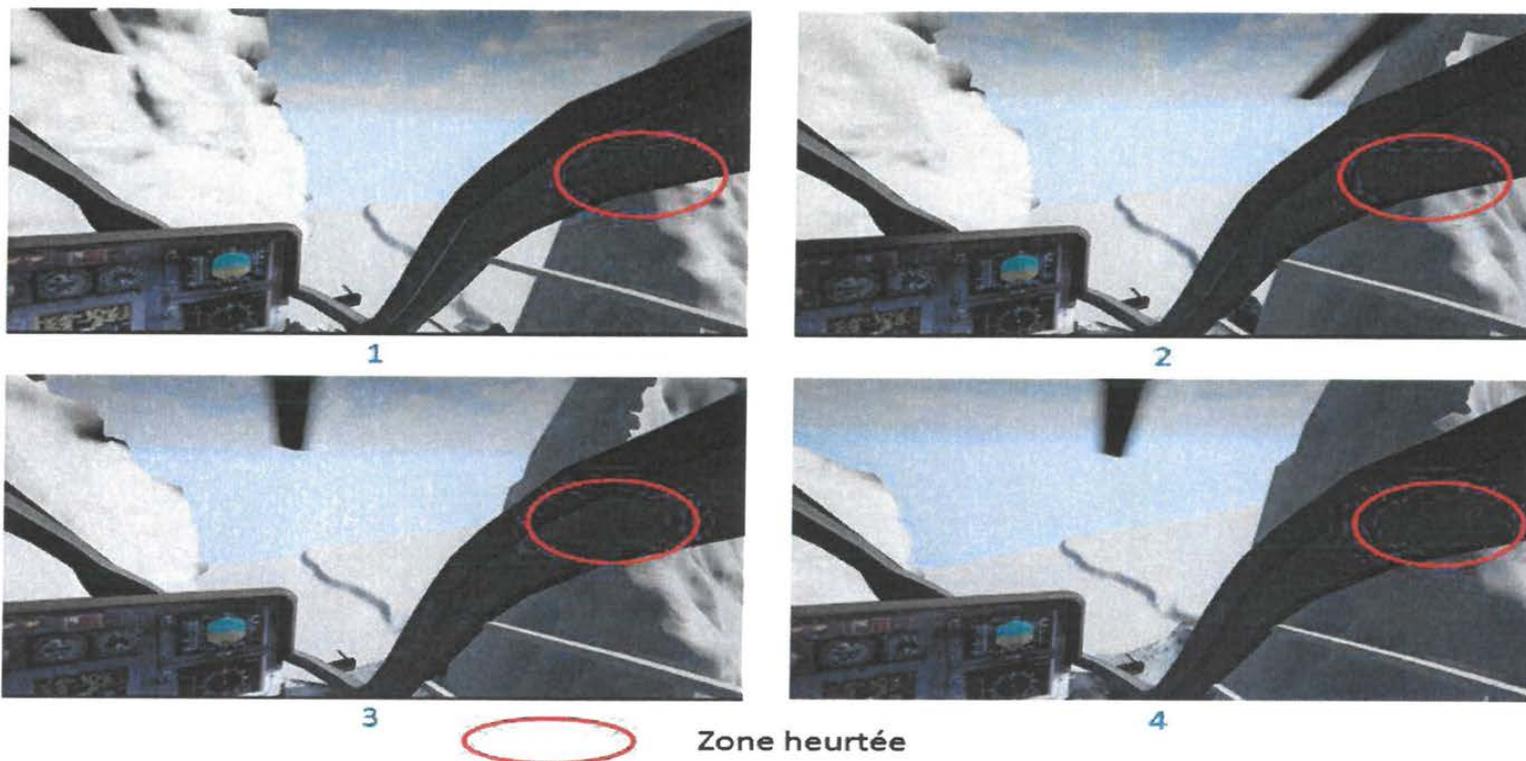
3- Rough perception of the distances

Masking of the relief by the structure

Captures d'écran de l'animation 3D³⁰ dans les dernières secondes

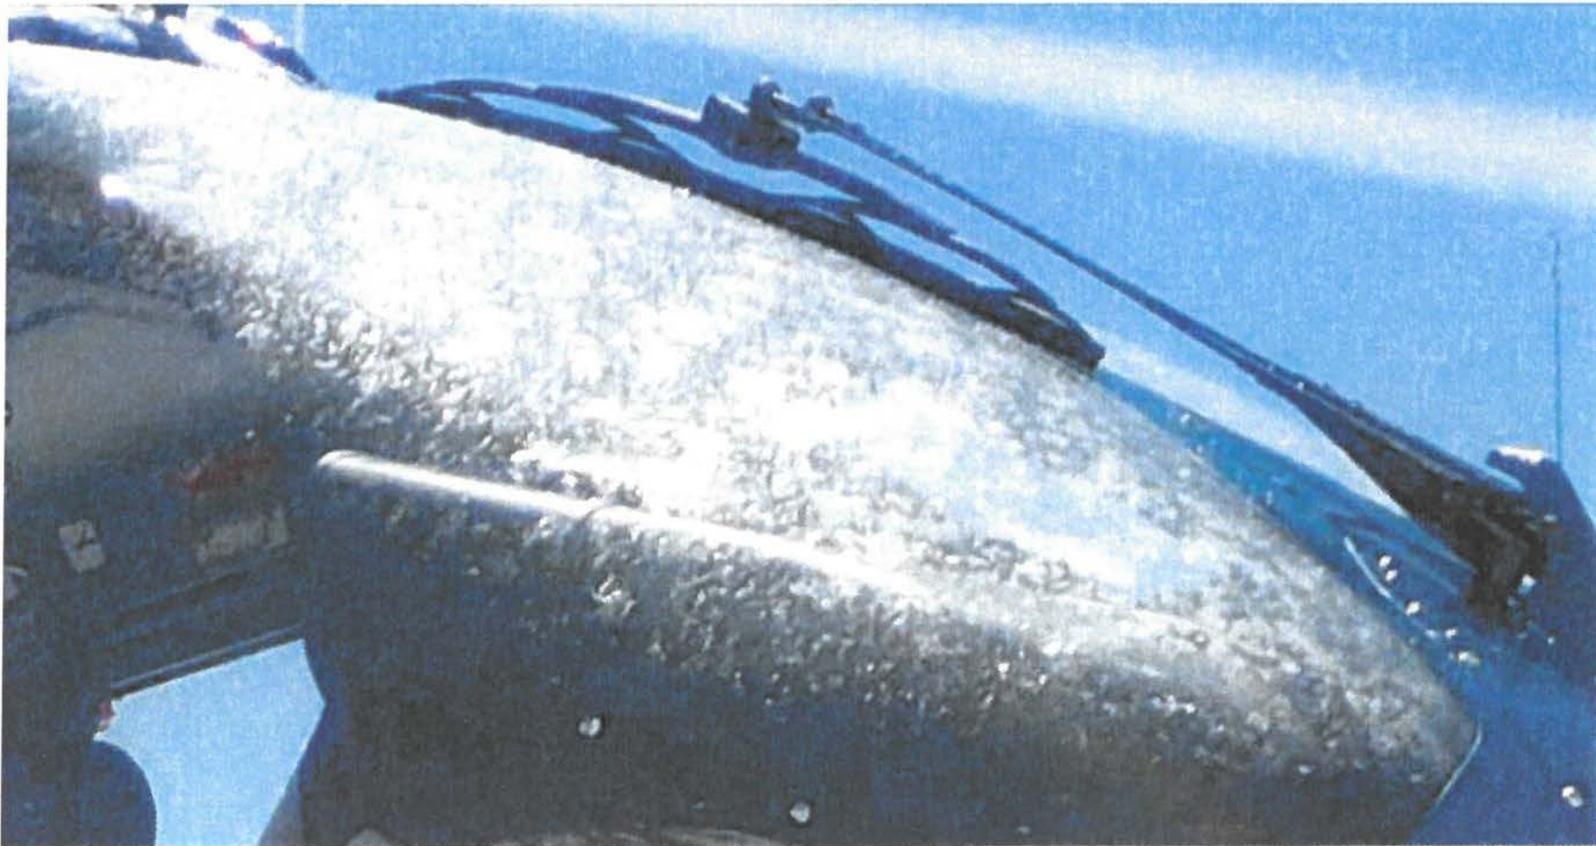
4- Snow on the windscreen

Photo du plexiglas lors de la troisième rotation
