# Rotor vs Rock

A Main Rotor Strike During a Live Slinging Operation

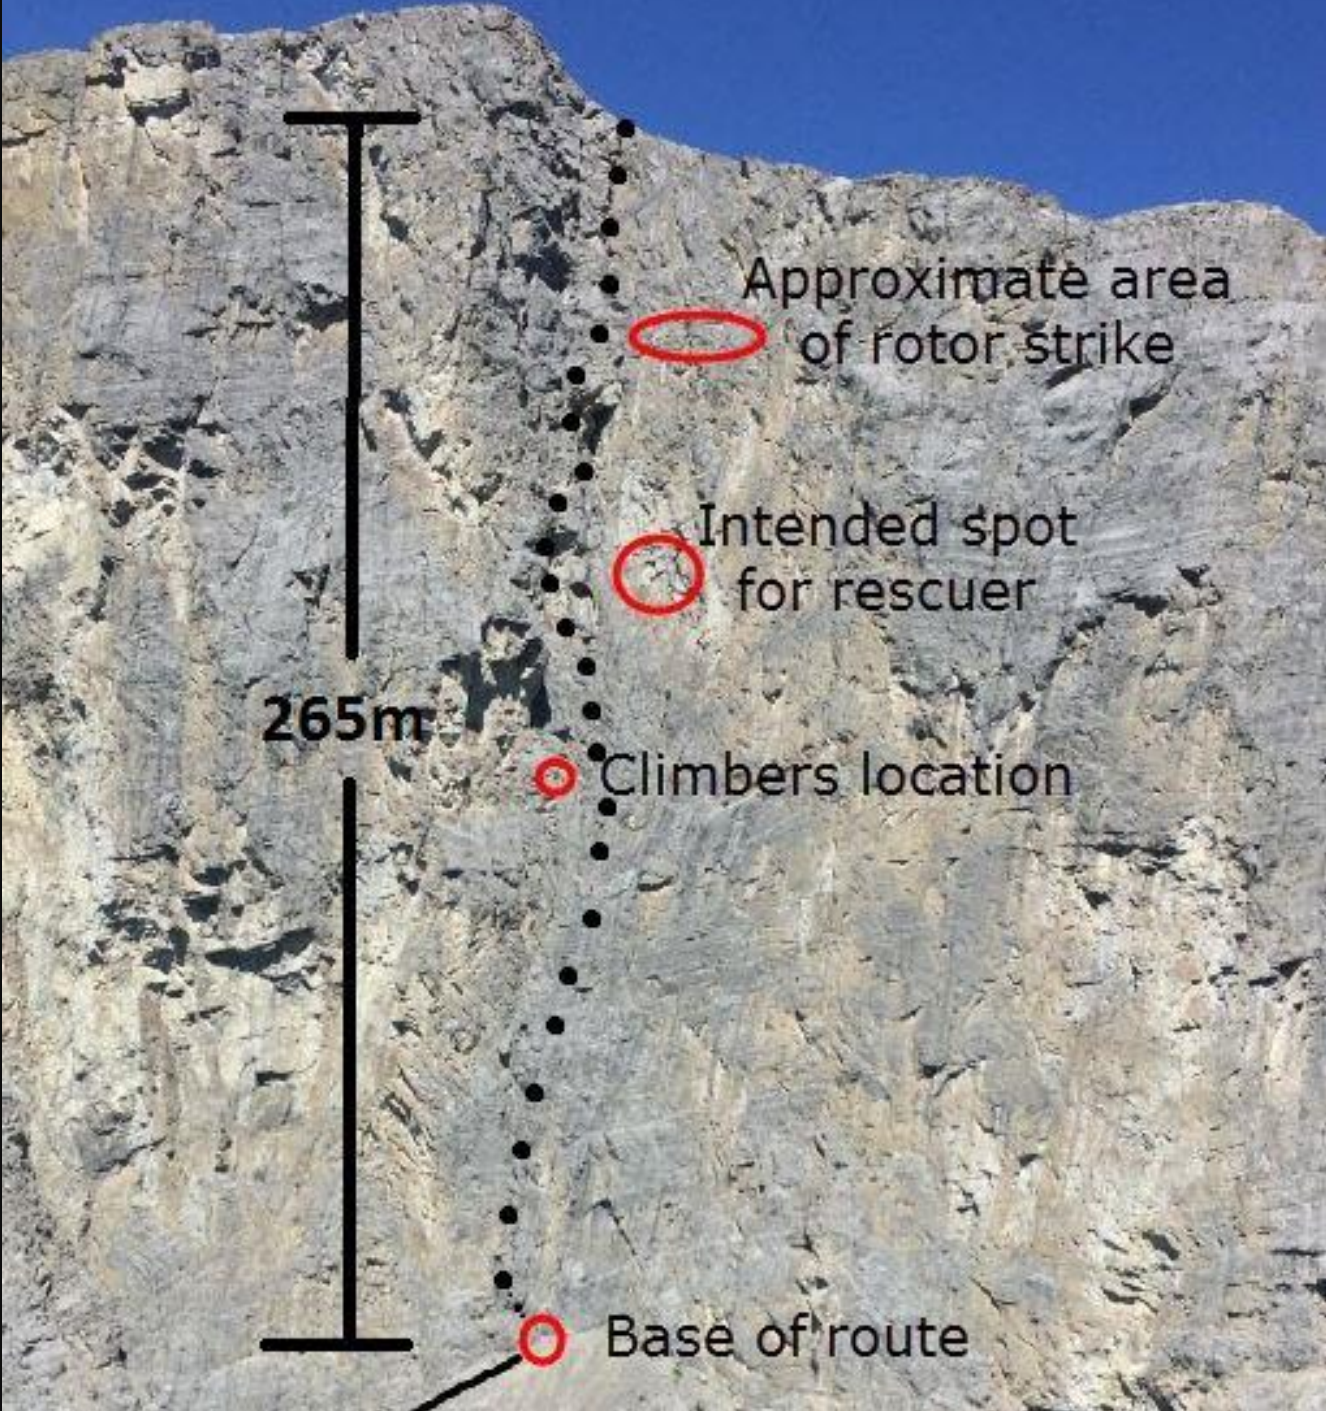
- 200ft (61m) rope was used
- Pilot flew direct with live load
- Rescuer was within inches of the ledge
- Staff described hearing a “gun shot” or “thunder”
- Conservation Officer on top declared a rotor strike over the radio
- The pilot declared an emergency landing
- The landing flight took 1.5 minutes

Approximate area  
of rotor strike

Intended spot  
for rescuer

Climbers location

Base of route

265m
