& Heliseilerei GmbH

Human external cargo (HEC), fixed rope systems

Comparison: EN 1891 vs. Dyneema (HMPE) ropes used for rescue

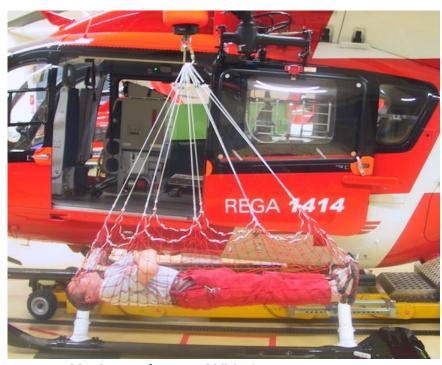
Redundancy system AS332L GSG9 – WLL 800 kg

Horizontal net – WLL 1 person
