AIR RESCUE REPORT

International Commission for Alpine Rescue

October 9 - 12, 2008 - Chamonix - France

ACCIDENTS & INCIDENT REVIEWS FROM MEMBER COUNTRIES:

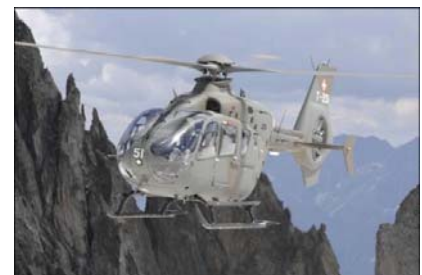
Switzerland – COG discussions

The EC 635 is the military variant of the EC135. There were contract discussion between the manufacturer and the Swiss army on the centre of gravity envelope for normal operations. Although grounding the fleet was discussed this did not happen as the issue was resolved by the manufacturer. Recent incidents in Austria with EC135s tipping over backward were a result of human factors. One was a result of not having the skids fully on the ground and the other was a snow landing with the rear of the skids breaking through.
