AIR RESCUE REPORT

International Commission for Alpine Rescue

IKAR-CISA

October 11-15, 2006 - Kranjska Gora, Slovenia

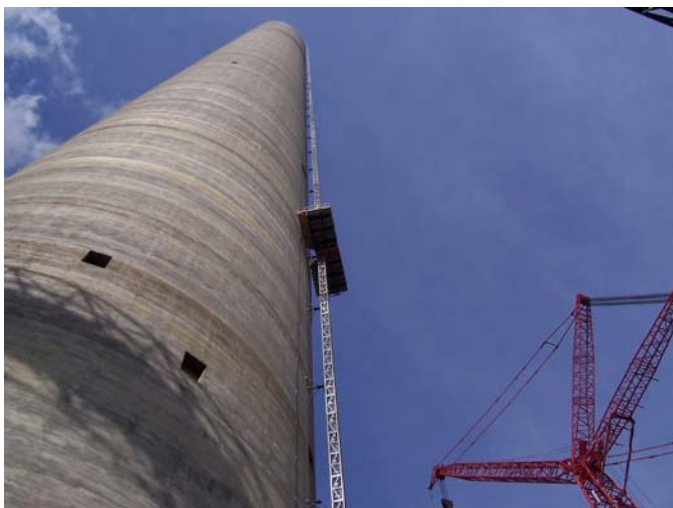
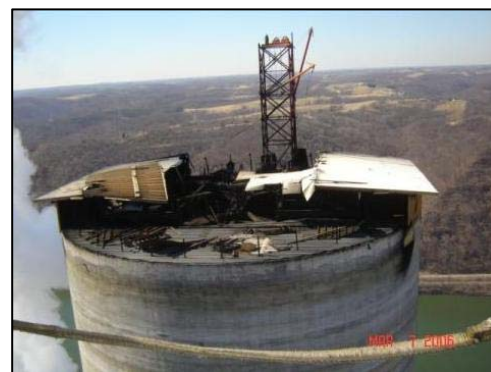
Hoist Rescue Incident Review- Maryland State Police

On March 4, 2006 a fire broke at the top of the 1,000 foot (367.6 meters) chimney, at the coal-fire American Electric Krammer-Mitchell Plant, south of Moundsville, West Virginia. This chimney, once the tallest in the world, is the fifth tallest today. The fire trapped four workers, who were installing fibreglass liners (scrubbers) in the concrete stack. Ground crews communicated with the men above by radio as they huddled in a 10-square-foot space on the platform, which was the only section not ablaze. The victims were forced to tether themselves to a portion of the smoke stack structure on the upwind side of the fire/smoke. They battled

A request for assistance was made to the Maryland State Police Aviation Command. They staffed the closest hoist-equipped helicopter, that responded "*Trooper Five*" (Eurocopter 365N Dauphin). Although the Maryland unit conducts 15 to 20 aerial hoisting rescues a year, this rescue provided unique challenges. The temporary wooden and corrugated metal construction platform at the top of the chimney created a large fire load with burning debris and oxygen-acetylene tanks that might explode, which caused the aircrew to rethink their original rescue plan. A decision was made to not deploy two HEAT (Helicopter Emergency Aerial Team) Cumberland Firefighters who had responded aboard Trooper Five. Rapid removal of the workers was considered the primary goal. A hoist rescue commenced following a face-to-face briefing with incident command on the ground and communicating their rescue plan to the stricken workers by radio. During the third and final hoist evolution, without anyone to steady the basket, it slipped off the edge of the platform as the subject got it. It fell out of sight into the darkness and smoke. After a very long moment, the basket reappeared. The third man had fallen into it and was safe. According to the aircrew, "*that was the heart-stopper of the night.*" The fourth worker was later found dead inside the giant chimney

- Aircraft non-Skid flooring made it difficult to get rescue basket inside aircraft to offload victims.
- Hook assembly striking the top of the doorway necessitated two providers to manipulate the basket into the aircraft far enough to remove the victim.
- Hover time would have been increased with a smaller aircrew.
- Radar altimeter not particularly useful due to extreme elevation. A small crane boom on top of the stack served as a visual of reference.

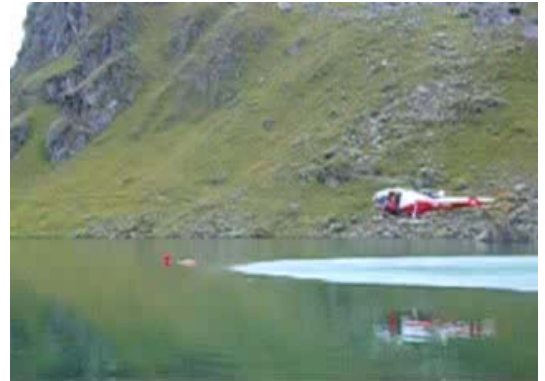
Lake Rescue Incident - Air Glaciers

Initially a rescue request was received at 7pm for a cardiac emergency at the cabane De Panossiere located at 3000 meters. Upon arrival it was determined that the patient was dead, when a second rescue request was received from the rescue center for a water rescue at nearby Louvie Lake. Although the helicopter personnel were not properly equipped for a water rescue they immediately responded via a five-minute flight to the lake, where a small boat with three subjects aboard had capsized. Two individuals had reached the shore, while the third was still hanging on to the overturned boat.

Initially a helicopter “skid rescue” was attempted, which caused the small boat to sink from the rotor wash. A second rescue attempt involved delivering a fixed rope to the victim in the water. Absolutely no effort was made by the victim to reach for the rope. Finally a third rescue attempt was made with the mountain guide from the aircraft being lowered on the hoist cable to the water as the aircraft remained 25 meters above the water. The unequipped rescuer simply grabbed the victim with one hand and the aircraft started to tow the pair toward shore. The pilot was not flying vertical reference with the door off and was relying on a shore-based reference point as well as the instructions of the hoist operator. During the flight the aircraft gained altitude and the rescuer lost control of the victim. The victim was quickly recovered again and the same scenario repeated itself with the aircraft gaining and losing altitude as they moved toward shore. Fortunately this “tea-bagging” rescue technique with the victim was finally successful in getting the victim to shore. The victim was later found to be highly intoxicated and hypothermic.

Discussion: During water rescue it is essential to have a pick-up sling (rescue strop) available. Having such minimal equipment on board at all times eliminates the need to improvise and thereby create a desperate situation. Vertical reference technique would have provided a more level flight profile during the rescue.

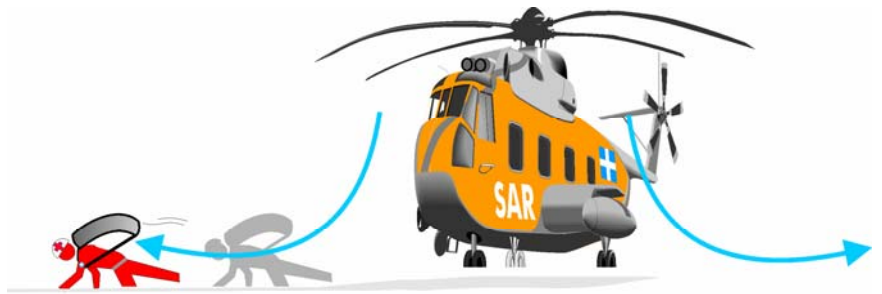
Rotor Wash Incident – Super Puma

The rotor wash of the Super Puma, which can reach 100 km/hour, caused a near-miss incident during a 2006 rescue. A mountain rescuer, who was wearing a bulky but lightweight vacuum mattress pack on his back, was deployed on to a snowfield from a hover. The aircraft remained two meters above

the deep soft snow and the rescuer jumped to the ground. As he struggled in the fresh snow and started to move out away from the aircraft, the powerful rotor wash caused the vacuum mattress pack to act as a “sail” from behind. The rotor wash pinned the rescuer out in a prone position and lifted the bottom edge of the pack literally dragging the stout rescuer across the surface of the snowfield. This incident highlights one of the limitations of using heavy lift helicopters in rescue work. The rotor wash must be considered when working around or under the aircraft. Rescue equipment is much more difficult to control than around a lighter machine.
