IKAR AIR RESCUE REPORT 2015

Killarney, Ireland

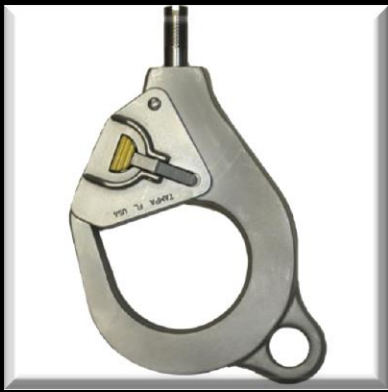
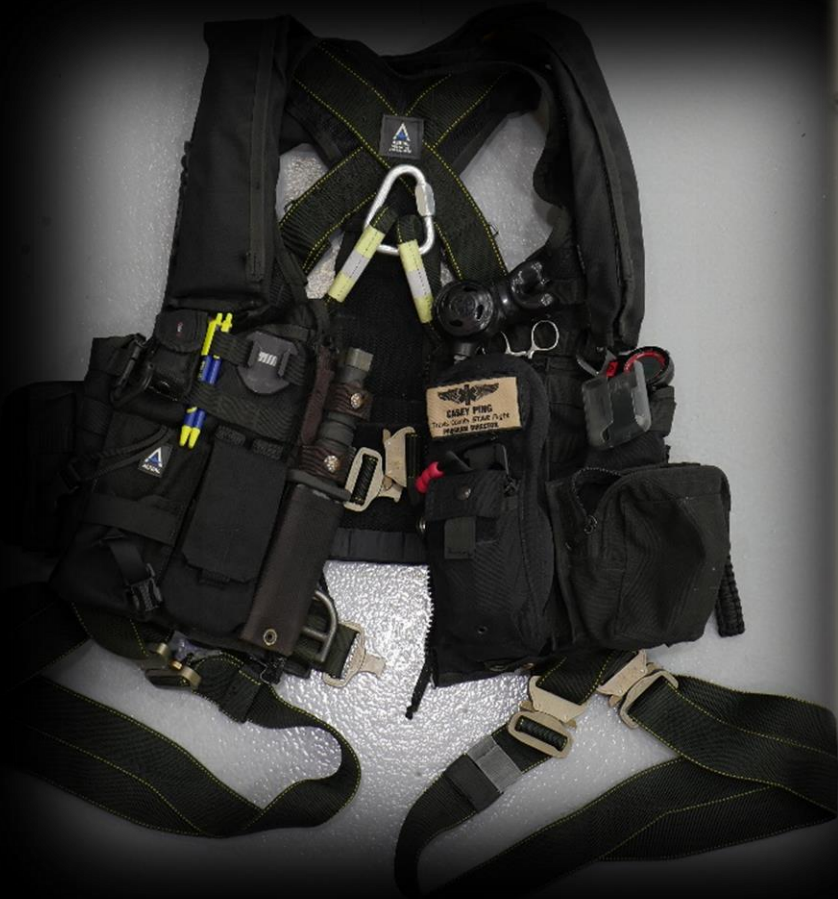
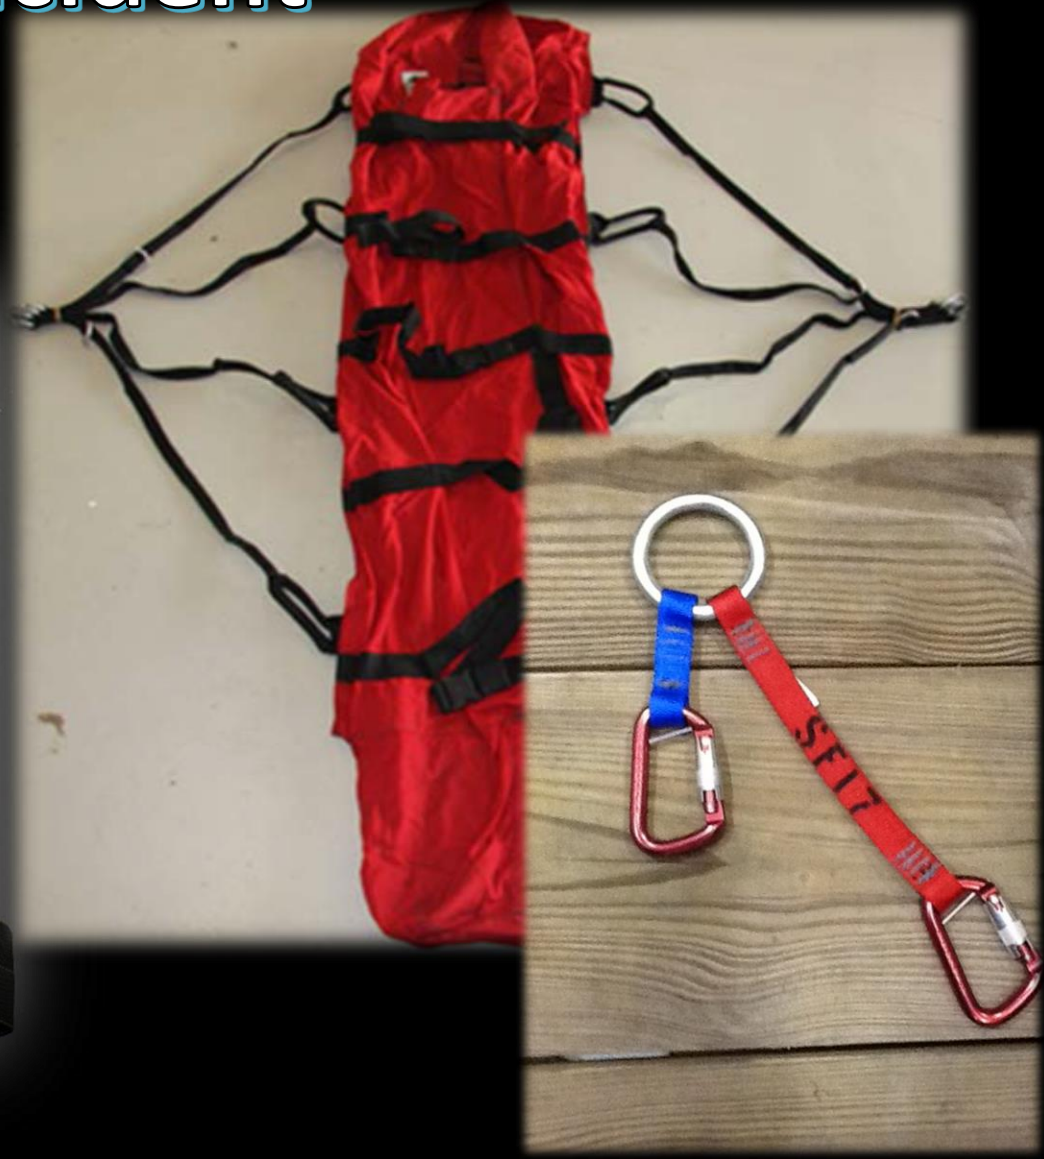
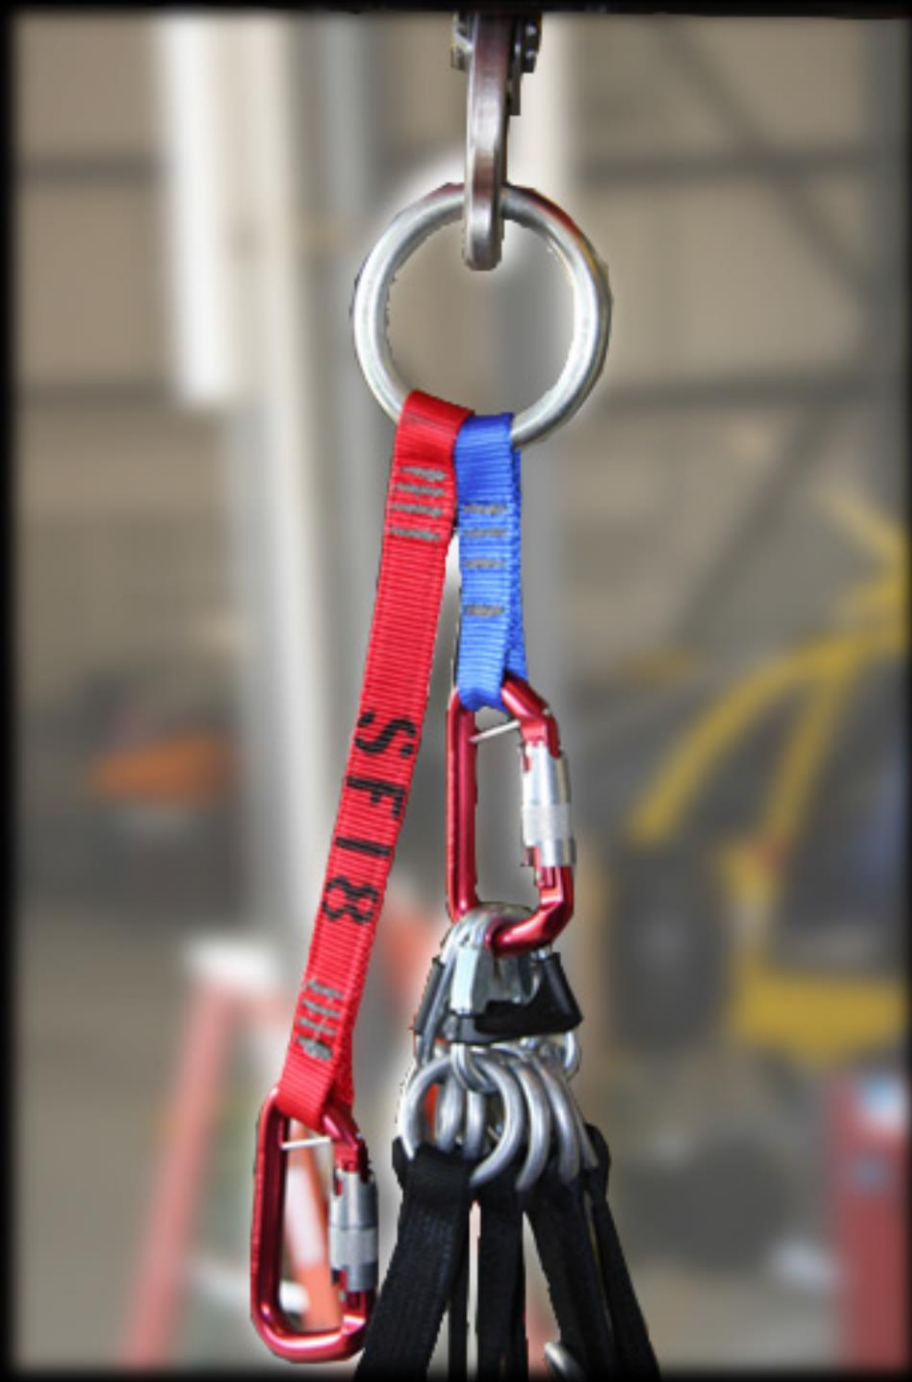
Equipment Used During Incident

- Uneventful insertion
- During extrication a slow spin started
- Crew initiated forward air speed
- As the spin stopped, Kristin was observed to be riding lower than normal, then fell from the line
