# **U.S. AIR RESCUE REPORT**

#### Charley Shimanski; U.S. Delegate October 18-20, 2017 – Chamonix, France

# 2018 USA AIR RESCUE REPORT

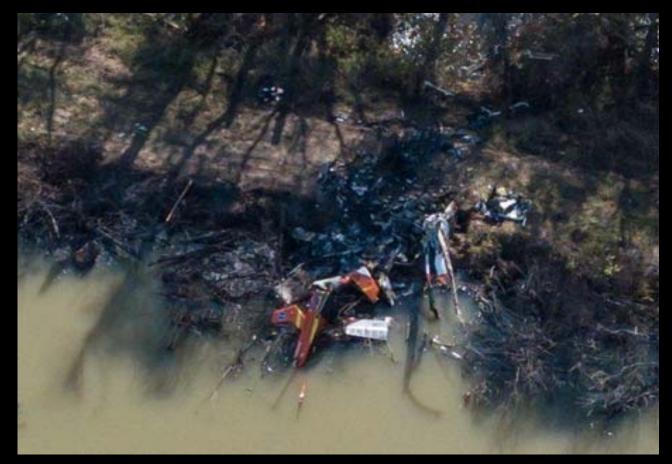
#### A witness reported hearing geese get loud right before the helicopter flew over a reservoir.

### "Several bird carcasses were located in the wreckage of the helicopter."

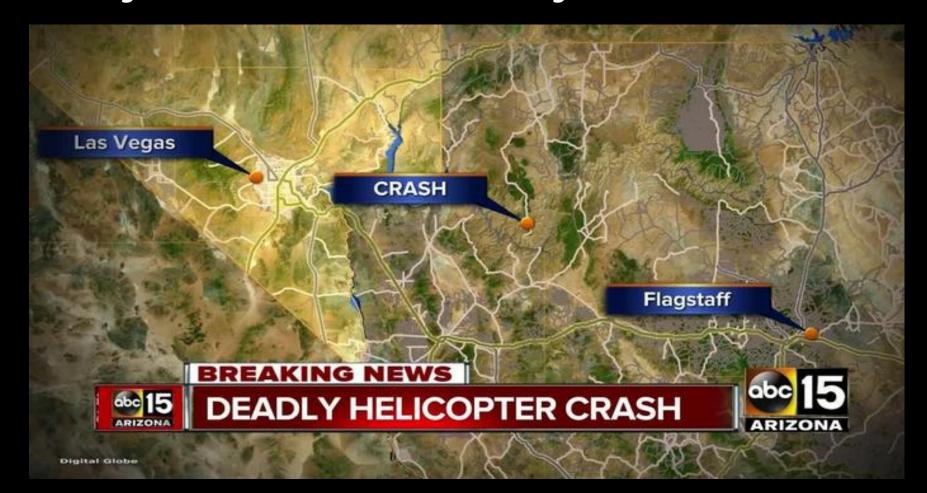
- The EC130 B4 was destroyed when it crashed on an approach to land.
- Three passengers died.
- The pilot and three passengers sustained serious injuries.

The helicopter was not equipped with a <u>crash-resistant fuel system</u> required by a 1994 FAA regulation.

A loophole exempts newly manufactured helicopter with certificates approved before 1994.  "Papillon will retrofit our tour fleet with crash resistant fuel systems"

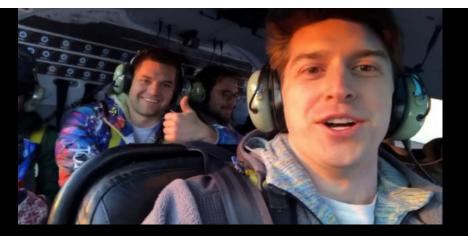
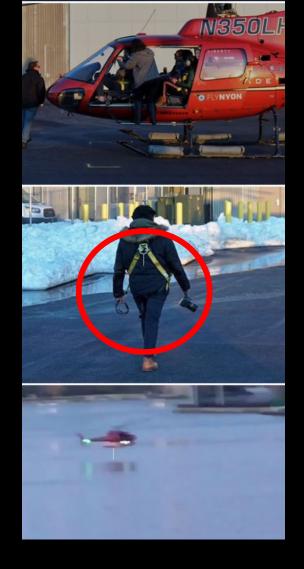
The front passenger and two rear outer passengers <u>sat sideways facing</u> outside

The 2 inboard passengers sat tethered on the floor with their feet on the skids.

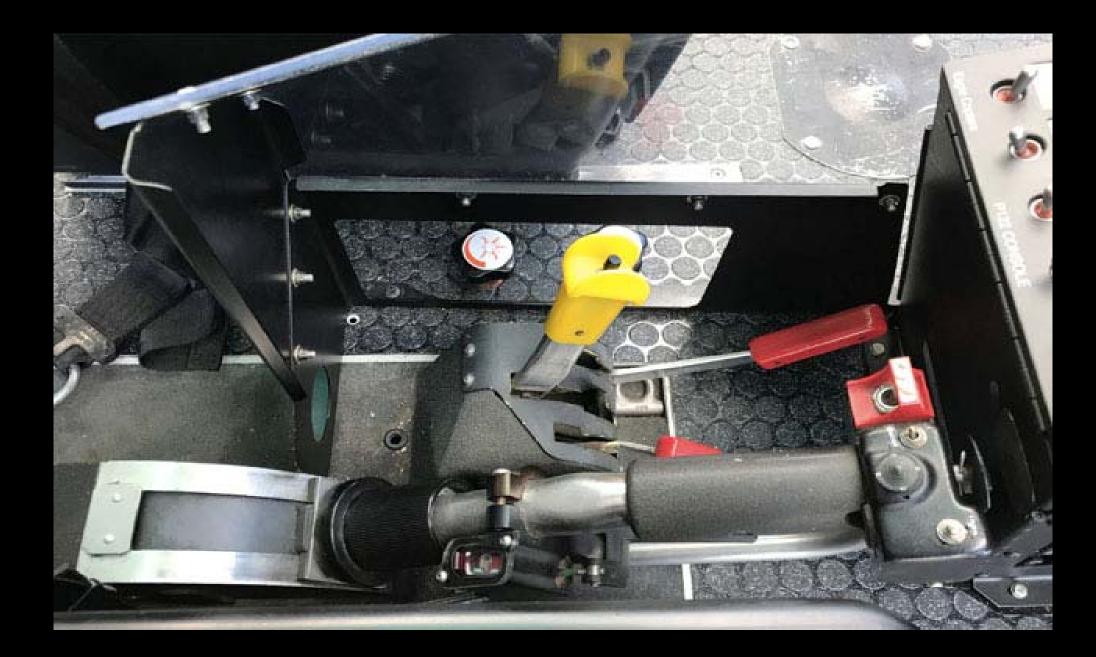
## The front seat passenger's tether was underneath the emergency fuel shutoff lever.

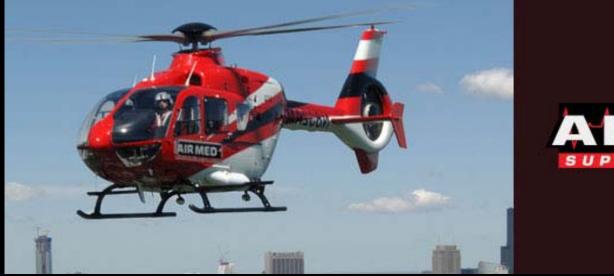
# The EC135 P1 impacted terrain at 2115 hrs during an autorotation following a dual engine failure

Surveillance video from a train platform showed a fire near the right engine in flight.

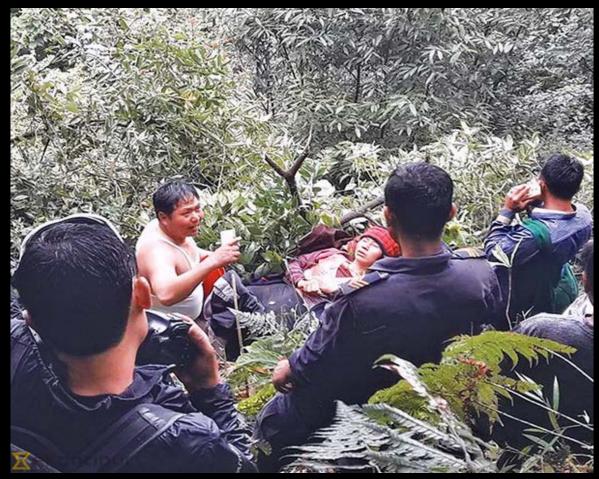
# Six perish, one survives Altitude Air

September 8, 2018 – Nuwakot District, Nepal

The helicopter was airlifting a patient along with other passengers.

The helicopter was scheduled to land at 8.18 a.m. but lost radio contact 8:10 a.m.

6 of the 7 people on board died and one survived.

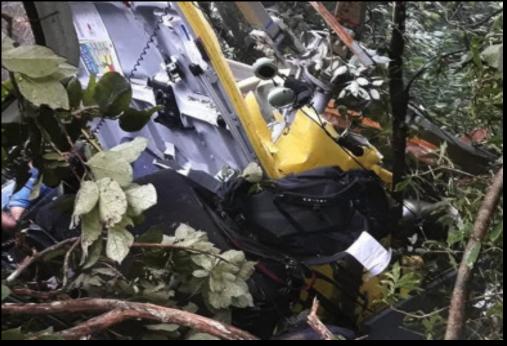
The pilot radio he was coming down from 9,500 feet to 5,500 feet.

TIA officials believe the crash happened due to bad weather. <u>"The</u> <u>weather was so bad that even</u> <u>rescue work was affected."</u>
