2019 USA ACCIDENT/INCIDENT REPORT

Charley Shimanski; U.S. Delegate
October 8-12, 2019 – Zakopane, Poland

Rescue Helicopter Crashes Trying to Rescue a Helicopter Crash Casualty October 3, 2019 – Polk County, Florida

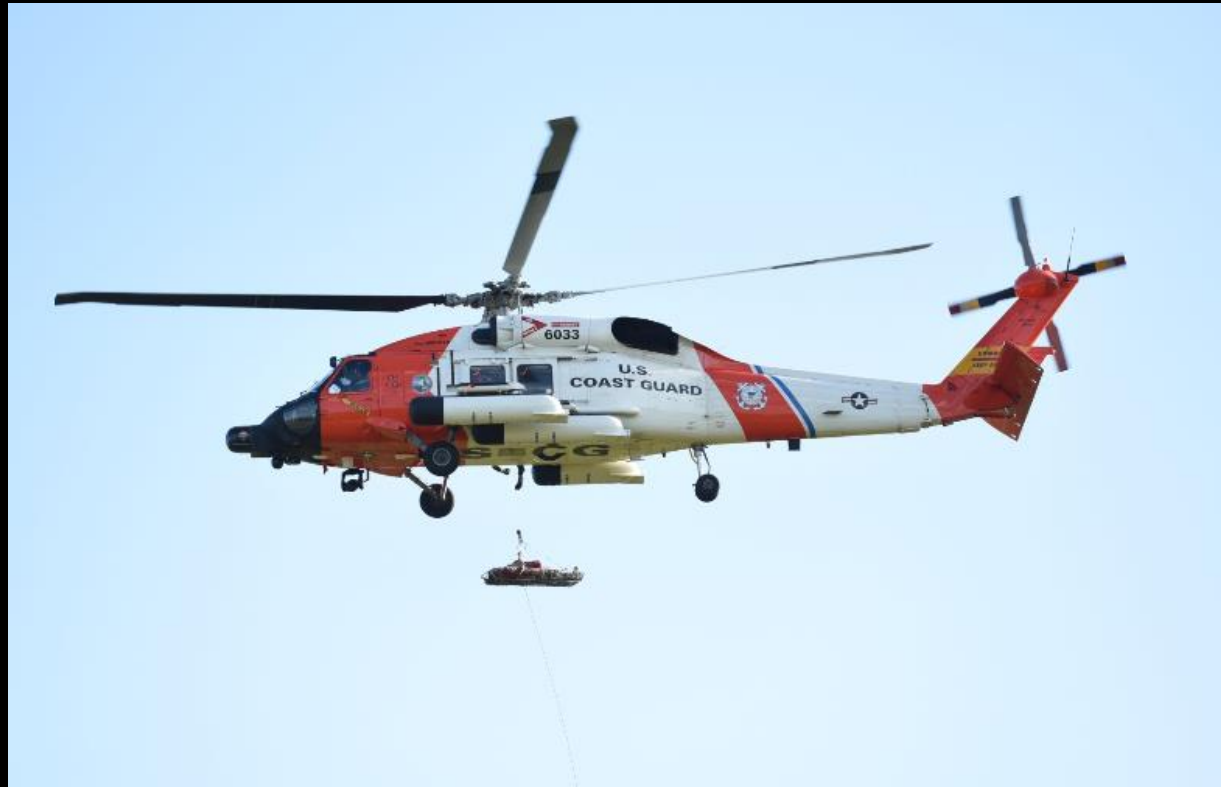
**A Coast Guard Air Station Clearwater MH-60
Jayhawk helicopter aircrew rescued
2 pilots from two helicopter crashes.
The two subjects were transported to Tampa
General Hospital.**

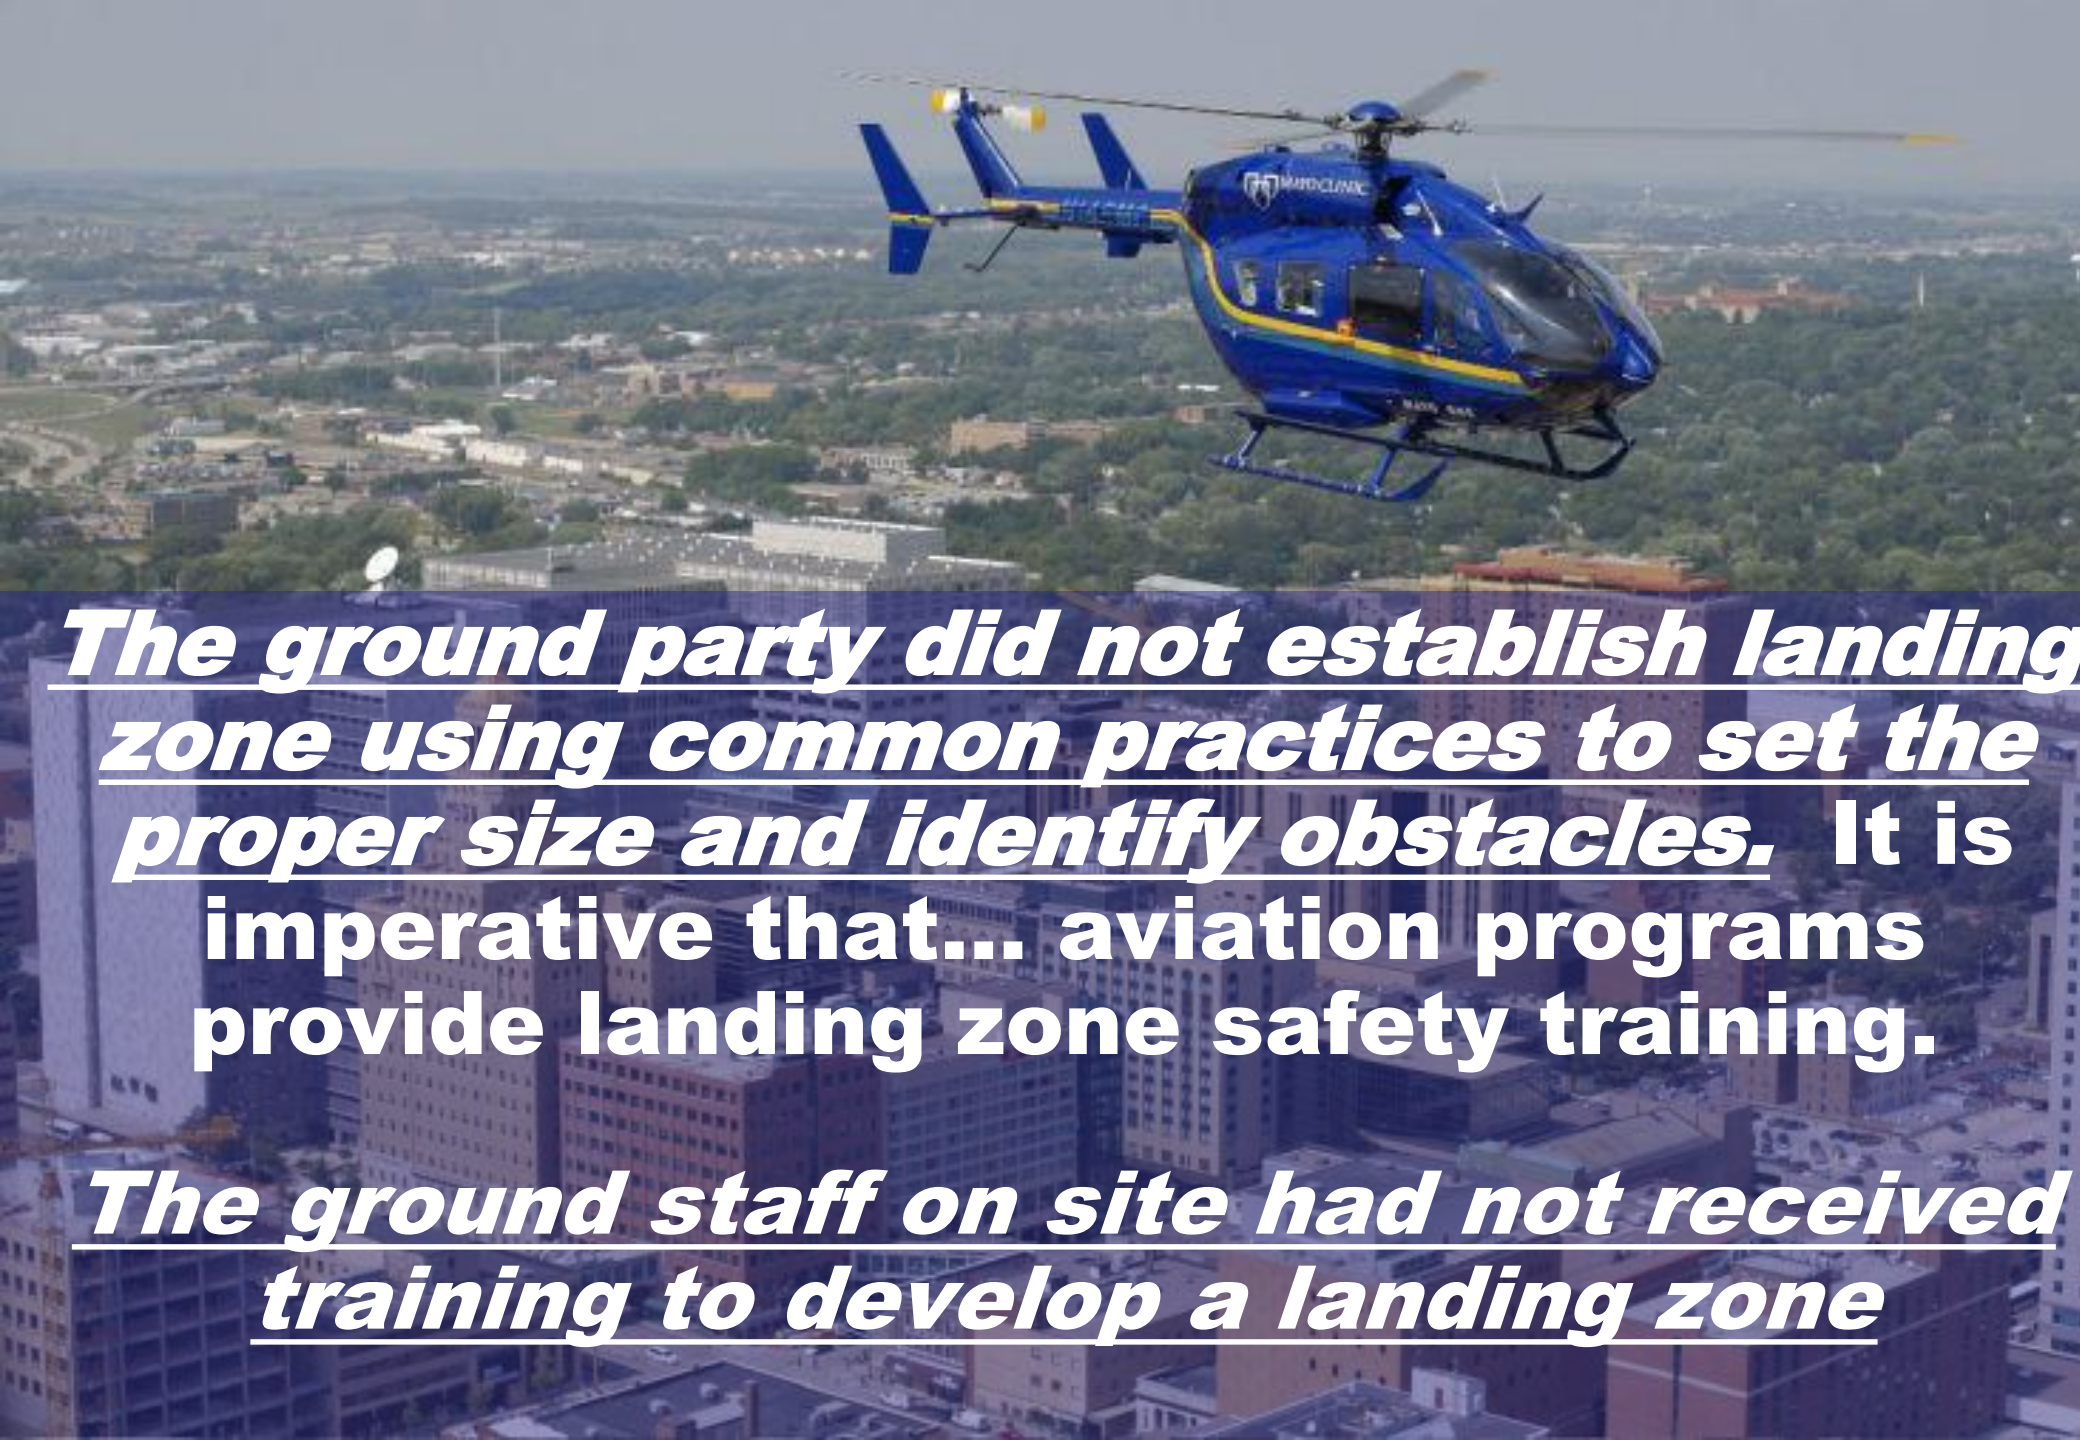
The ground party did not establish landing zone using common practices to set the proper size and identify obstacles. It is imperative that... aviation programs provide landing zone safety training.

The ground staff on site had not received training to develop a landing zone

Once the crew agreed to land at the smaller landing zone, they acknowledged that it seemed smaller than normal. The crew continued to consider options of going to the previously established landing zone instead of focusing on landing area they had chosen. **Because of this, they did not discuss the obstacles in the landing zone... and did not maintain situational awareness once they were committed to the landing zone.**

The pilot stopped his approach 3 feet above ground to avoid an unreported obstacle... The tail rotor made contact with the top of a fire truck parked to block the street.

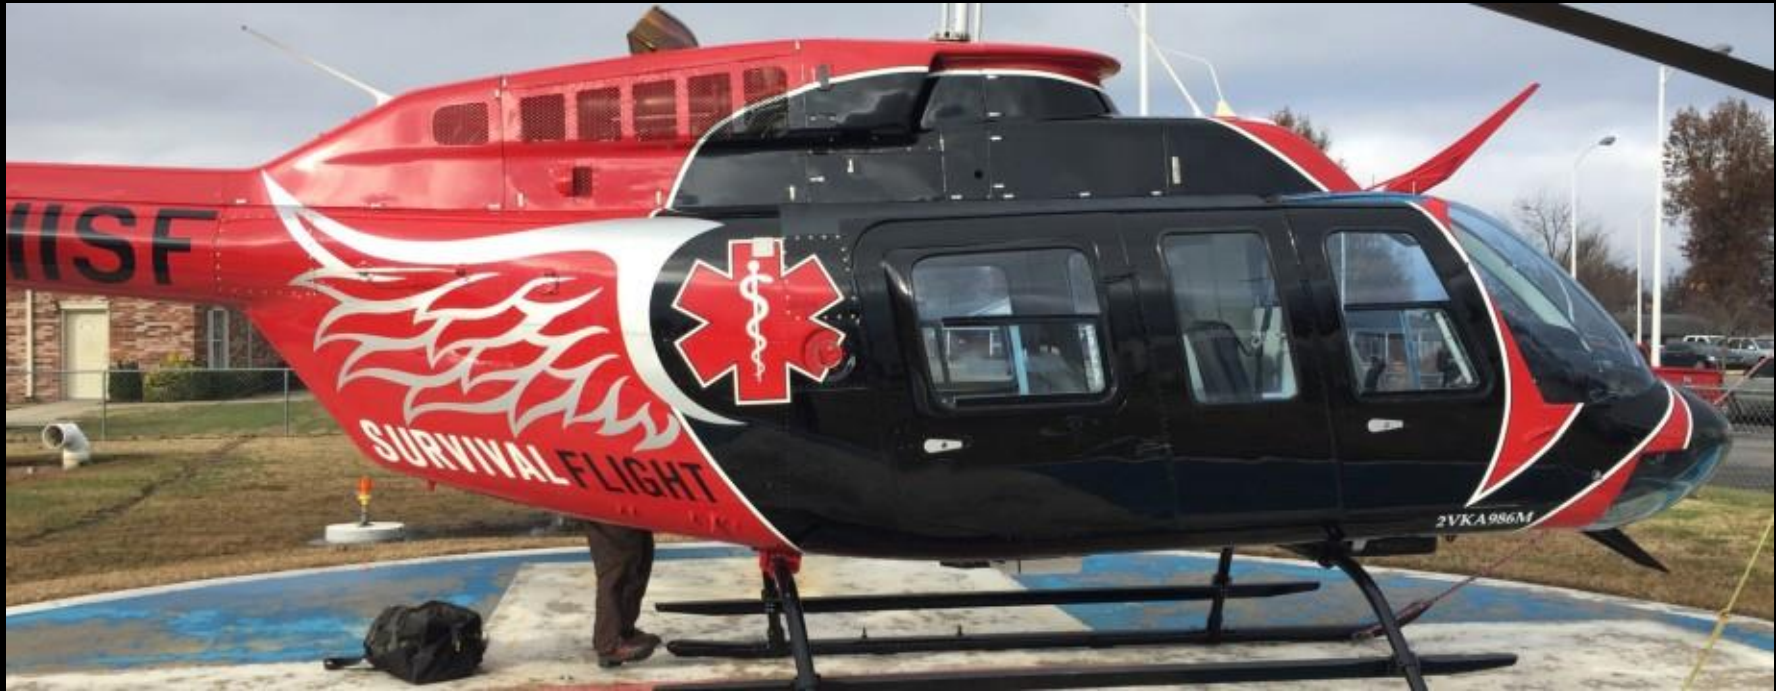
At 0650, the single-engine, turbine-powered, Bell 407 N191SF collided with forested, rising terrain about 4 miles northeast of Zaleski, Ohio.

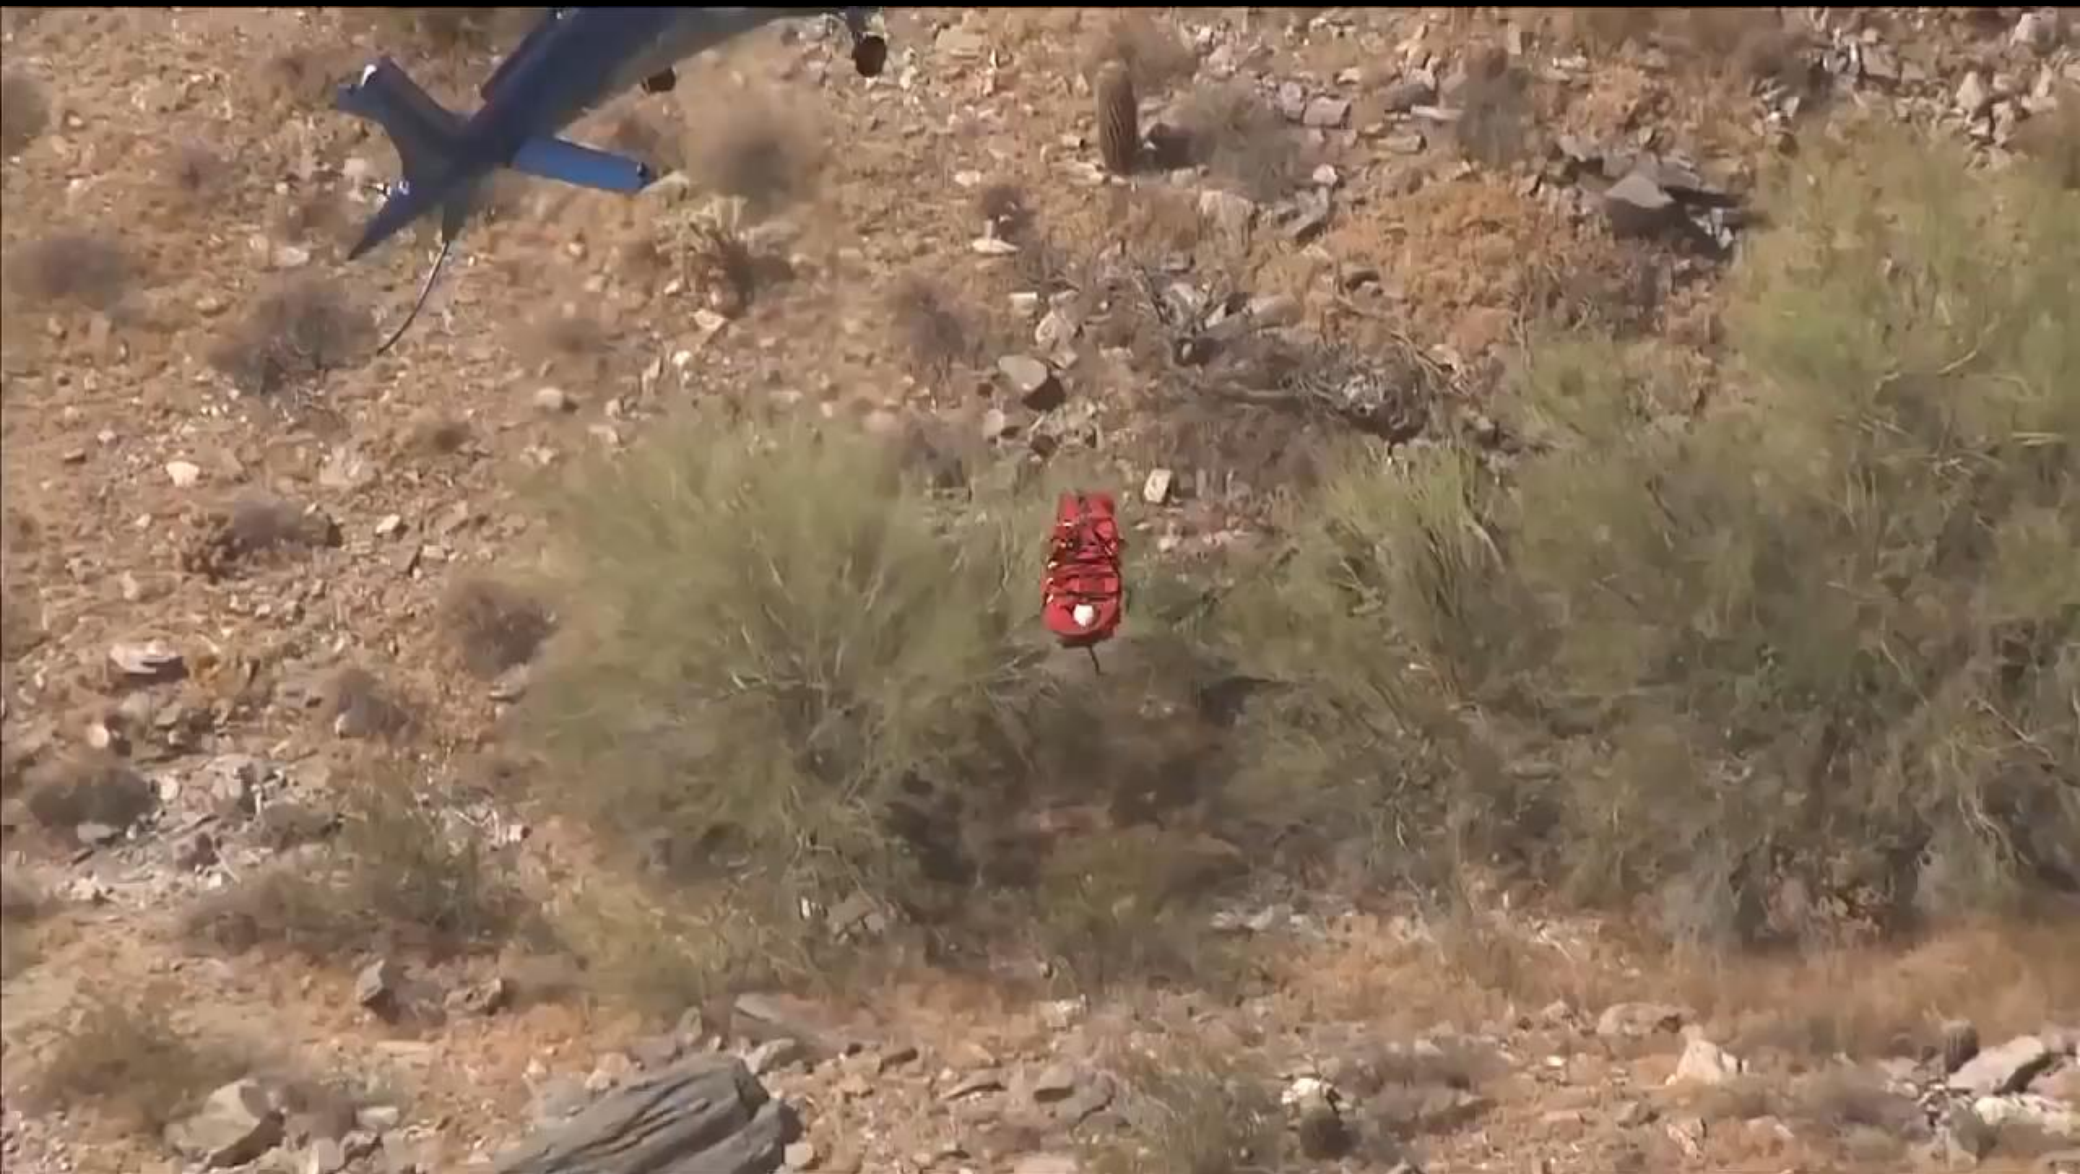
Video of the incident...

**The rescued woman spun in the basket for roughly a minute before the spinning subsided and the crew safely delivered her to an ambulance.
The litter spun 175 times**

“Sometimes, when we bring the helicopter up from the ground, [the basket] will start to spin. We have a line attached to the basket that’s supposed to prevent that. Today, it didn’t.”

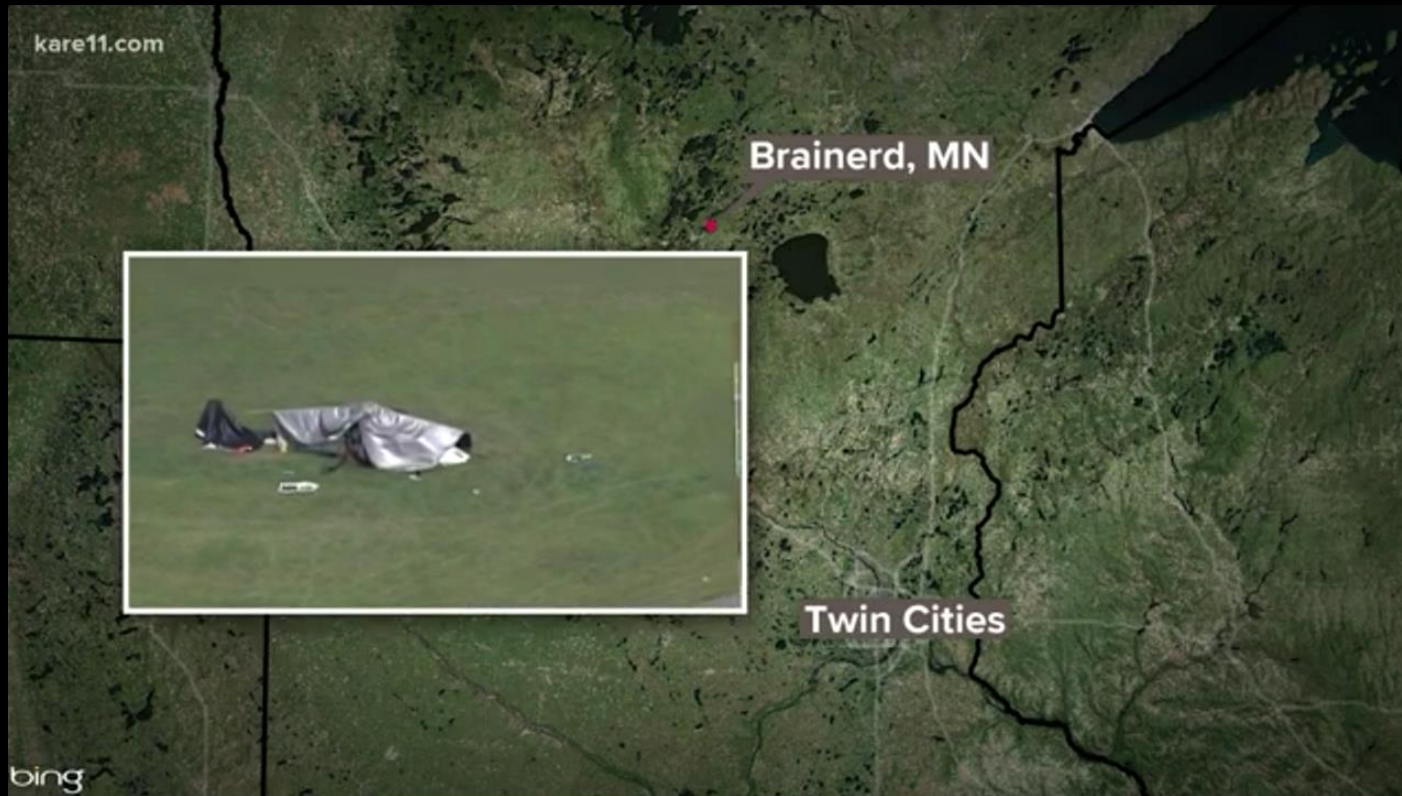
A-109 helicopter crashed in foggy conditions about 127 miles (204 kilometers) northwest of Minneapolis, Minnesota.

Heavy fog, but within minimums for an instrument landing.

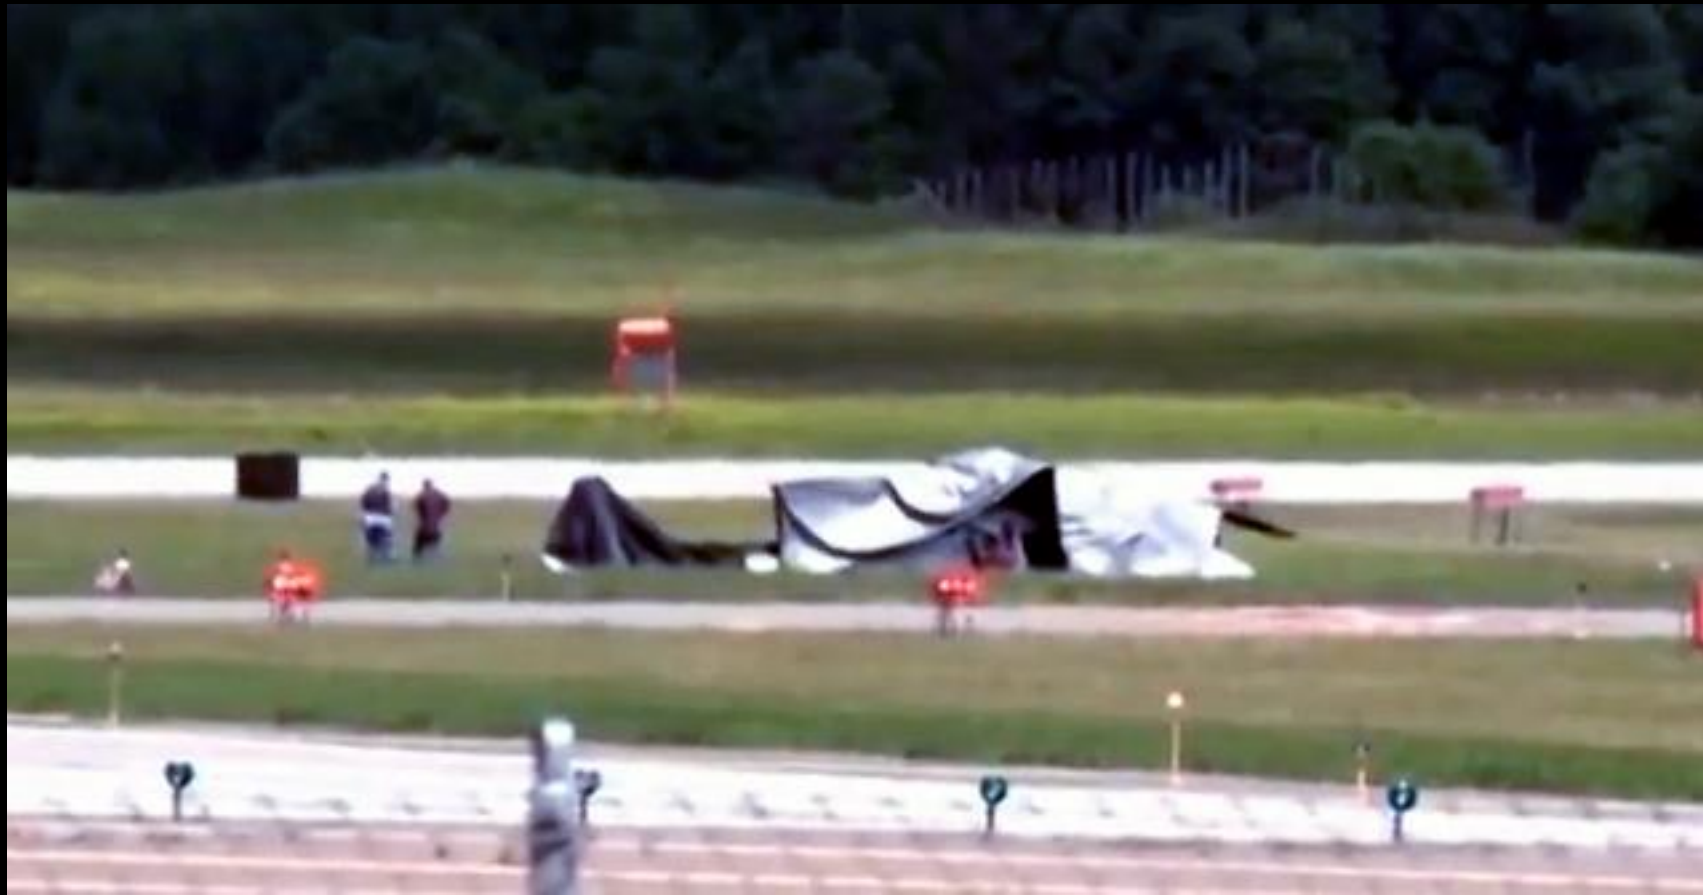
According to the paramedic, the runway surface and lights were visible below a thin fog layer during the approach... He recalled the pilot remarking that the weather conditions were foggy, and they would need to go-around.

He then noticed the helicopter spin to the right and hit the ground.

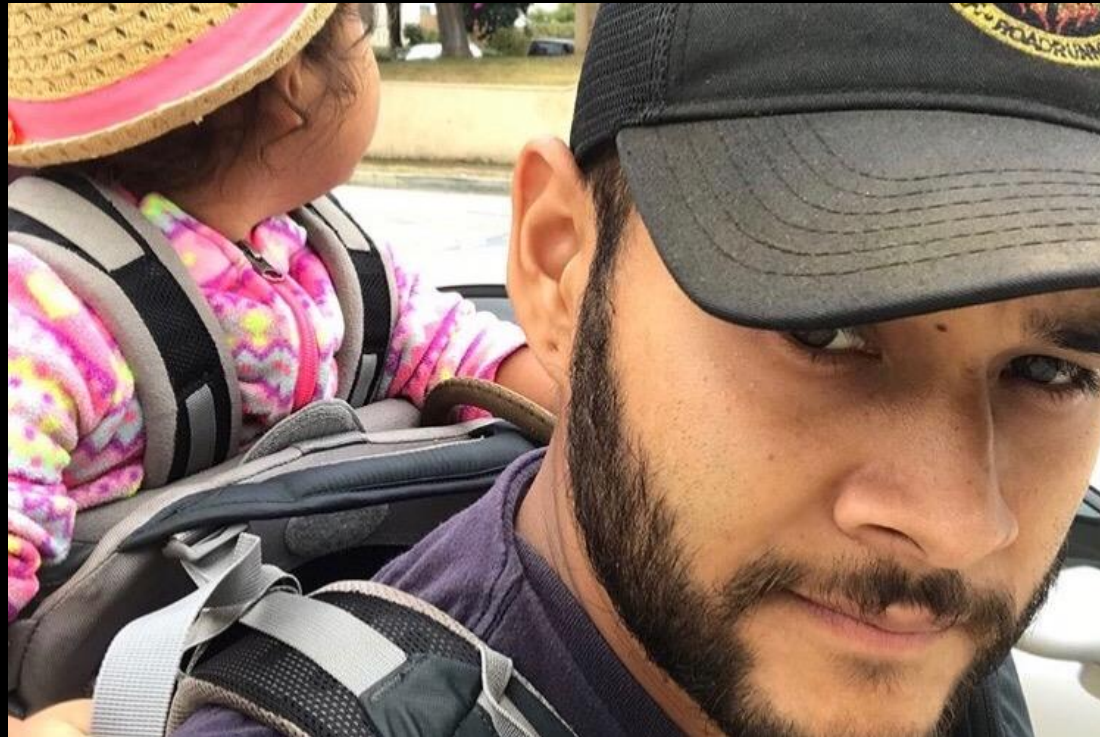
On July 31, 2019, Firefighter Edgardo Garay and his engine crew responded to an incident to render medical aid to an injured hiker.

While the medevac helicopter was preparing to hoist the patient out, it is believed that the helicopter's rotor wash knocked over a dead tree, striking Firefighter Garay and his partner on the head.

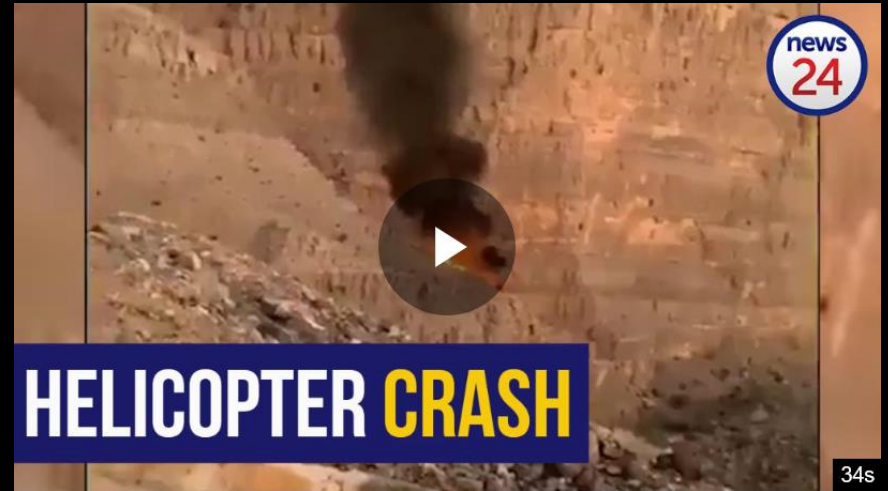
The Agusta 139 helicopter was on a rescue mission at Jebel Jais, a mountain in the Ras al-Khaimah emirate, when it came down on Saturday.

The country's National Search and Rescue Centre said four people had died.

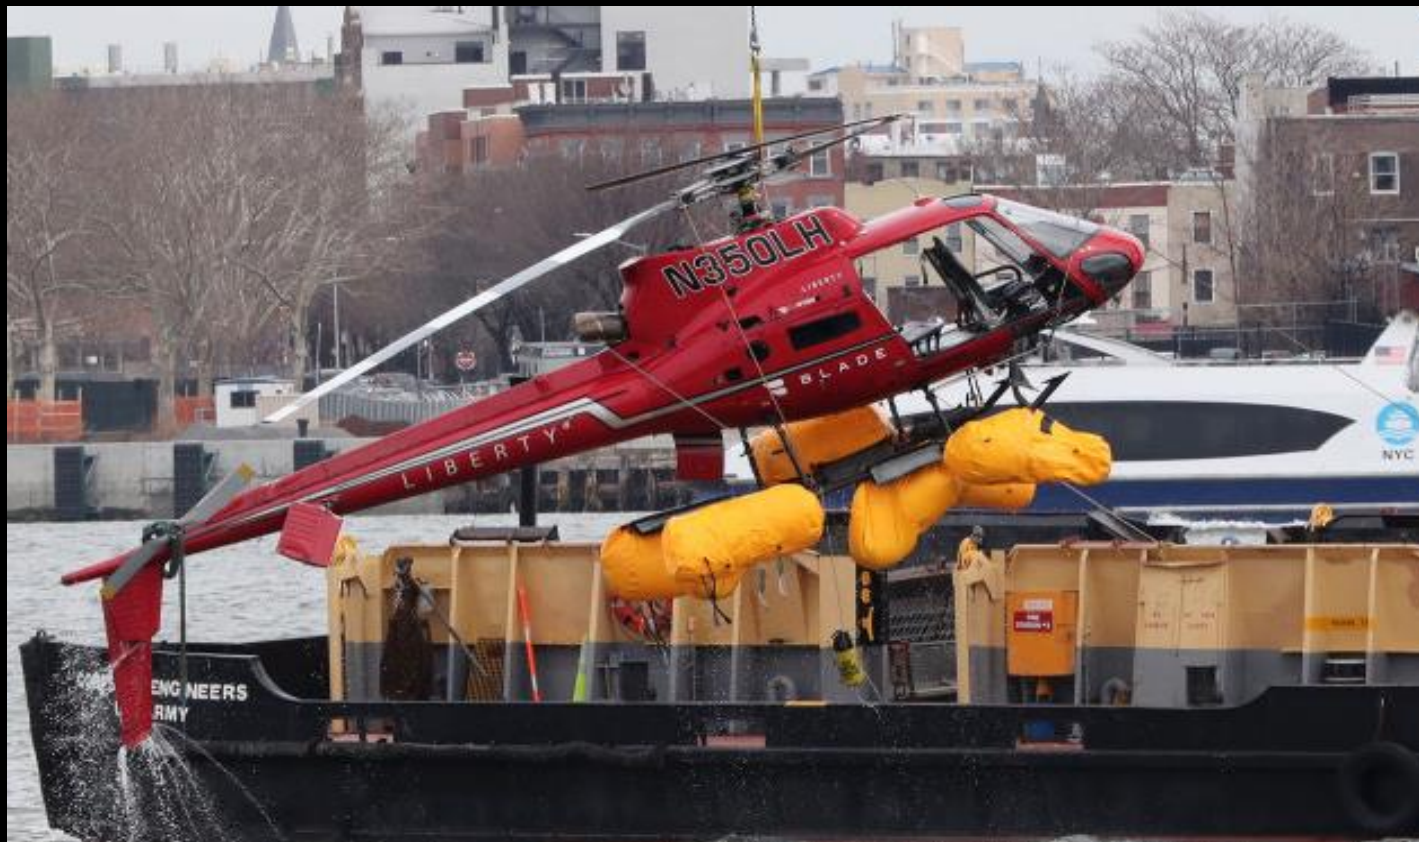
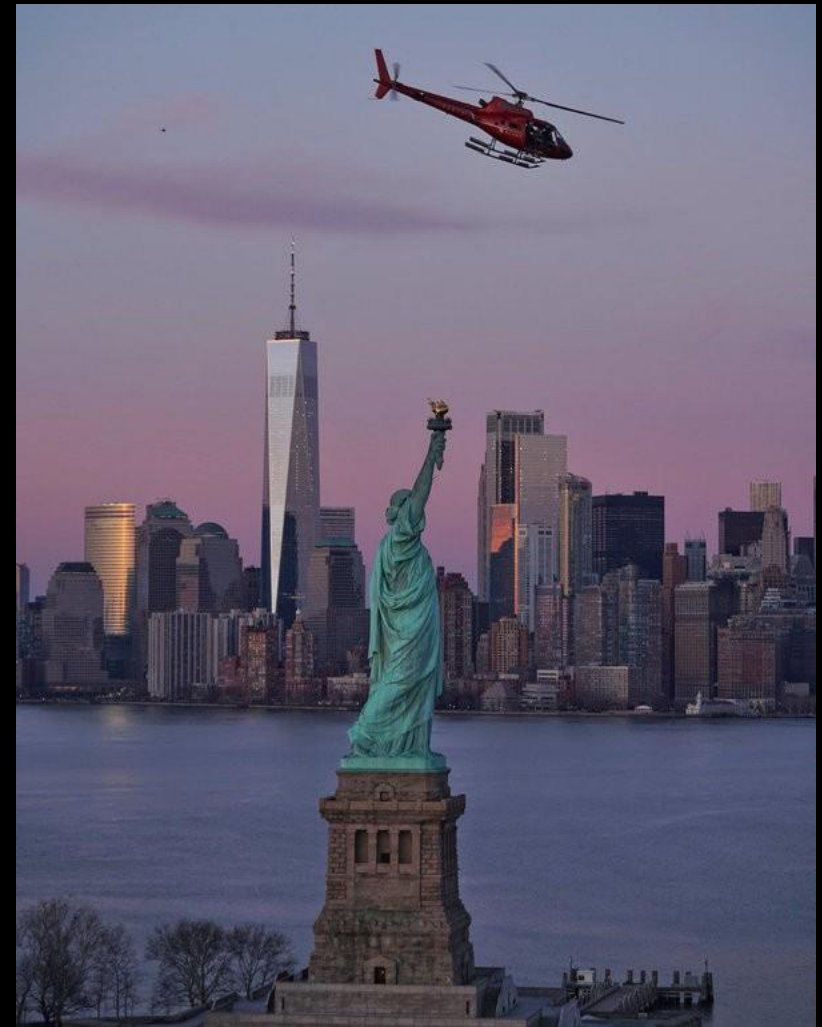
Tourist Helicopter into East River

All 5 passengers die, pilot survives

5 passengers on a “doors open” photography flight

Each passenger was
restrained in the
helicopter with:

1. Helicopter
manufacturer's 4-point
seatbelt, and
2. An aftermarket harness
tethered to hard points.

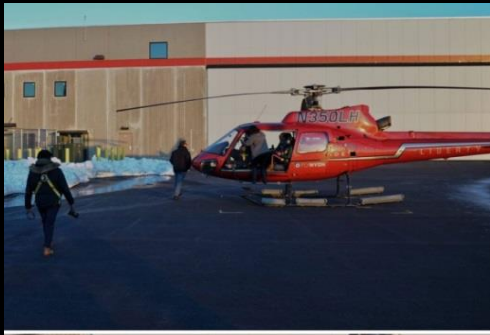
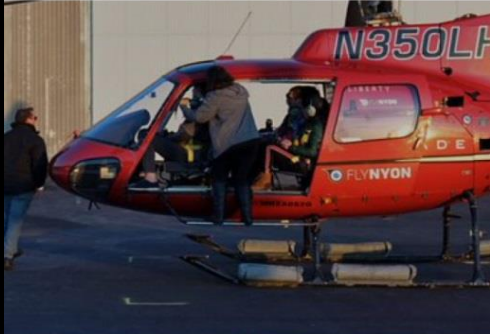
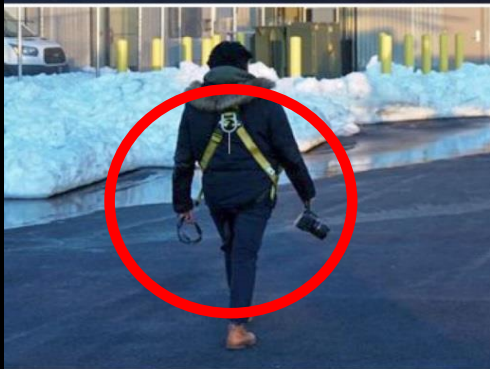
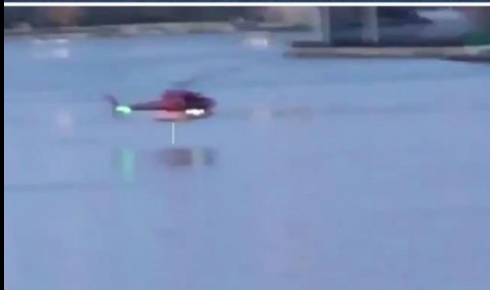
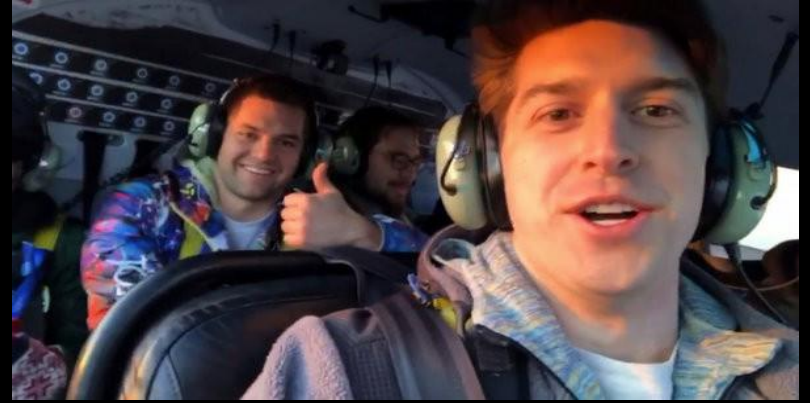
**The front passenger and
two rear outer passengers
sat sideways facing
outside**

**The 2 inboard passengers
sat tethered on the floor
with their feet on the skids.**

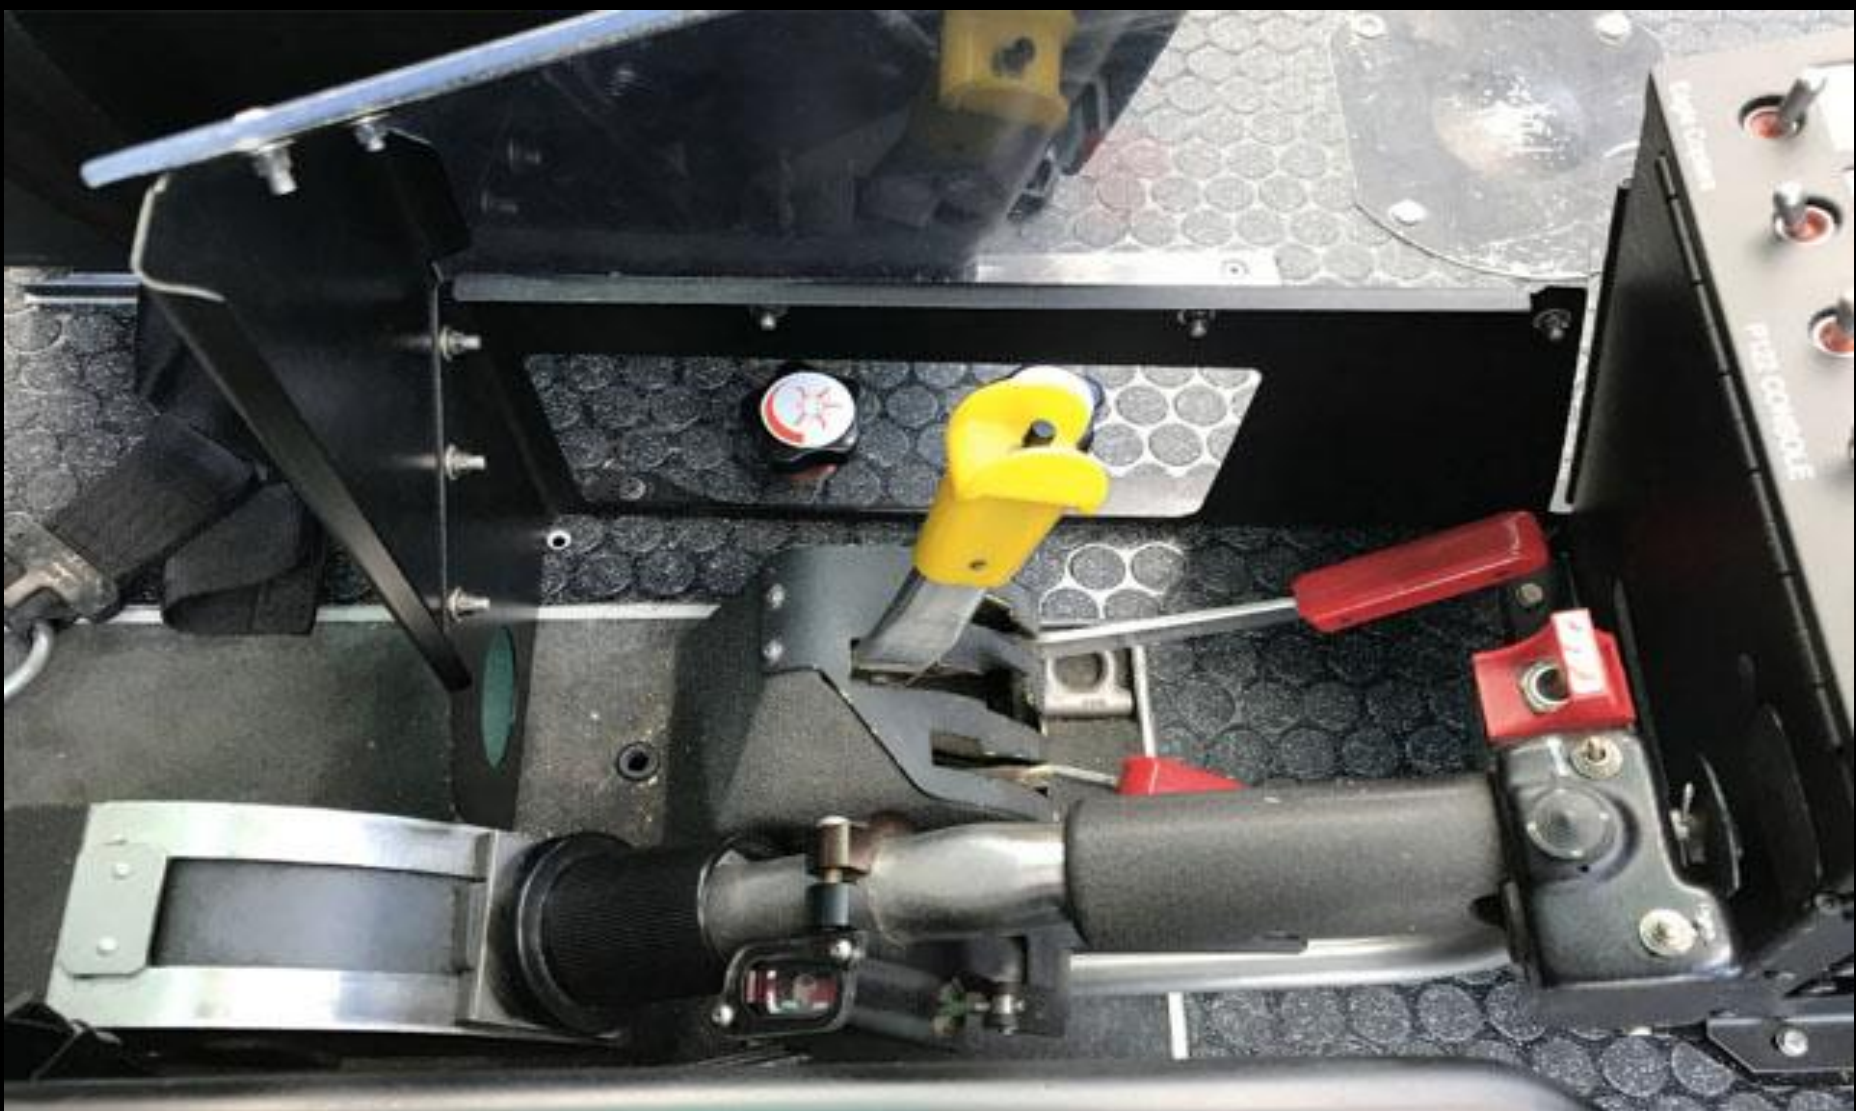
- attempted to restart the engine (failed)
- tried the starter again (failed)
- checked the fuel control lever (normal)
- activated the floats (2 failed)
- *reached down for the emergency fuel shutoff lever, it was in the off position*

The front seat passenger's tether
was underneath
the emergency fuel shutoff lever.

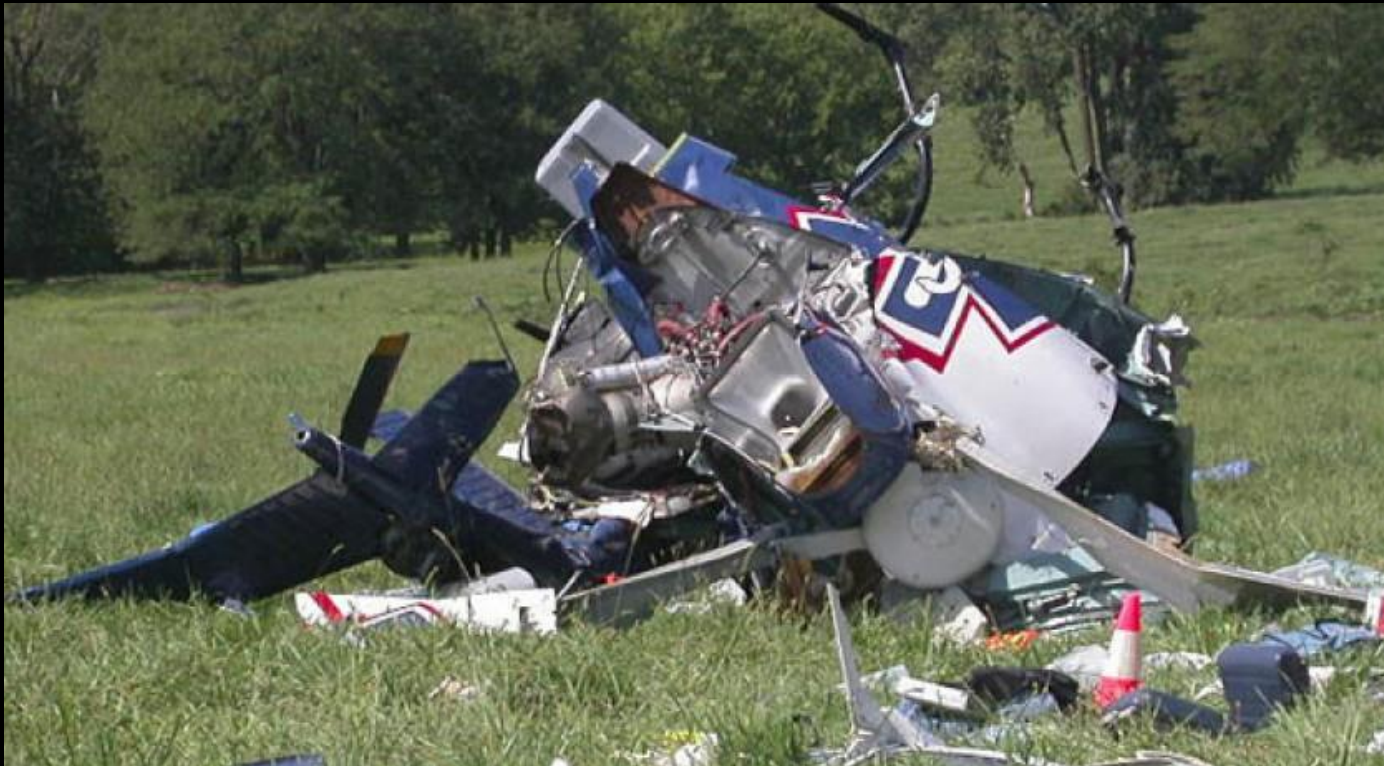
Texting contributed to fatal crash according to NTSB

The pilot of a medical helicopter that crashed in Missouri in 2011 had been texting, and that was a contributing factor to the disaster that killed four people, federal investigators said.

The crash was caused by a tired pilot who skipped preflight safety checks that would have revealed the helicopter was low on fuel.

After discovering the fuel problem, the pilot decided to continue on the last leg of the flight anyway.

The pilot exchanged 20 personal text messages... preceding the helicopter crash, according to the NTSB.

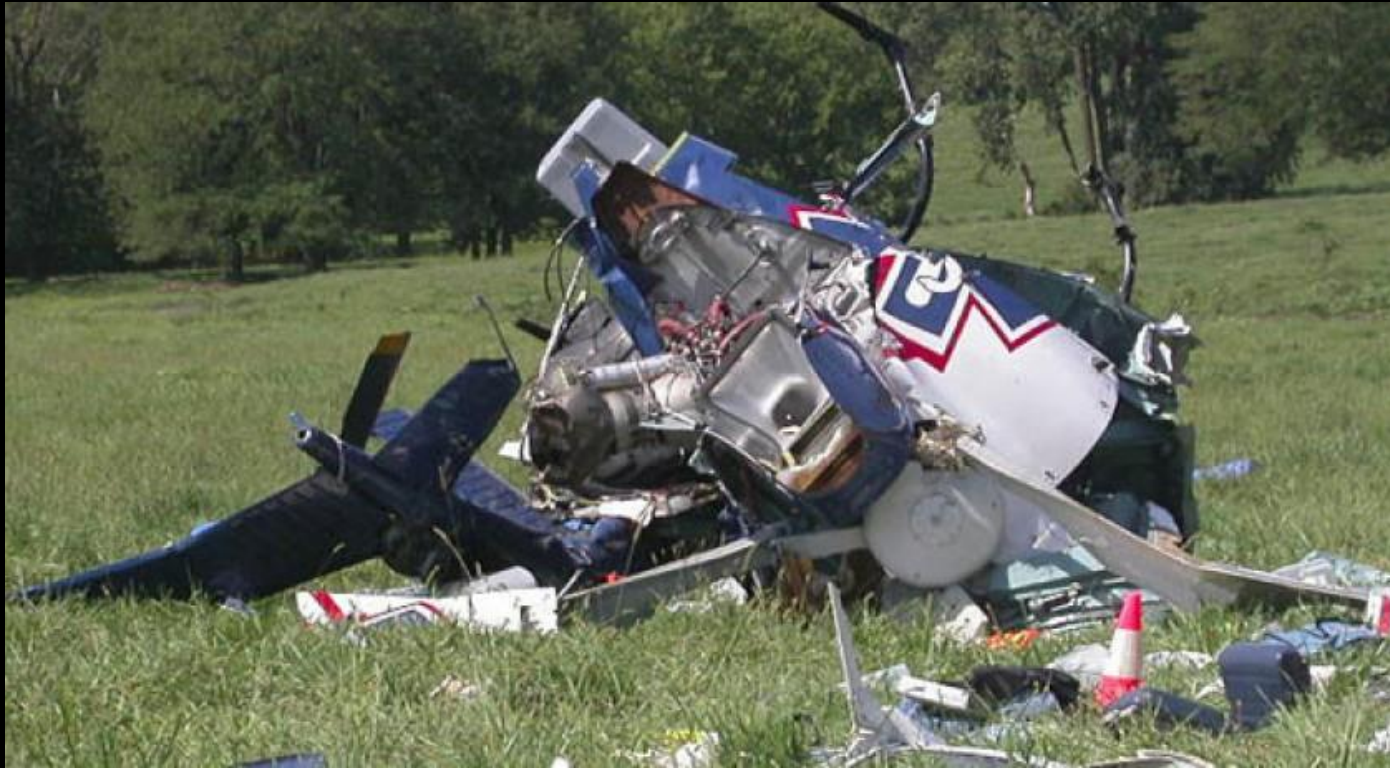
When the helicopter crashed, there was no fire. Less than one liter of fuel remained in the craft, which lost power due to “fuel exhaustion.”

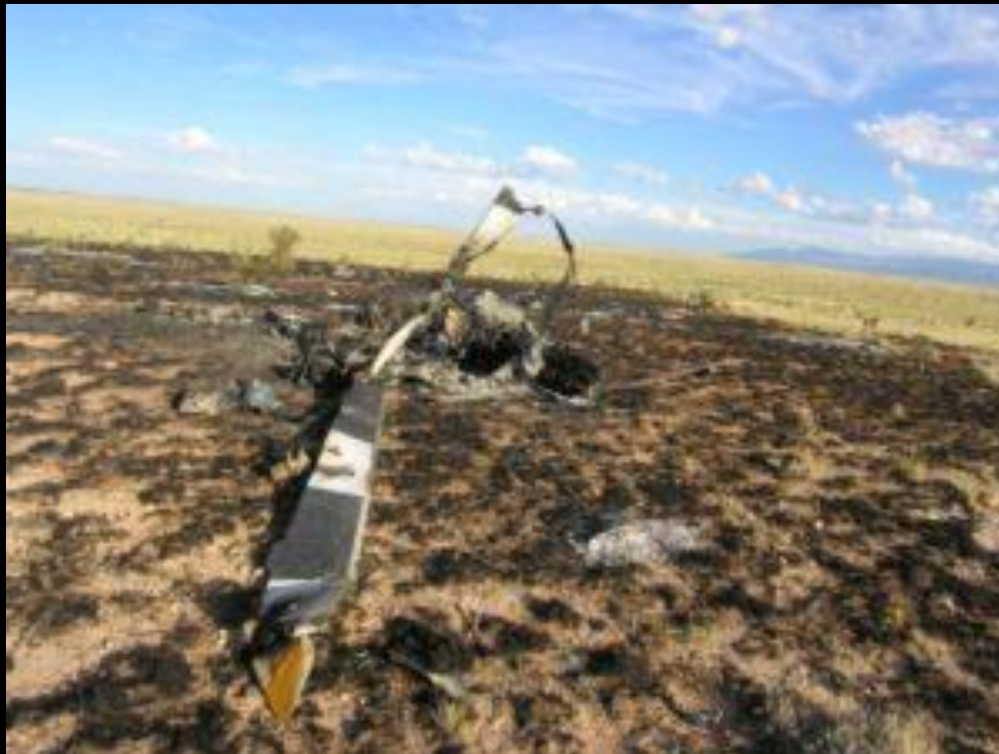
Pilot Used His Cell Phone While in Flight KRQE-TV

The news helicopter pilot who was killed in the crash had placed a cell phone call to his car rental company during the accident flight.

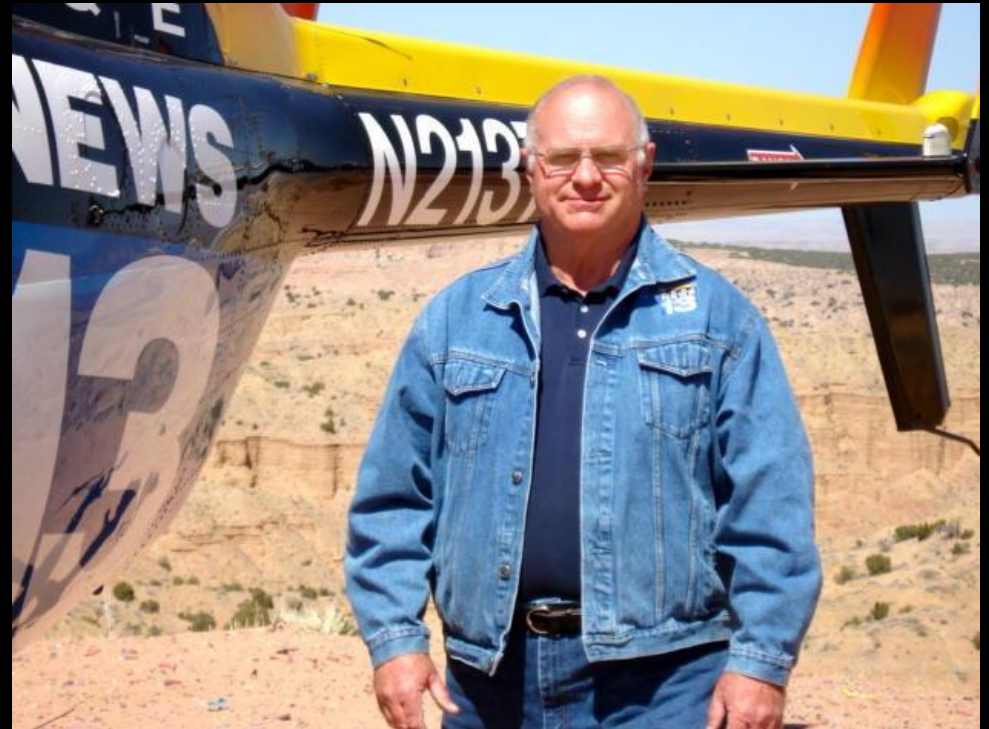
Bob Martin was the only person on board the helicopter when it impacted terrain.
